**РОССИЙСКИЙ МОРСКОЙ РЕГИСТР СУДОХОДСТВА  
RUSSIAN MARITIME REGISTER OF SHIPPING**

**ПРИЛОЖЕНИЕ К ПРАВИЛАМ  
РОССИЙСКОГО МОРСКОГО РЕГИСТРА СУДОХОДСТВА  
УНИФИЦИРОВАННЫЕ ИНТЕРПРЕТАЦИИ  
И РЕКОМЕНДАЦИИ  
МЕЖДУНАРОДНОЙ АССОЦИАЦИИ  
КЛАССИФИКАЦИОННЫХ ОБЩЕСТВ**

**IACS UNIFIED INTERPRETATIONS  
AND RECOMMENDATIONS**

НД № 2-020101-085-R-E

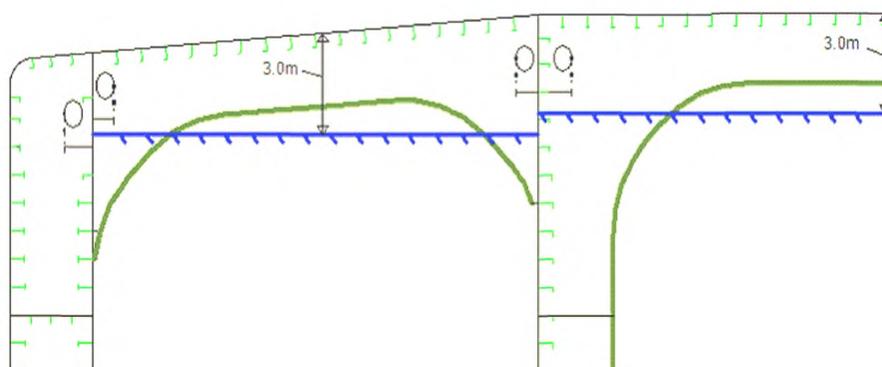
Where rafting is indicated in the ship structures access manual as the means to gain ready access to the under deck structure, the term “*similar obstructions*” referred to in the regulation includes internal structures (e.g., webs >1.5m deep) which restrict the ability to raft (at the maximum water level needed for rafting of under deck structure) directly to the nearest access ladder and hatchway to deck. When rafts or boats alone, as an alternative means of access, are allowed under the conditions specified in resolution A.744(18), permanent means of access are to be provided to allow safe entry and exit. This means:

- a) access direct from the deck via a vertical ladder and small platform fitted approximately 2m below the deck in each bay; or
- b) access to deck from a longitudinal permanent platform having ladders to deck in each end of the tank. The platform shall, for the full length of the tank, be arranged in level with, or above, the maximum water level needed for rafting of under deck structure. For this purpose, the ullage corresponding to the maximum water level is to be assumed not more than 3m from the deck plate measured at the midspan of deck transverses and in the middle length of the tank. (See Figure below). A permanent means of access from the longitudinal permanent platform to the water level indicated above is to be fitted in each bay (e.g., permanent rungs on one of the deck webs inboard of the longitudinal permanent platform).

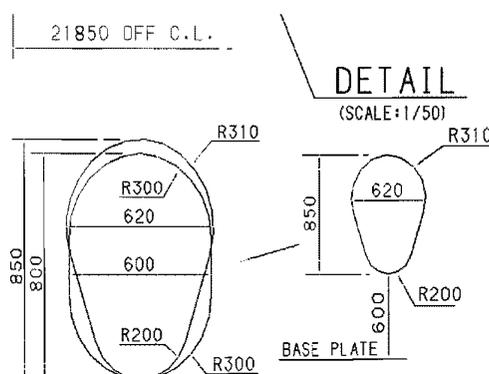
1. The minimum clear opening of not less than 600 mm x 800 mm may also include an opening with corner radii of 300 mm. An opening of 600mm in height x 800mm in width may be accepted as access openings in vertical structures where it is not desirable to make large opening in the structural strength aspects, i.e. girders and floors in double bottom tanks.
2. Subject to verification of easy evacuation of injured person on a stretcher the vertical opening 850 mm x 620 mm with wider upper half than 600 mm, while the lower half may be less than 600 mm with the overall height not less than 850 mm is considered an acceptable alternative to the traditional opening of 600 mm x 800 mm with corner radii of 300 mm.

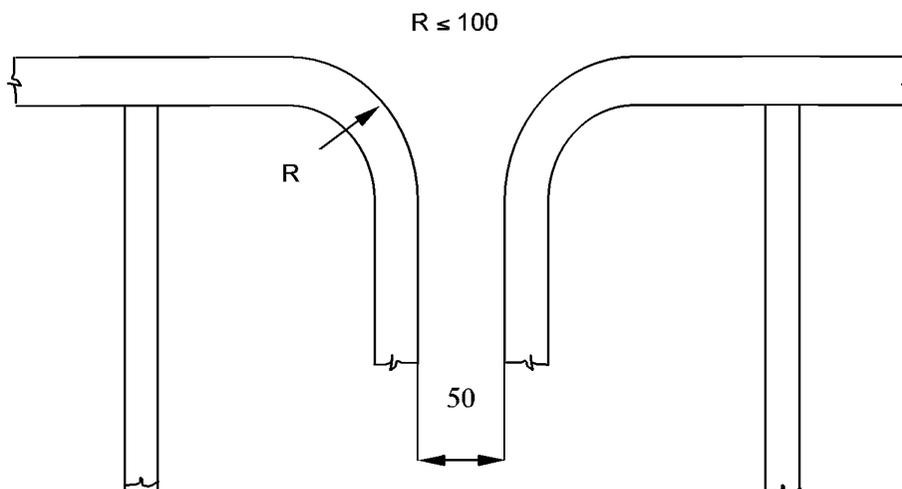
The maximum distance between the stanchion and other structural members is not to exceed 200 mm where the top and mid handrails are not connected together and 300 mm when they are connected together.

When the top and mid handrails are connected by a bent rail, the outside radius of the bent part is not to exceed 100 mm (see Figure below).

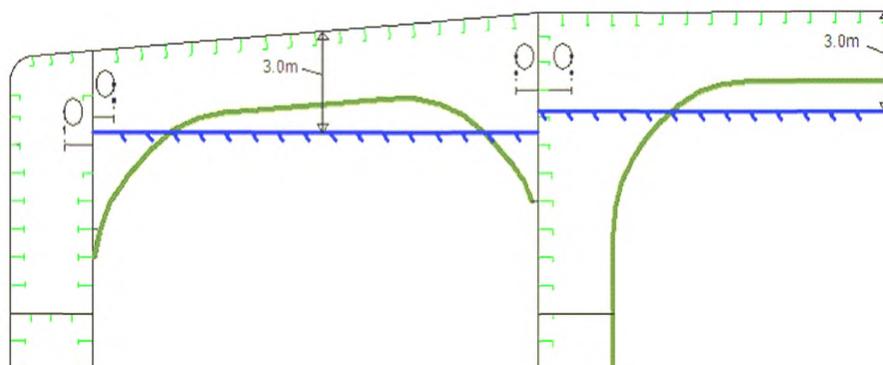
Where rafting is indicated in the ship structures access manual as the means to gain ready access to the under deck structure, the term "*similar obstructions*" referred to in the regulation includes internal structures (e.g., webs >1.5m deep) which restrict the ability to raft (at the maximum water level needed for rafting of under deck structure) directly to the nearest access ladder and hatchway to deck. When rafts or boats alone, as an alternative means of access, are allowed under the conditions specified in resolution A.744(18), A.1049(27) (2011 ESP Code), as amended, permanent means of access are to be provided to allow safe entry and exit. This means:

- a) access direct from the deck via a vertical ladder and small platform fitted approximately 2m below the deck in each bay; or
- b) access to deck from a longitudinal permanent platform having ladders to deck in each end of the tank. The platform shall, for the full length of the tank, be arranged in level with, or above, the maximum water level needed for rafting of under deck structure. For this purpose, the ullage corresponding to the maximum water level is to be assumed not more than 3m from the deck plate measured at the midspan of deck transverses and in the middle length of the tank. (See Figure below). A permanent means of access from the longitudinal permanent platform to the water level indicated above is to be fitted in each bay (e.g., permanent rungs on one of the deck webs inboard of the longitudinal permanent platform).

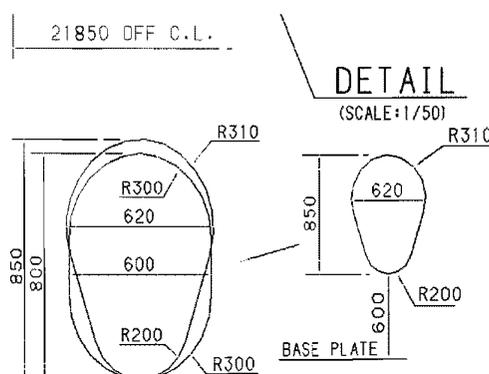
1. The minimum clear opening of not less than 600 mm x 800 mm may also include an opening with corner radii of 300 mm. An opening of 600mm in height x 800mm in width may be accepted as access openings in vertical structures where it is not desirable to make large opening in the structural strength aspects, i.e. girders and floors in double bottom tanks.
2. Subject to verification of easy evacuation of injured person on a stretcher the vertical opening 850 mm x 620 mm with wider upper half than 600 mm, while the lower half may be less than 600 mm with the overall height not less than 850 mm is considered an acceptable alternative to the traditional opening of 600 mm x 800 mm with corner radii of 300 mm.

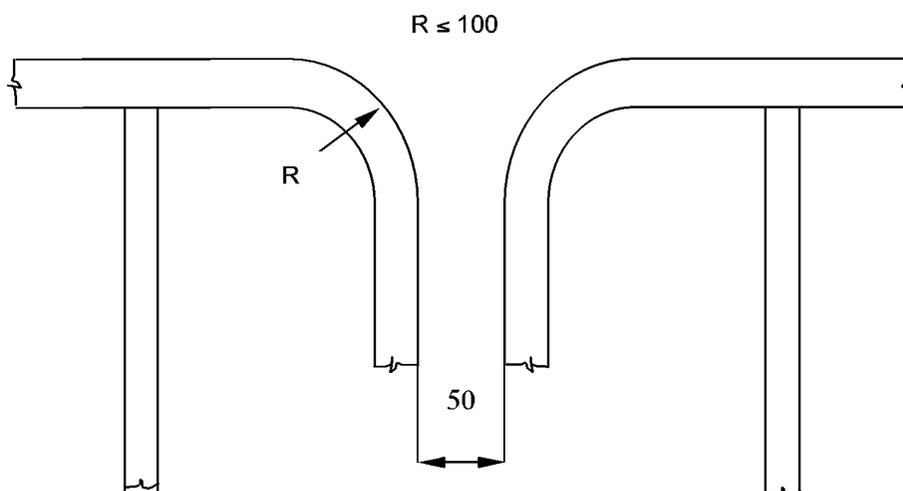
The maximum distance between the stanchion and other structural members is not to exceed 200 mm where the top and mid handrails are not connected together and 300 mm when they are connected together.

When the top and mid handrails are connected by a bent rail, the outside radius of the bent part is not to exceed 100 mm (see Figure below).

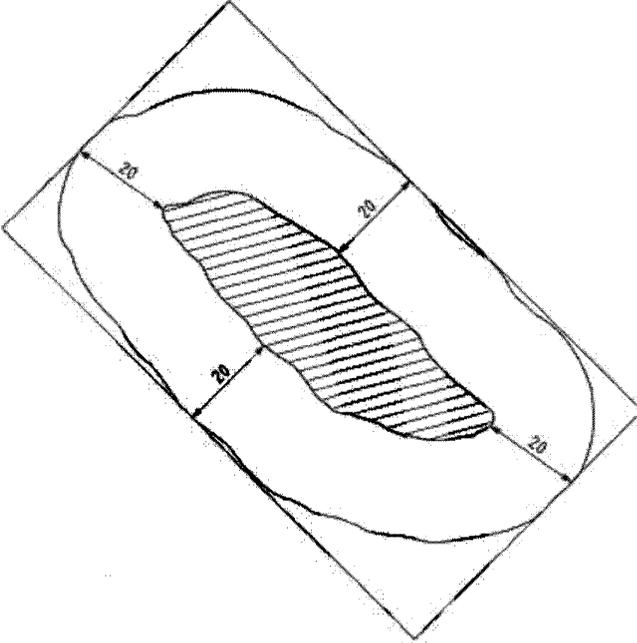
For isolated surface discontinuities, influenced area is obtained by drawing a continuous line which follows the circumference of the discontinuity at a distance of 20 mm. (Figure 1)

Figure 1 - Determination of the area influenced by an isolated discontinuity (Ref. Nr. EN 10163-1:2004+AC:2007 E)

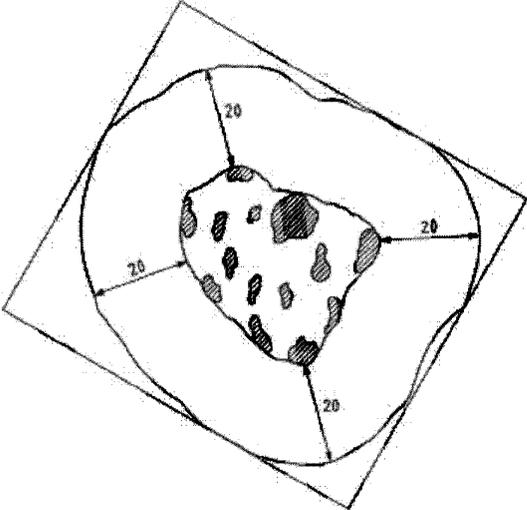
For surface discontinuities appearing in a cluster, influenced area is obtained by drawing a continuous line which follows the circumference of the cluster at a distance of 20 mm. (Figure 2)

Figure 2 - Determination of the area influenced by clustered discontinuities (Ref. Nr. EN 10163-1:2004+AC:2007 E)

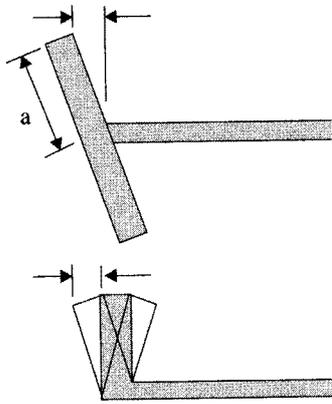
<p><math>\pm 1.5 \text{ mm}</math></p>	<p><math>\pm 3 \text{ mm}</math></p>	<p>per 100 mm of a</p>
<p>Distortion of face plate</p>

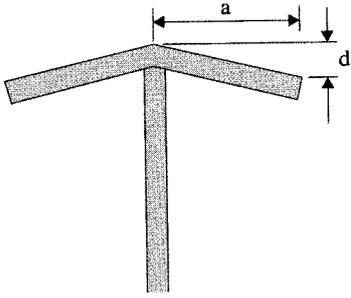
<p><math>d \leq 3 + a/100 \text{ mm}</math></p>	<p><math>d \leq 5 + a/100 \text{ mm}</math></p>	
<p>Distortion in plane of web and flange of built up longitudinal frame, transverse frame, girder and transverse web.</p>

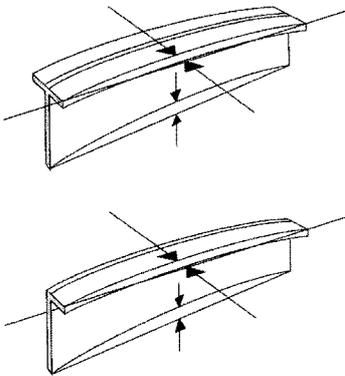
<p><math>\pm 10 \text{ mm}</math></p>	<p><math>\pm 25 \text{ mm}</math></p>	<p>per 10 m in length</p>

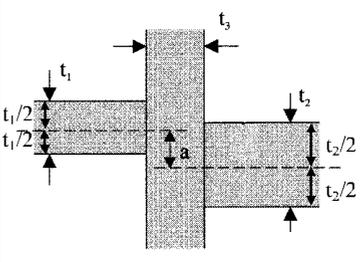
<p style="text-align: center;"><math>t_1 &lt; t_2</math></p>		<p>Strength member and higher stress member:  <math>a \leq t_1/3</math></p> <p>Other:  <math>a \leq t_1/2</math></p>	<p>Alternatively, heel line can be used to check the alignment.</p> <p>Where <math>t_3</math> is less than <math>t_1</math>, then <math>t_3</math> should be substituted for <math>t_1</math> in the standard.</p>
<p>Alignment of fillet welds</p>

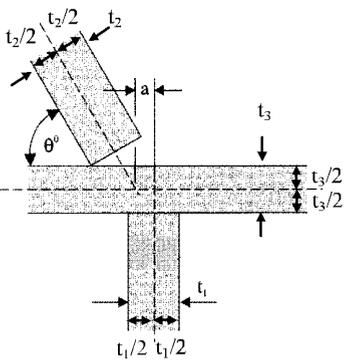
<p>Strength member and higher stress member:  <math>a \leq t_1/3</math></p> <p>Other:  <math>a \leq t_1/2</math></p>	<p>Alternatively, heel line can be used to check the alignment.</p> <p>Where <math>t_3</math> is less than <math>t_1</math>, then <math>t_3</math> should be substitute for <math>t_1</math> in the standard.</p>

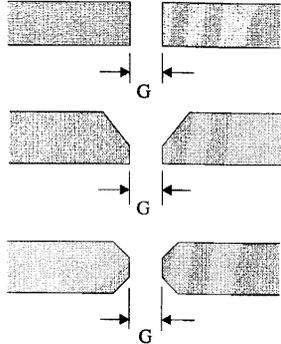
$0 \leq G \leq 0.8 \text{ mm}$	$G = 2 \text{ mm}$	See Note 1.
<p><b>NOTE 1</b></p> <p>Different plate edge preparation may be accepted or approved by the Classification Society in accordance with URW28 or other recognized standard accepted by the Classification Society.                      For welding procedures other than manual welding, see paragraph 3.2 Qualification of welding procedures.</p>

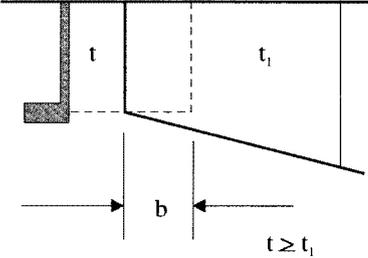
<p><math>t \geq t_1</math></p> <p><math>b = (2t + 25)\text{ mm, min. } 50\text{ mm}</math></p>	
<p>Gap between beam and frame</p>

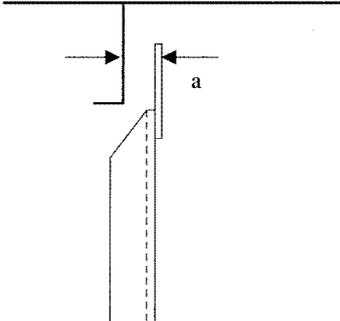
<p><math>3\text{ mm} &lt; a \leq 5\text{ mm}</math>: weld leg length to be increased by the same amount as increase in gap in excess of 3 mm</p> <p><math>a &gt; 5\text{ mm}</math> release and adjust</p>

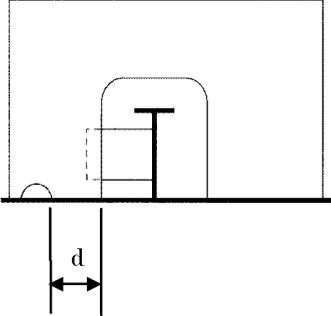
<p>When <math>d &lt; 75</math> mm web plate to be cut between scallop and slot, and collar plate to be fitted</p>

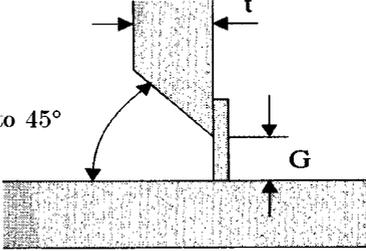
<p><math>3 \text{ mm} &lt; G \leq 5 \text{ mm}</math> – leg length increased to Rule leg + (G-2)</p> <hr/> <p><math>5 \text{ mm} &lt; G \leq 16 \text{ mm}</math> or <math>G \leq 1.5t</math> - chamfer by <math>30^\circ</math> to <math>45^\circ</math>, build up with welding, on one side, with backing strip if necessary, grind and weld.</p>

<p><math>30^\circ</math> to <math>45^\circ</math></p> <hr/> <p><math>G &gt; 16 \text{ mm}</math> or <math>G &gt; 1.5t</math> use insert plate of minimum width 300 mm</p>

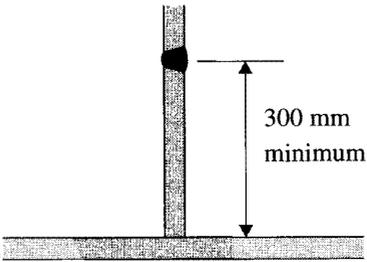
<p>300 mm minimum</p>	
<p>Liner treatment</p>

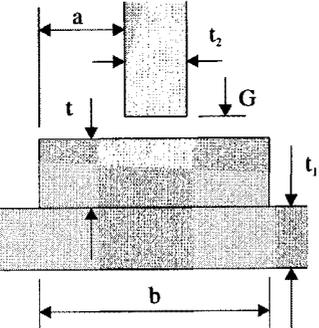
<p><math>t_2 \leq t \leq t_1</math>  <math>G \leq 2 \text{ mm}</math>  <math>a = 5 \text{ mm} + \text{fillet leg length}</math></p>	<p>Not to be used in cargo area or areas of tensile stress through the thickness of the liner</p>

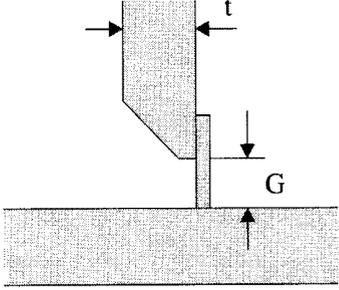
<p><math>3 \text{ mm} &lt; G \leq 5 \text{ mm}</math> build up weld</p> <hr/> <p><math>5 \text{ mm} &lt; G \leq 16 \text{ mm}</math> - build up with welding, with backing strip if necessary, remove backing strip if used, back gouge and back weld.</p>

<hr/> <p><math>G &gt; 16 \text{ mm}</math> new plate to be inserted of minimum width 300 mm</p>

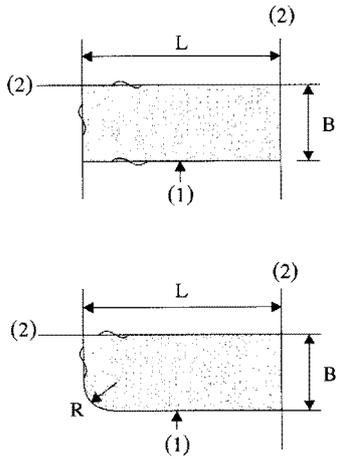
<p> <math>L = 300 \text{ mm minimum}</math>  <math>B = 300 \text{ mm minimum}</math>  <math>R = 5t \text{ mm}</math>  <math>100\text{mm minimum}</math> </p> <p>(1) seam with insert piece is to be welded first</p> <p>(2) original seam is to be released and welded over for a minimum of 100 mm.</p>	
<p>Remedial of built section by insert plate</p>

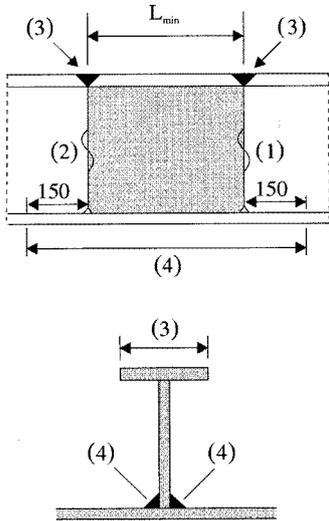
<p> <math>L_{\min} \geq 300 \text{ mm}</math> </p> <p>Welding sequence  <math>(1) \rightarrow (2) \rightarrow (3) \rightarrow (4)</math> </p> <p>Web butt weld scallop to be filled during final pass (4)</p>

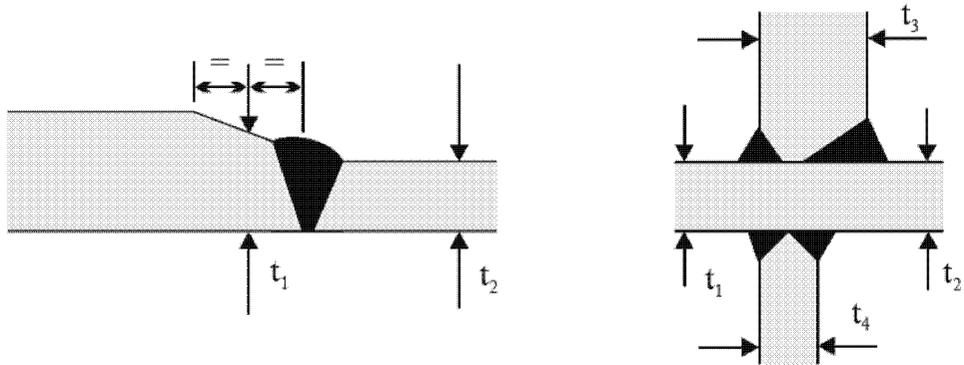
2) Combined thickness  $t_{comb} = t_1 + t_2 + t_3 + t_4$ , see figure

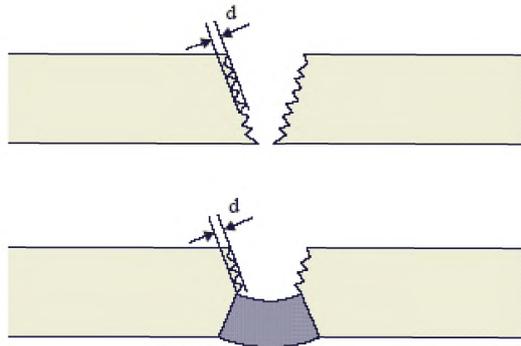
Fig 6.1 Groove roughness

Item	Standard	Limit	Remarks
Material Grade	Same as original or higher		See Section 4
Welding Consumables	IACS UR W17 (ref. 6)	Approval according to equivalent international standard	
Groove / Roughness	See note and Fig 6.1	$d < 1.5 \text{ mm}$	Grind smooth
Pre-Heating	See Table 5.1	Steel temperature not lower than 5°C	
Welding with water on the outside	See Section 5.3	Acceptable for normal and high strength steels	- Moisture to be removed by a heating torch
Alignment	As for new construction		
Weld Finish	IACS Recommendation 20 (ref. 10)		
NDE	IACS Recommendation 20 (ref. 10)	At random with extent to be agreed with attending surveyors

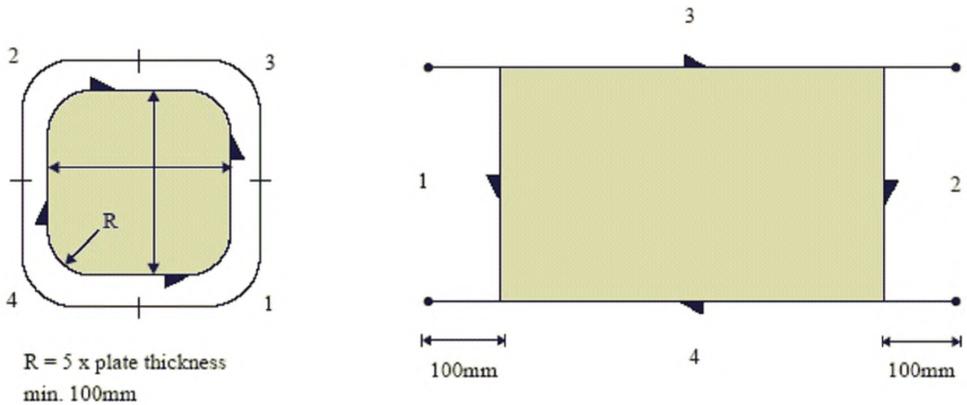
**Fig 6.2 Welding sequence for inserts**

Item	Standard	Limit	Remarks
Size Insert	Min. 300 x 300 mm R = 5 x thickness Circular inserts: $D_{\min} = 200 \text{ mm}$	Min. 200 x 200 mm Min R = 100 mm	
Material Grade	Same as original or higher		See Section 4.
Edge Preparation	As for new construction		In case of non compliance increase the amount of NDE
Welding Sequence	See Fig 6.2 Weld sequence is 1 → 2 → 3 → 4		For primary members sequence 1 and 2 transverse to the main stress direction
Alignment	As for new construction		
Weld Finish	IACS Recommendation 20 (ref. 10)		
NDE	IACS Recommendation 20 (ref. 10)

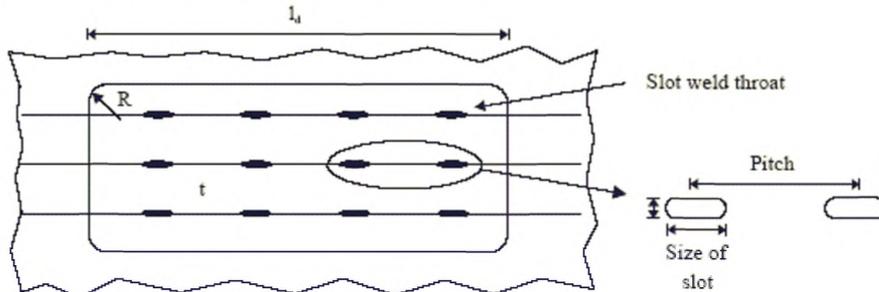
Fig 6.3 Doublers on plates

Local doublers are normally only allowed as temporary repairs, except as original compensation for openings, within the main hull structure.

Item	Standard	Limit	Remarks
Existing Plating		General: $t \geq 5$ mm	For areas where existing plating is less than 5 mm plating a permanent repair by insert is to be carried out.
Extent / Size	Rounded off corners.	min 300 x 300 mm $R \geq 50$ mm	
Thickness of Doubler (td)	$td \leq tp$ ( $tp$ = original thickness of existing plating)	$td > tp/3$	
Material Grade	Same as original plate		See Section 4
Edge Preparation	As for [newbuilding] new construction		Doublers welded on primary strength members: ( $Le$ : leg length) when $t > Le + 5$ mm, the edge to be tapered (1:4)
Welding	As for [newbuilding] new construction		Welding sequence similar to insert plates.
Weld Size (throat thickness)	Circumferencial and in slots: $0.6 \times td$		
Slot Welding	Normal size of slot: (80-100) x 2 td  Distance from doubler edge and between slots: $d \leq 15 td$	Max pitch between slots 200 mm  $d_{max} = 500$ mm	For doubler extended over several supporting elements, see Figure 6.3

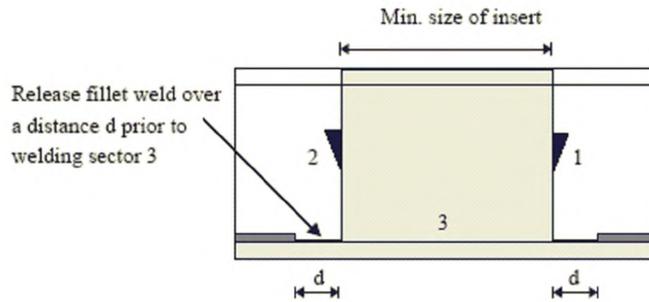
**Fig 6.4 Welding sequence for inserts of stiffeners**

Item	Standard	Limit	Remarks
Size Insert	Min. 300 mm	Min. 200 mm	
Material Grade	Same as original or higher		See Section 4.
Edge Preparation	As for new construction. Fillet weld stiffener web / plate to be released over min. $d = 150$ mm		
Welding Sequence	See Fig 6.4 Welding sequence is 1 → 2 → 3		
Alignment	As for new construction		
Weld Finish	IACS Recommendation 20 (ref. 10)		
NDE	IACS Recommendation 20 (ref. 10)

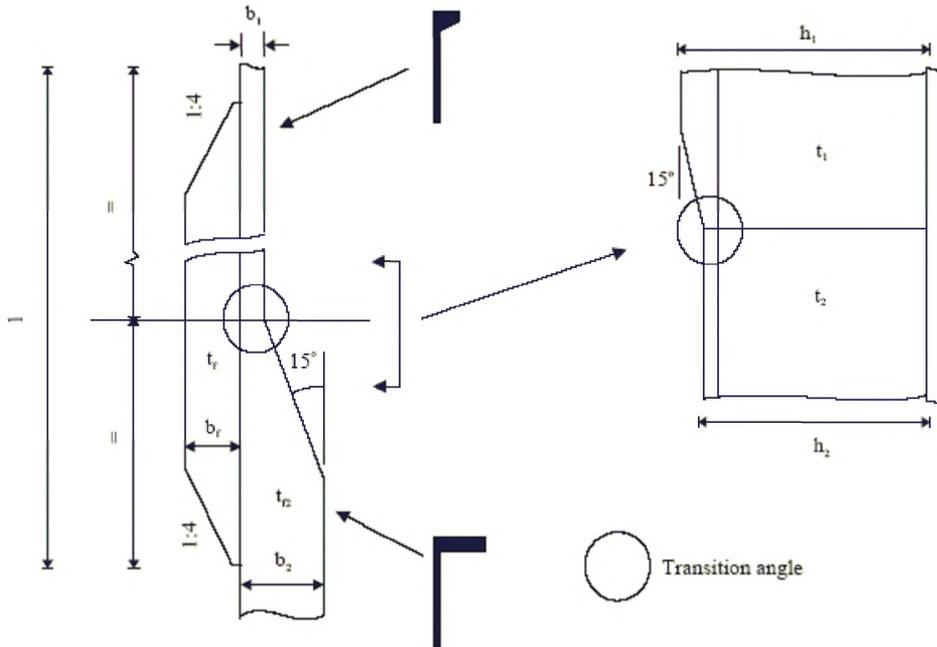
**Fig 6.5 Transition between inverted angle and bulb profile**

The application of the transition is allowed for secondary structural elements.

Item	Standard	Limit	Remarks
$(h_1 - h_2)$	$\leq 0.25 \times b_1$		
$ t_1 - t_2 $	2 mm		Without tapering transition.
Transition Angle	15 degrees		At any arbitrary section
Flanges	$t_f = t_{f_2}$ $b_f = b_{f_2}$		
Length of Flatbar	$4 \times h_1$		
Material			See Section 4.

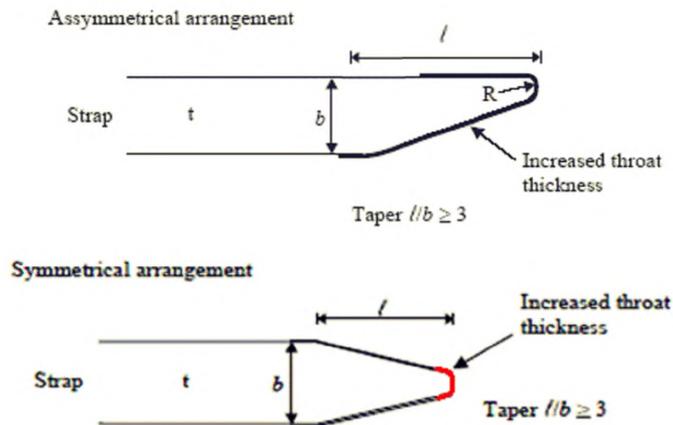
Fig 6.6 Application of Doubling Straps

- the end termination points of the straps, so that toe support is such that no isolated hard point occurs.
- in the case of application of symmetrical or asymmetrical-ended straps, the corners at the end of the tapering should be properly rounded.
- any butts between lengths of doubling straps, so that there is adequate separation of the butt weld from the primary structure below during welding, and so that a high quality root run under controlled circumstances is completed prior to completing the remainder of the weld. Ultrasonic testing should be carried out on completion to verify full penetration.

Item	Standard	Limit	Remarks
Tapering	$l/b > 3$		Special consideration to be drawn to design of strap terminations in fatigue sensitive areas.
Radius	$0.1 \times b$	min 30 mm	
Material			See paragraph 2.0 General requirement to materials.
Weld Size			Depending on number and function of straps. Throat thickness to be increased 15 % toward ends.
Welding	Welding sequence from middle towards the free ends		See sketch. For welding of lengths > 1000 mm step welding to be applied.

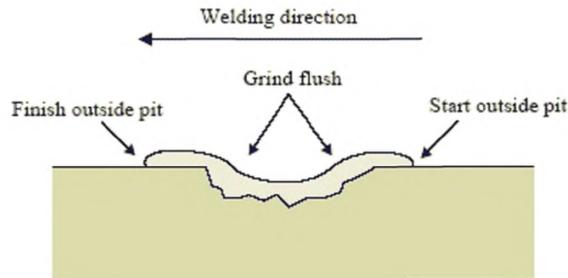
Fig 6.7 Welding of pits

Shallow pits may be filled by applying coating or pit filler. Pits can be defined as shallow when their depth is less than  $\frac{1}{3}$  of the original plate thickness.

Item	Standard	Limit	Remarks
Extent / Depth	Pits / grooves are to be welded flush with the original surface.	If deep pits or grooves are clustered together or remaining thickness is less than 6 mm, the plates should be renewed.	See also IACS Recommendation 12 (ref. 9)
Cleaning	Heavy rust to be removed		
Pre-Heating	See Table 5.1	Required when ambient temperature < 5°C	Always use propane torch or similar to remove any moisture
Welding Sequence	Reverse direction for each layer		See also IACS Recommendation 12 (ref. 9)
Weld Finish	IACS Recommendation 20 (ref. 10)		
NDE	IACS Recommendation 20 (ref. 10)	Min. 10% extent	Preferably MPI

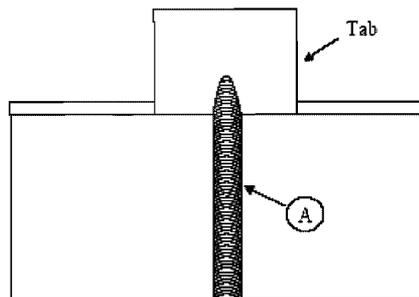
Fig 6.8.b End crack termination

Item	Standard	Limit	Remarks
Groove Preparation	$\theta = 45-60^\circ$ $r = 5 \text{ mm}$		For through plate cracks as for newbuilding. Also see Fig 6.8.d
Termination	Termination to have slope 1:3		For cracks ending on edges weld to be terminated on a tab see Fig 6.8.b
Extent	On plate max. 400 mm length. Vee out 50 mm past end of crack	On plate max 500 mm. Linear crack, not branched	
Welding Sequence	See Fig 6.8.c for sequence and direction	For cracks longer than 300 mm step-back technique should be used Fig 6.8.a	Always use low hydrogen welding consumables
Weld Finish	IACS Recommendation 20 (ref. 10)		
NDE	IACS Recommendation 20 (ref. 10)	100 % MP or PE of groove	100 % surface crack detection + UE or RE for butt joints

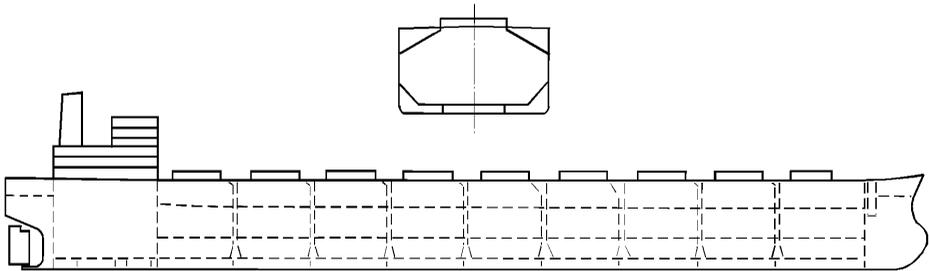
**Figure 1** General view of a typical single skin bulk carrier

This manual gives guidelines for a bulk carrier type ship which is constructed with a single deck, single skin, double bottom, hopper side tanks and topside tanks in cargo spaces, and is intended primarily to carry dry cargo, including ore, in bulk. **Figure 1** shows the general view of a typical single skin bulk carrier with 9 cargo holds.

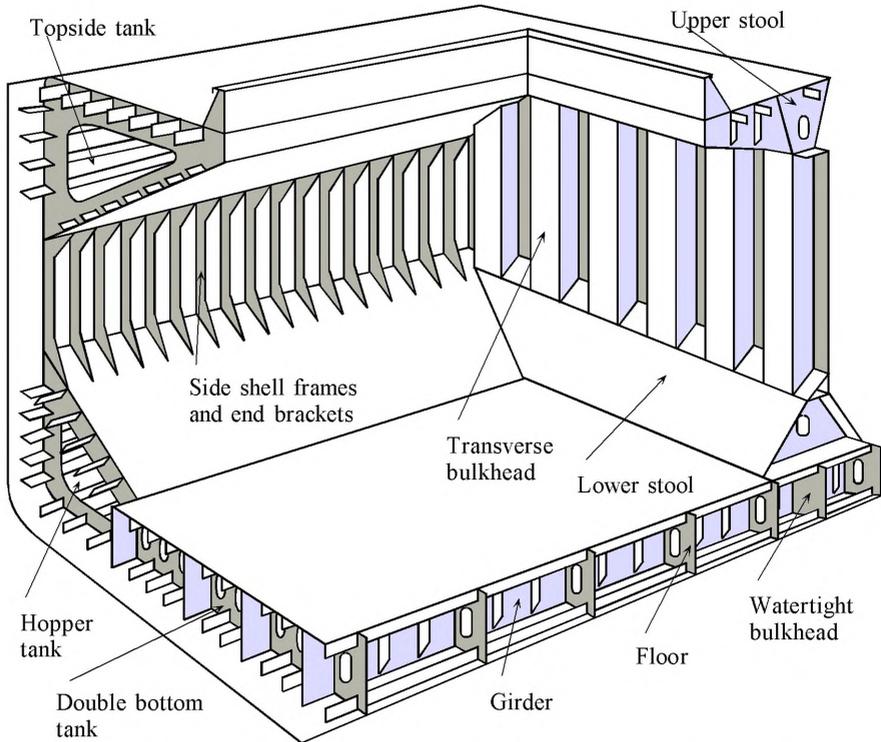
**Figure 2 Typical cargo hold configuration for a single skin bulk carrier**

**Figure 2** shows a typical cargo hold structural arrangement in way of cargo hold region.

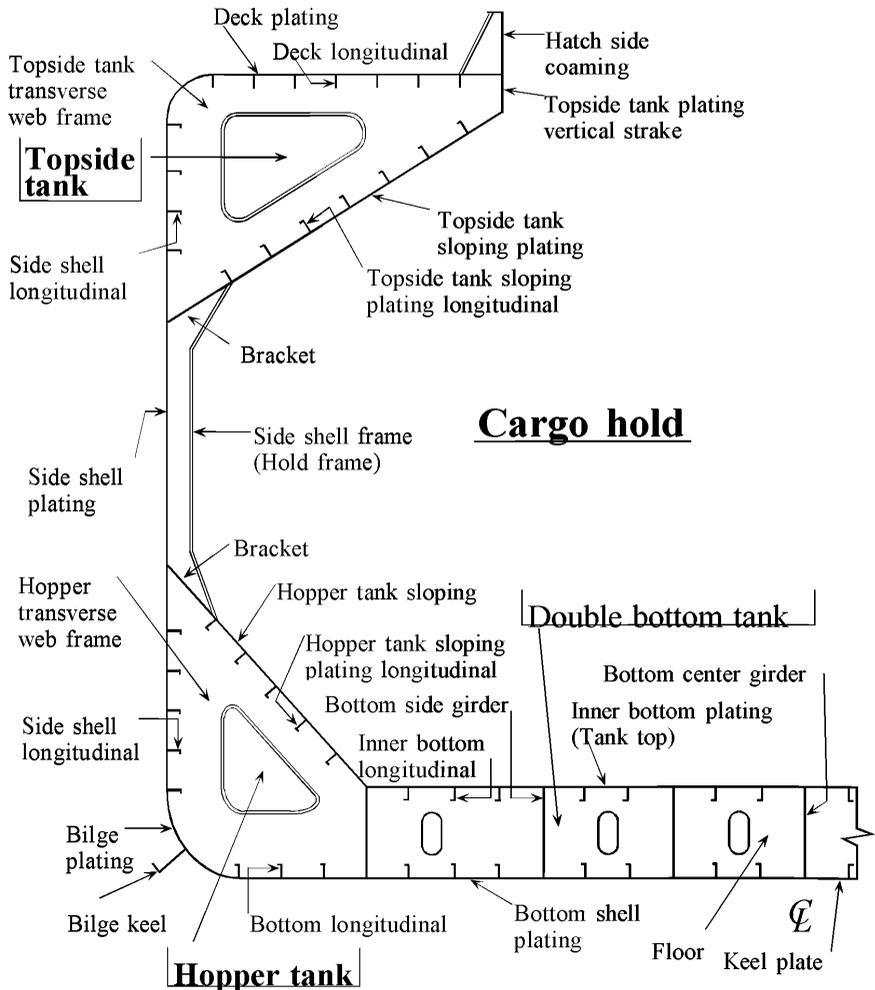
**Figure 3 (a) Nomenclature for typical transverse section in way of cargo hold**

**3.2.1** For clarity of definition and reporting of survey data, it is recommended that standard nomenclature for structural elements be adopted. Typical sections in way of cargo holds are illustrated in **Figures 3 (a)** and **(b)**. These figures show the generally accepted nomenclature.

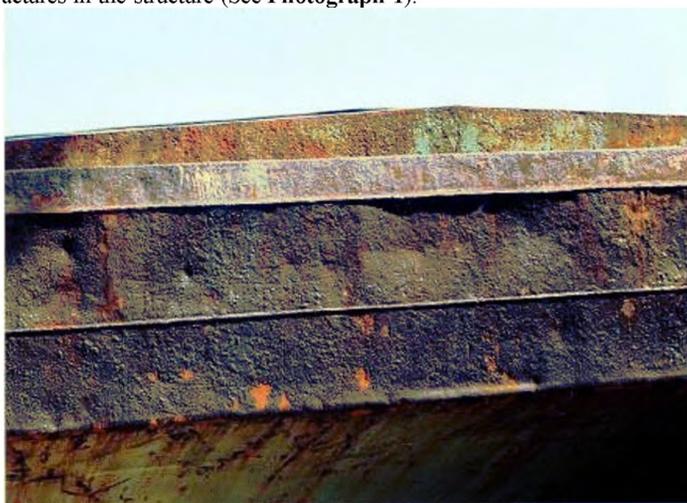
**Photograph 1** Heavy corrosion of hatch coaming and topside tank plating vertical strake

- 3.1.1 The level of wastage of under-deck stiffeners/structure in cross deck may have to be established by means of thickness measurements. The combined effect of the marine environment and the high humidity atmosphere within cargo hold s will give rise to a high corrosion rate.
- 3.1.2 Severe corrosion of the hatch coaming plating inside cargo hold and topside tank plating vertical strake may occur due to difficult access for the maintenance of the protective coating. This may lead to fractures in the structure (See **Photograph 1**).

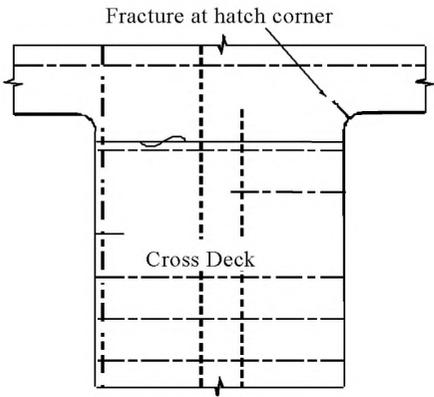
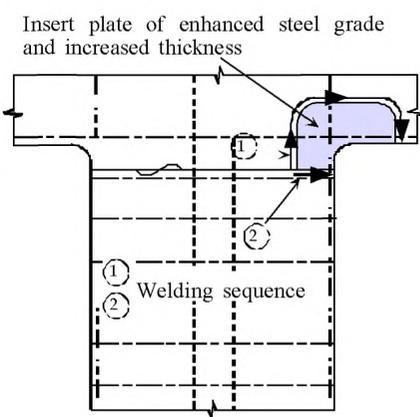
<b>BULK CARRIERS</b>		<b>Guidelines for Surveys, Assessment and Repair of Hull Structure</b>	
<b>Part 1</b>	<b>Cargo hold region</b>	<b>Example No.</b>	
<b>Area 1</b>	<b>Deck structure</b>	<b>1</b>	
<b>Detail of damage</b>		Fractures at main cargo hatch corner	
<b>Sketch of damage</b>		<b>Sketch of repair</b>

<b>Notes on possible cause of damage</b>		<b>Notes on repairs</b>	
<ol style="list-style-type: none"> <li>1. Stress concentration at hatch corners, i.e. radius of corner.</li> <li>2. Welded attachment of shedder plate close to edge of hatch corner.</li> <li>3. Wire rope groove.</li> </ol>		<ol style="list-style-type: none"> <li>1. The corner plating in way of the fracture is to be cropped and renewed. If stress concentration is primary cause, insert plate should be increased thickness, enhanced steel grade and/or improved geometry. Insert plate should be continued beyond the longitudinal and transverse extent of the hatch corner radius ellipse or parabola, and the butt welds to the adjacent deck plating should be located well clear of the butts in the hatch coaming. It is recommended that the edges of the insert plate and the butt welds connecting the insert plates to the surrounding deck plating be made smooth by grinding. In this respect caution should be taken to ensure that the micro grooves of the grinding are parallel to the plate edge.</li> <li>2. If the cause of fracture is welded attachment of shedder plate, the deck connection should be left unwelded.</li> <li>3. If the cause of the fracture is wire rope groove, replacement to the original design can be accepted.</li> </ol>

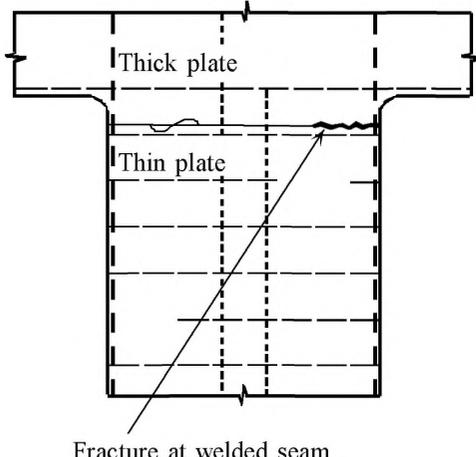
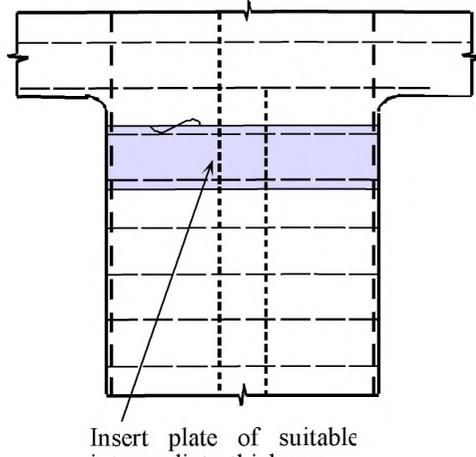
<b>BULK CARRIERS</b>		<b>Guidelines for Surveys, Assessment and Repair of Hull Structure</b>	
<b>Part 1</b>	<b>Cargo hold region</b>	<b>Example No.</b>	
<b>Area 1</b>	<b>Deck structure</b>	<b>2-a</b>	
<b>Detail of damage</b>	Fractures of welded seam between thick plate and thin plate at cross deck		
<b>Sketch of damage</b>		<b>Sketch of repair</b>

<p>Thick plate</p> <p>Thin plate</p> <p>Fracture at welded seam</p>

<p>Insert plate of suitable intermediate thickness</p>	
<b>Notes on possible cause of damage</b>		<b>Notes on repairs</b>	
<ol style="list-style-type: none"> <li>1. Stress concentration created by abrupt change in deck plating thickness.</li> <li>2. In-plane bending in cross deck strip due to torsional (longitudinal) movements of ship sides.</li> <li>3. Welded seam not clear of tangent point of hatch corner.</li> </ol>		<ol style="list-style-type: none"> <li>1. Insert plate of intermediate thickness is recommended.</li> <li>2. Smooth transition between plates (beveling) should be considered.</li> </ol>

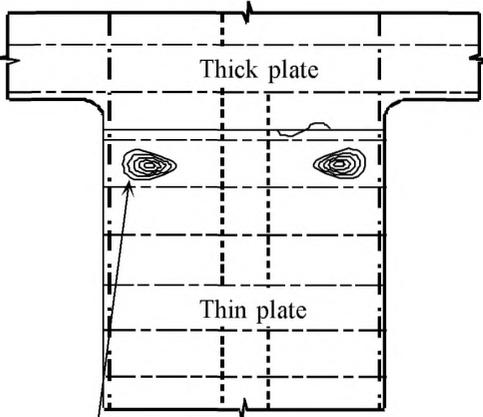
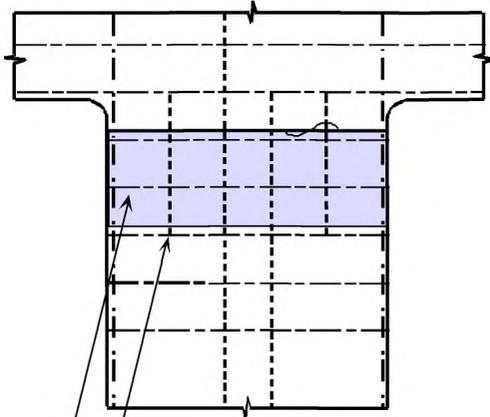
<b>BULK CARRIERS</b>		<b>Guidelines for Surveys, Assessment and Repair of Hull Structure</b>	
<b>Part 1</b>	<b>Cargo hold region</b>	<b>Example No.</b>	
<b>Area 1</b>	<b>Deck structure</b>	<b>2-b</b>	
<b>Detail of damage</b>	Plate buckling in thin plate near thick plate at cross deck		
<b>Sketch of damage</b>		<b>Sketch of repair</b>

<p>Buckling of cross deck plating (Buckling of hatch end structure should be examined. Refer to <b>Example 7-a.</b>)</p>

<p>Additional transverse stiffening and/or insertion of plate with suitable intermediate thickness</p>	
<b>Notes on possible cause of damage</b>		<b>Notes on repairs</b>	
<ol style="list-style-type: none"> <li>1. In-plane bending of cross deck strip due to torsional (longitudinal) movement of ship sides, often in combination with corrosion.</li> <li>2. Insufficient plate thickness and/or transverse stiffening.</li> </ol>		<ol style="list-style-type: none"> <li>1. Transverse stiffeners extending from hatch sides towards centerline at least 10% of breadth of hatch, and/or increased plate thickness in the same area.</li> </ol>

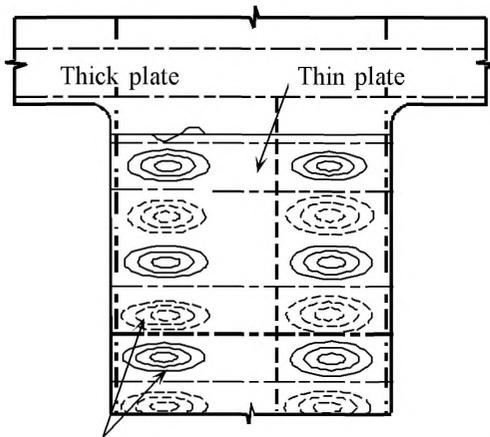
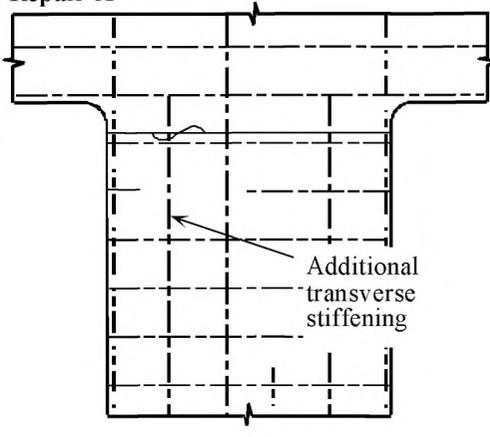
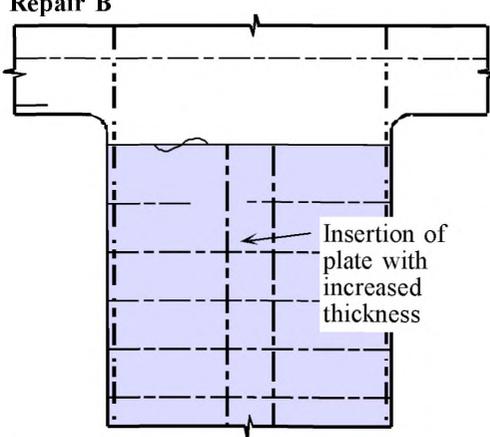
<b>BULK CARRIERS</b>		<b>Guidelines for Surveys, Assessment and Repair of Hull Structure</b>	
<b>Part 1</b>	<b>Cargo hold region</b>	<b>Example No.</b>	
<b>Area 1</b>	<b>Deck structure</b>	<b>2-c</b>	
<b>Detail of damage</b>		Overall buckling of cross deck plating	
<p><b>Sketch of damage</b></p>

<p>Buckling of cross deck plating (Buckling of hatch end structure should be examined. Refer to Example 7-a.)</p>		<p><b>Sketch of repair</b></p> <p><b>Repair A</b></p>

<p>Additional transverse stiffening</p> <p><b>Repair B</b></p>

<p>Insertion of plate with increased thickness</p>	
<p><b>Notes on possible cause of damage</b></p> <ol style="list-style-type: none"> <li>1. Transverse compression of deck due to sea load.</li> <li>2. Transverse compression of deck due to excessive loading in two adjacent holds.</li> <li>3. Insufficient plate thickness and/or transverse stiffening.</li> </ol>		<p><b>Notes on repairs</b></p> <ol style="list-style-type: none"> <li>1. <b>Repair A</b> Plating of original thickness in combination with additional transverse stiffening.</li> <li>2. <b>Repair B</b> Insertion of plating of increased thickness.</li> </ol>

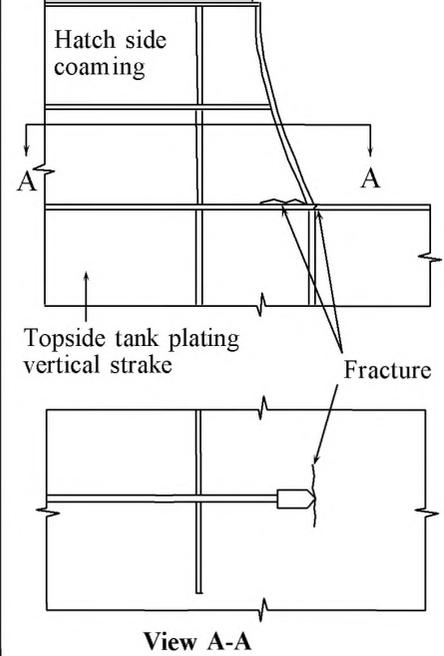
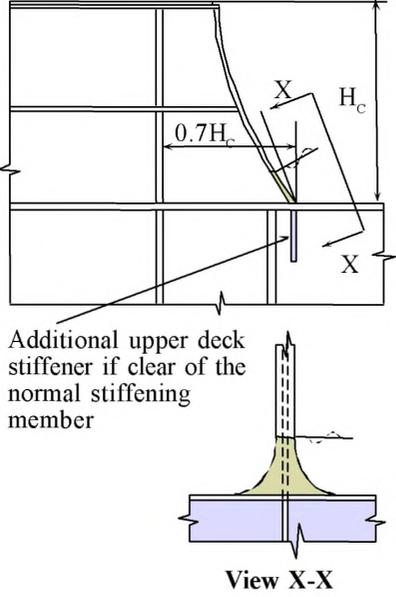
<b>BULK CARRIERS</b>		<b>Guidelines for Surveys, Assessment and Repair of Hull Structure</b>	
<b>Part 1</b>	<b>Cargo hold region</b>	<b>Example No.</b>	
<b>Area 1</b>	<b>Deck structure</b>	<b>3-a</b>	
<b>Detail of damage</b>		Fractures in the web or in the deck at the toes of the longitudinal hatch coaming termination bracket	
<p><b>Sketch of damage</b></p>

<p><b>View A-A</b></p>		<p><b>Sketch of repair</b></p>

<p><b>View X-X</b></p>	
<p><b>Notes on possible cause of damage</b></p> <ol style="list-style-type: none"> <li>1. This damage is caused by stress concentrations attributed to the design of the bracket.</li> </ol>		<p><b>Notes on repairs</b></p> <ol style="list-style-type: none"> <li>1. The design of the bracket can be altered as shown above, however, it is to be ensured that an additional under deck stiffener is provided at the toe of the termination bracket, where the toe is clear of the normal stiffening member.</li> <li>2. Full penetration weld for a distance of <math>0.15 H_C</math> from toe of side coaming termination bracket and for connection of athwartship gusset bracket to deck.</li> <li>3. The fracture in deck plating to be veed-out and rewelded or deck plating cropped and part renewed as appropriate, using low hydrogen electrodes for welding.</li> </ol>

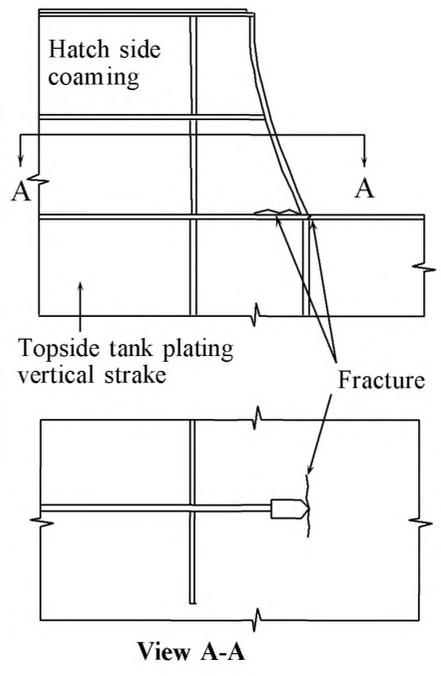
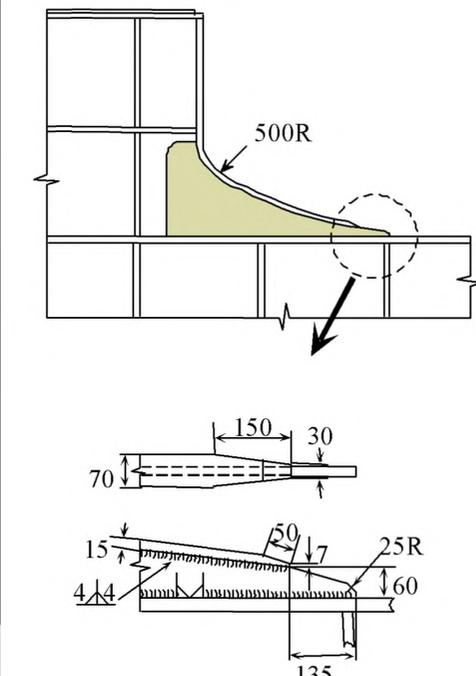
<b>BULK CARRIERS</b>		<b>Guidelines for Surveys, Assessment and Repair of Hull Structure</b>	
<b>Part 1</b>	<b>Cargo hold region</b>	<b>Example No.</b>	
<b>Area 1</b>	<b>Deck structure</b>	<b>3-b</b>	
<b>Detail of damage</b>		Fractures in the web or in the deck at the toes of the longitudinal hatch coaming termination bracket	
<p><b>Sketch of damage</b></p>

<p>Hatch side coaming</p> <p>Topside tank plating vertical strake</p> <p>Fracture</p> <p>View A-A</p>		<p><b>Sketch of repair</b></p>

<p>500R</p> <p>150 30</p> <p>70</p> <p>15 50 7 25R 60</p> <p>135</p>	
<p><b>Notes on possible cause of damage</b></p> <ol style="list-style-type: none"> <li>1. This damage is caused by stress concentrations attributed to the design of the bracket.</li> </ol>		<p><b>Notes on repairs</b></p> <ol style="list-style-type: none"> <li>1. The design of the bracket can be altered as shown above, however, it is to be ensured that an additional under deck stiffener is provided at the toe of the termination bracket, where the toe is clear of the normal stiffening member.</li> <li>2. The fracture in deck plating to be veed-out and rewelded or deck plating cropped and part renewed as appropriate, using low hydrogen electrodes for welding.</li> </ol>

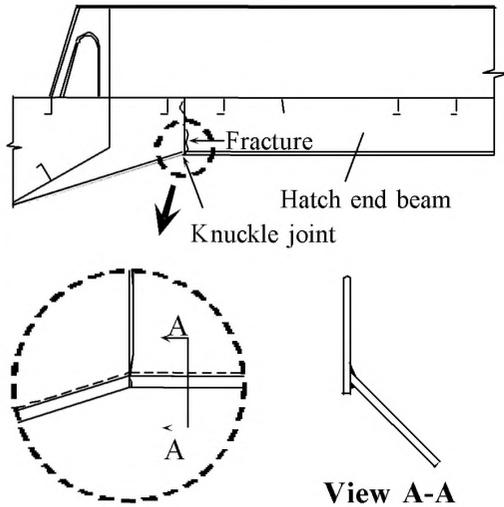
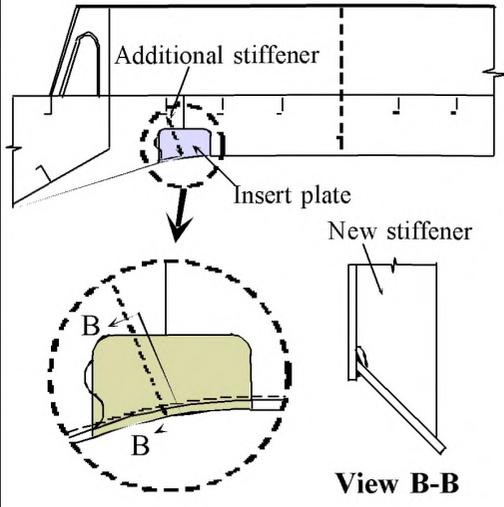
<b>BULK CARRIERS</b>		<b>Guidelines for Surveys, Assessment and Repair of Hull Structure</b>
<b>Part 1</b>	<b>Cargo hold region</b>	<b>Example No.</b>
<b>Area 1</b>	<b>Deck structure</b>	<b>7-b</b>
<b>Detail of damage</b>		Fractures in hatch end beam at knuckle joint
<b>Sketch of damage</b>

<b>Sketch of repair</b>

<b>Notes on possible cause of damage</b> 1. Stress concentration at knuckle joint.		<b>Notes on repairs</b> 1. Fractured part to be cropped and renewed. 2. Improvement to avoid stress concentration at knuckle joint should be considered.

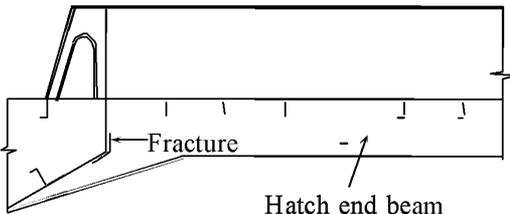
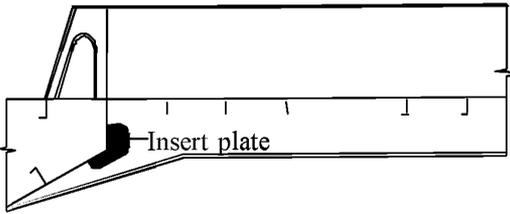
<b>BULK CARRIERS</b>		<b>Guidelines for Surveys, Assessment and Repair of Hull Structure</b>	
<b>Part 1</b>	<b>Cargo hold region</b>	<b>Example No.</b>	
<b>Area 1</b>	<b>Deck structure</b>	<b>8</b>	
<b>Detail of damage</b>		Fractures in hatch end beam at the joint to topside tank	
<b>Sketch of damage</b>		<b>Sketch of repair</b>

<b>Notes on possible cause of damage</b>		<b>Notes on repairs</b>	
<ol style="list-style-type: none"> <li>1. Misalignment of the hatch end beam with transverse web frame in topside tank.</li> <li>2. Stress concentration.</li> </ol>		<ol style="list-style-type: none"> <li>1. Fractured part to be cropped and renewed.</li> </ol>

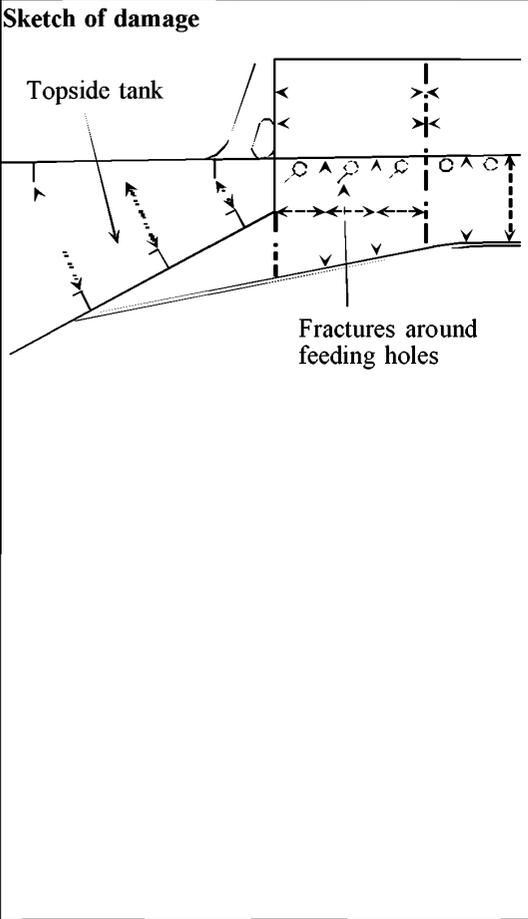
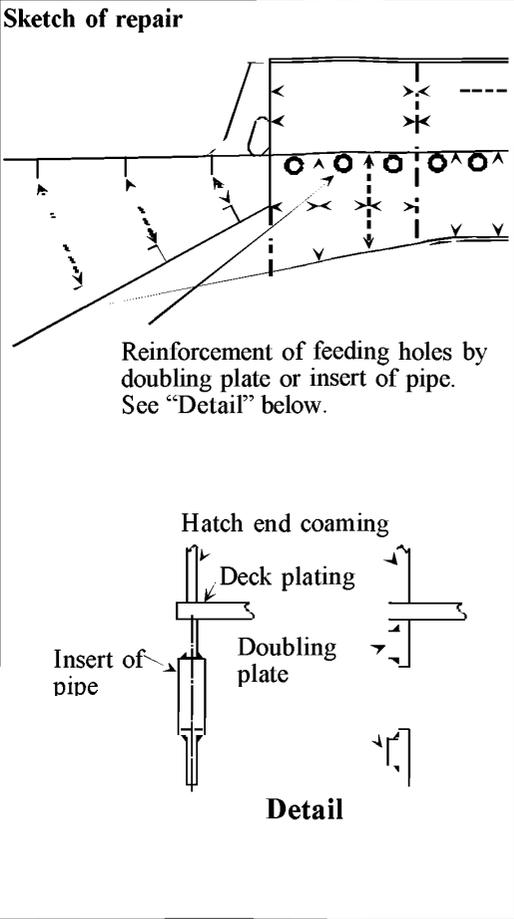
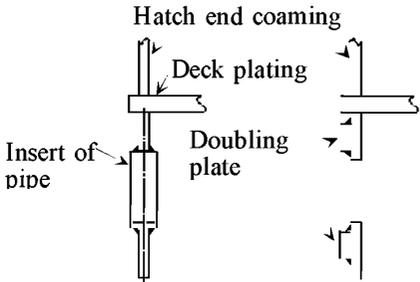
<b>BULK CARRIERS</b>		<b>Guidelines for Surveys, Assessment and Repair of Hull Structure</b>	
<b>Part 1</b>	<b>Cargo hold region</b>	<b>Example No.</b>	
<b>Area 1</b>	<b>Deck structure</b>	<b>9</b>	
<b>Detail of damage</b>		Fractures in hatch end beam around feeding holes	
<p><b>Sketch of damage</b></p>

<p><b>Sketch of repair</b></p>

<b>Detail</b> </p>	
<p><b>Notes on possible cause of damage</b></p> <ol style="list-style-type: none"> <li>1. Inadequate reinforcement around feeding hole.</li> <li>2. Corrosion.</li> </ol>		<p><b>Notes on repairs</b></p> <ol style="list-style-type: none"> <li>1. Fractured part to be veed-out or cropped and renewed.</li> <li>2. If the fractured part is free from corrosion, reinforcement should be considered.</li> </ol>

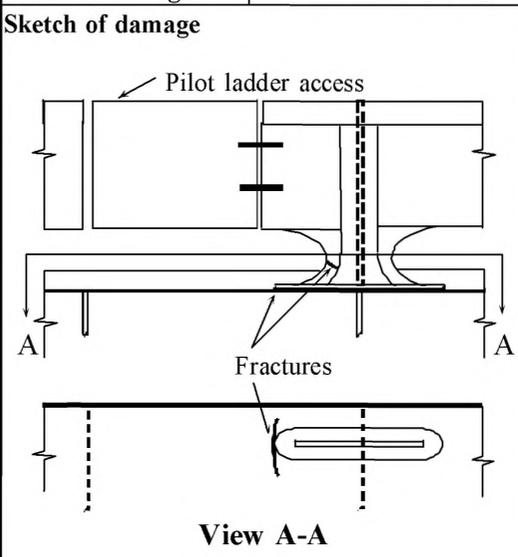
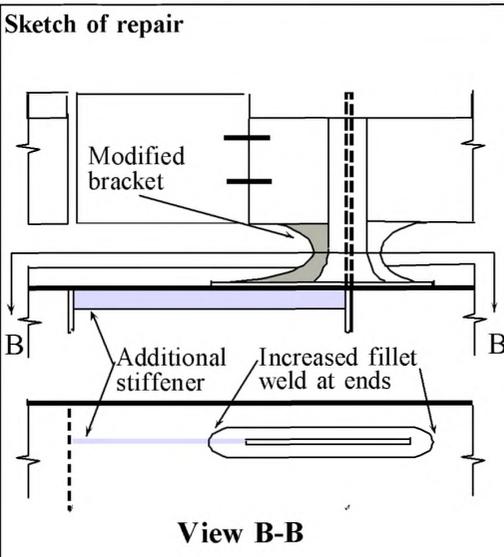
<b>BULK CARRIERS</b>		<b>Guidelines for Surveys, Assessment and Repair of Hull Structure</b>	
<b>Part 1</b>	<b>Cargo hold region</b>	<b>Example No.</b>	
<b>Area 1</b>	<b>Deck structure</b>	<b>12</b>	
<b>Detail of damage</b>		Fractures in deck plating at the pilot ladder access of bulwarks	
<b>Sketch of damage</b>		<b>Sketch of repair</b>

<p>Pilot ladder access</p> <p>Fractures</p> <p>View A-A</p>

<p>Modified bracket</p> <p>Additional stiffener</p> <p>Increased fillet weld at ends</p> <p>View B-B</p>	
<b>Notes on possible cause of damage</b>		<b>Notes on repairs</b>	
<ol style="list-style-type: none"> <li>1. Stress concentration at the termination of bulwarks.</li> </ol>		<ol style="list-style-type: none"> <li>1. Fractured deck plating should be cropped and part renewed.</li> <li>2. Reduction of stress concentration should be considered. In the above figure gusset plate was replaced with soft type for the fracture in gusset plate and pad plate was increased. Additional stiffeners were provided for the fracture in deck plating.</li> </ol>
