**РОССИЙСКИЙ МОРСКОЙ РЕГИСТР СУДОХОДСТВА  
RUSSIAN MARITIME REGISTER OF SHIPPING**

**ПРИЛОЖЕНИЕ К ПРАВИЛАМ  
РОССИЙСКОГО МОРСКОГО РЕГИСТРА СУДОХОДСТВА  
УНИФИЦИРОВАННЫЕ ИНТЕРПРЕТАЦИИ  
И РЕКОМЕНДАЦИИ  
МЕЖДУНАРОДНОЙ АССОЦИАЦИИ  
КЛАССИФИКАЦИОННЫХ ОБЩЕСТВ**

**IACS UNIFIED INTERPRETATIONS  
AND RECOMMENDATIONS**

НД № 2-020101-085-R-E

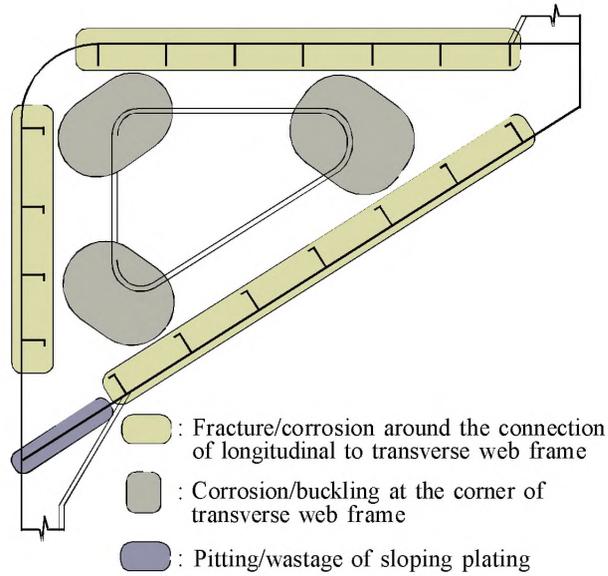
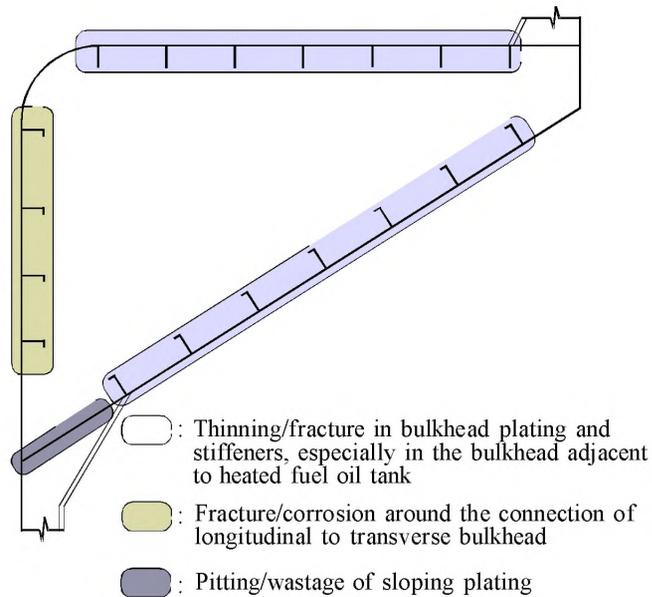
**Figure 1 Topside tank - Potential problem areas**

- (a) Structure in corrosive environment
  - Deck plating and deck longitudinal
  - Transverse bulkhead adjacent to heated fuel oil tank
  - Lowest part of sloping plating
- (b) Structure subject to high stress
  - Face plates and web plates of transverse at corners
  - Connection of side longitudinal to transverse
- (c) Areas susceptible to coating breakdown
  - Back side of face plate of longitudinal
  - Welded joint
  - Edge of access opening
- (d) Areas subjected to poor drainage
  - Web of side and sloping longitudinals

**(a) Transverse web frame section**

**(b) Transverse bulkhead section**

**2.1.2** Rate and extent of corrosion depends on the environmental conditions, and protective measures employed, such as coatings and sacrificial anodes. The following structures are generally susceptible to corrosion (See **Figure 1**).

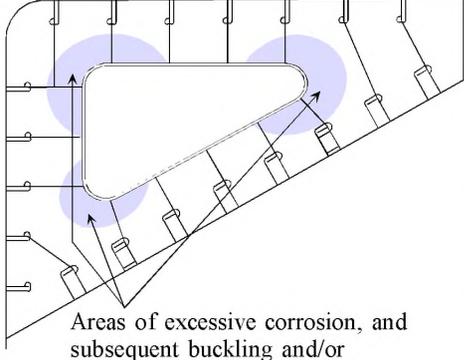
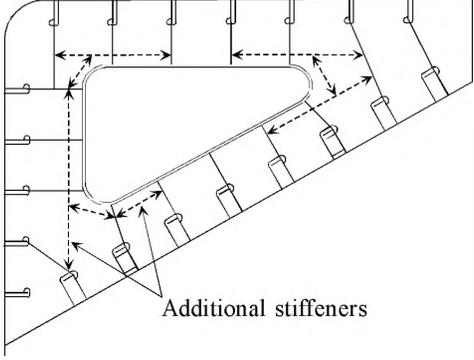
<b>BULK CARRIERS</b>		<b>Guidelines for Surveys, Assessment and Repair of Hull Structure</b>	
<b>Part 1</b>	<b>Cargo hold region</b>	<b>Example No.</b>	
<b>Area 2</b>	<b>Topside tank structure</b>	<b>2-a</b>	
<b>Detail of damage</b>		Thinning and subsequent buckling of web plating in the vicinity of the radii of the opening	
<b>Sketch of damage</b>		<b>Sketch of repair</b>

<p>Areas of excessive corrosion, and subsequent buckling and/or</p>

<p>Additional stiffeners</p>	
<b>Notes on possible cause of damage</b>		<b>Notes on repairs</b>	
<ol style="list-style-type: none"> <li>1. Insufficient buckling strength.</li> <li>2. Corrosion due to stress concentration at corners.</li> </ol>		<ol style="list-style-type: none"> <li>1. Buckled plating is to be cropped and parts renewed, if necessary.</li> <li>2. Additional stiffeners as shown above and/or renewal with plating of increased thickness should be considered.</li> </ol>

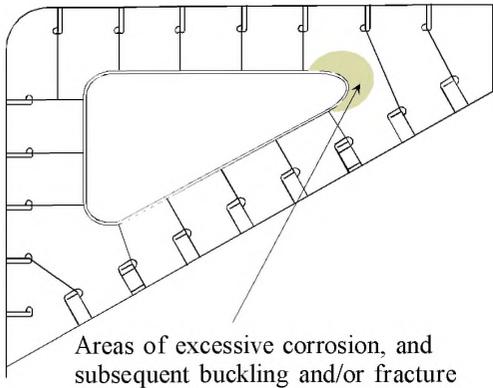
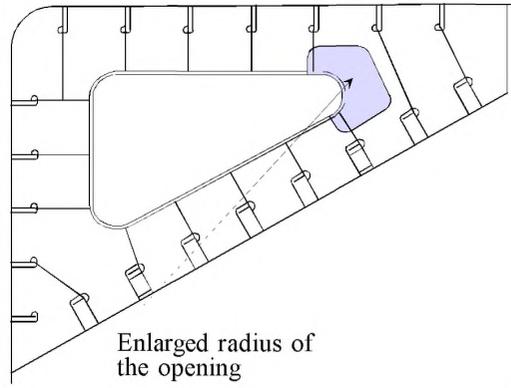
<b>BULK CARRIERS</b>		<b>Guidelines for Surveys, Assessment and Repair of Hull Structure</b>	
<b>Part 1</b>	<b>Cargo hold region</b>	<b>Example No.</b>	
<b>Area 2</b>	<b>Topside tank structure</b>	<b>2-b</b>	
<b>Detail of damage</b>	Thinning and subsequent buckling of web plating in the vicinity of the radii of the opening		
<b>Sketch of damage</b>		<b>Sketch of repair</b>

<p>Areas of excessive corrosion, and subsequent buckling and/or fracture</p>

<p>Enlarged radius of the opening</p>	
<b>Notes on possible cause of damage</b>		<b>Notes on repairs</b>	
<ol style="list-style-type: none"> <li>1. Corrosion caused by stress concentration at the corner due to insufficient radius for the opening.</li> </ol>		<ol style="list-style-type: none"> <li>1. Corroded/buckled plating is to be cropped and parts renewed with plating of increased thickness and additional stiffeners are preferable to minimize deflection.</li> <li>2. An attempt should be made to improve the design of the radius if felt necessary.</li> </ol>

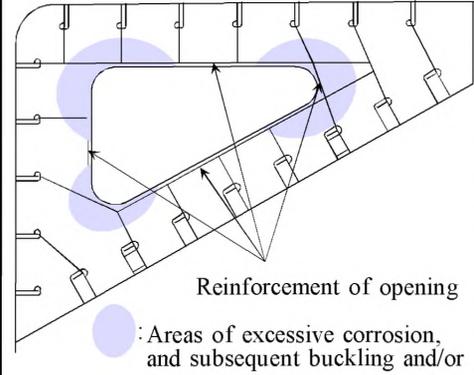
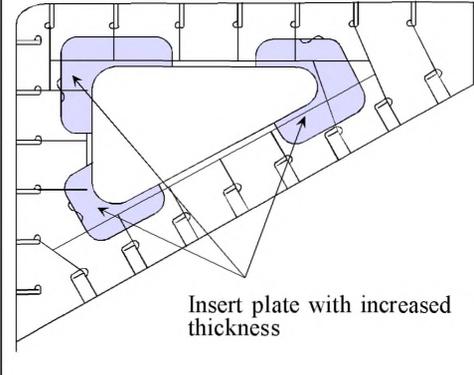
<b>BULK CARRIERS</b>		<b>Guidelines for Surveys, Assessment and Repair of Hull Structure</b>	
<b>Part 1</b>	<b>Cargo hold region</b>	<b>Example No.</b>	
<b>Area 2</b>	<b>Topside tank structure</b>	<b>2-c</b>	
<b>Detail of damage</b>		Thinning and subsequent buckling of web plating in the vicinity of the radii of the opening	
<b>Sketch of damage</b>		<b>Sketch of repair</b>

<p>Reinforcement of opening</p> <p>Areas of excessive corrosion, and subsequent buckling and/or</p>

<p>Insert plate with increased thickness</p>	
<b>Notes on possible cause of damage</b>		<b>Notes on repairs</b>	
<p>1. Additional stresses at the free edge of transverse web. (In <b>Example 2-a - 2-c</b> face plate is provided for the reinforcement of the opening.)</p>		<p>1. Corroded/buckled plating is to be cropped and part renewed with plating of increased thickness.</p>

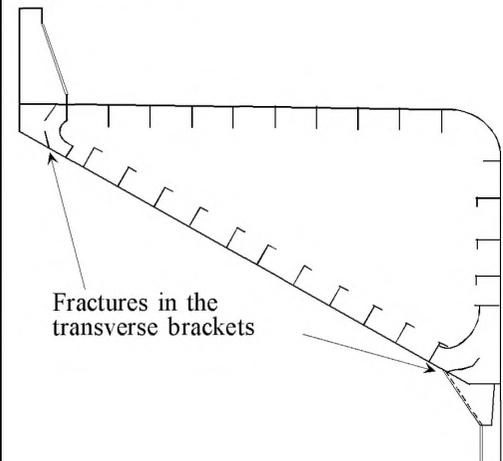
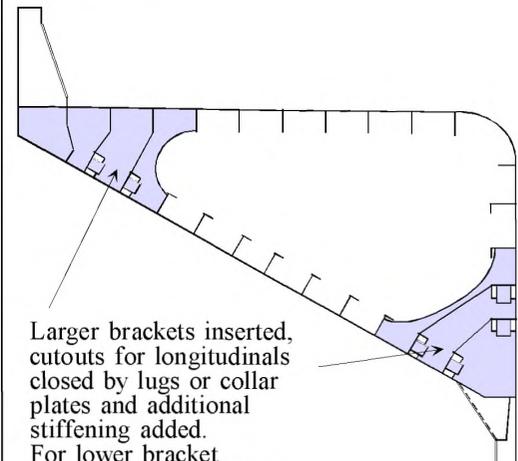
<b>BULK CARRIERS</b>		<b>Guidelines for Surveys, Assessment and Repair of Hull Structure</b>	
<b>Part 1</b>	<b>Cargo hold region</b>	<b>Example No.</b>	
<b>Area 2</b>	<b>Topside tank structure</b>	<b>7-a</b>	
<b>Detail of damage</b>		Fractures in transverse brackets	
<b>Sketch of damage</b>		<b>Sketch of repair</b>

<p>Fractures in the transverse brackets</p>

<p>Larger brackets inserted, cutouts for longitudinals closed by lugs or collar plates and additional stiffening added. For lower bracket alternatively increase the thickness</p>	
<b>Notes on possible cause of damage</b>		<b>Notes on repairs</b>	
<ol style="list-style-type: none"> <li>1. General levels of corrosion and presence of stress concentrations.</li> <li>2. Misalignment of the brackets with adjoining structure, e.g. side shell frame brackets and/or coaming brackets.</li> <li>3. High shear stresses due to insufficient bracket size.</li> <li>4. Inadvertent overloading.</li> </ol>		<ol style="list-style-type: none"> <li>1. If the damage is caused by misalignment with the side shell frame brackets or the hatch coaming brackets the misalignment is to be rectified and the replacement by larger brackets incorporated only if considered necessary.</li> </ol>

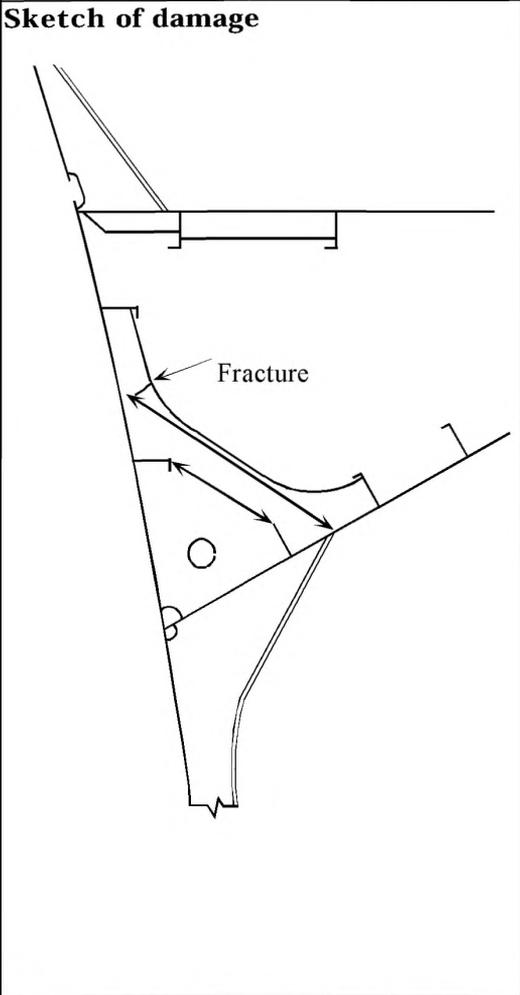
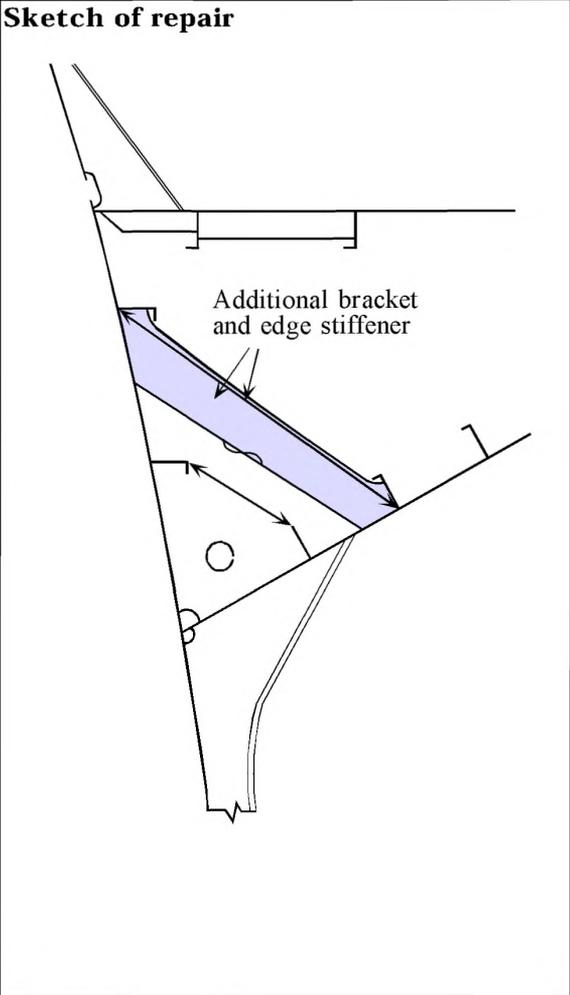
<b>BULK CARRIERS</b>		<b>Guidelines for Surveys, Assessment and Repair of Hull Structure</b>	
<b>Part 1</b>	<b>Cargo hold region</b>	<b>Example No.</b>	
<b>Area 2</b>	<b>Topside tank structure</b>	<b>7-b</b>	
<b>Detail of damage</b>		Fractures in transverse bracket	
<b>Sketch of damage</b>		<b>Sketch of repair</b>

<b>Notes on possible cause of damage</b>		<b>Notes on repairs</b>	
<ol style="list-style-type: none"> <li>1. Insufficient strength.</li> <li>2. Corrosion.</li> </ol>		<ol style="list-style-type: none"> <li>1. Fractured part to be cropped and renewed.</li> <li>2. If the fractured part is free from corrosion, increased size and thickness should be considered. Partial renewal of the bracket may be accepted depending on the nature of the fracture.</li> </ol>

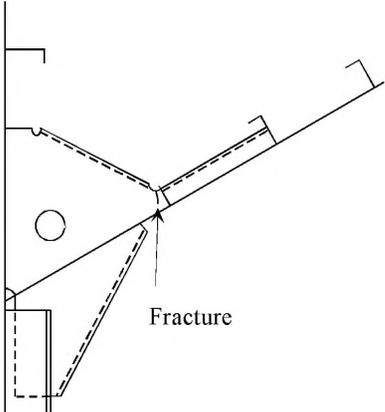
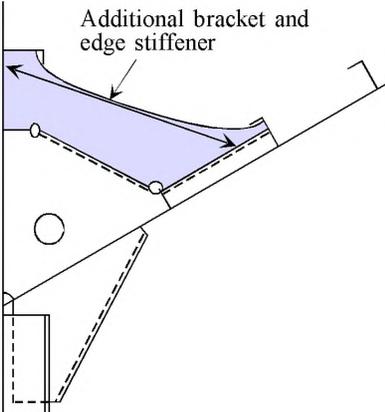
<b>BULK CARRIERS</b>		<b>Guidelines for Surveys, Assessment and Repair of Hull Structure</b>	
<b>Part 1</b>	<b>Cargo hold region</b>	<b>Example No.</b>	
<b>Area 2</b>	<b>Topside tank structure</b>	<b>7-c</b>	
<b>Detail of damage</b>		Fractures at toes of transverse bracket	
<b>Sketch of damage</b>		<b>Sketch of repair</b>

<b>Notes on possible cause of damage</b>		<b>Notes on repairs</b>	
<ol style="list-style-type: none"> <li>1. Stress concentration due to the shape of the bracket.</li> </ol>		<ol style="list-style-type: none"> <li>1. Cracked weld to be veed-out and rewelded.</li> </ol>

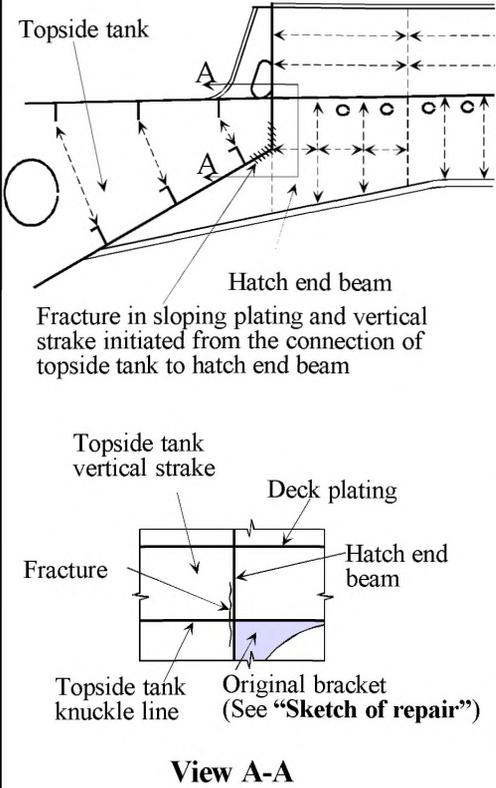
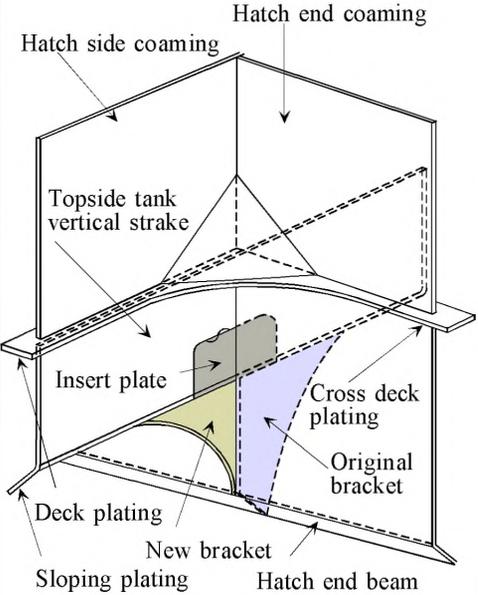
<b>BULK CARRIERS</b>		<b>Guidelines for Surveys, Assessment and Repair of Hull Structure</b>	
<b>Part 1</b>	<b>Cargo hold region</b>	<b>Example No.</b>	
<b>Area 2</b>	<b>Topside tank structure</b>	<b>8</b>	
<b>Detail of damage</b>		Fractures in sloping plating and vertical strake initiated from the connection of topside tank to hatch end beam	
<p><b>Sketch of damage</b></p>

<p>Topside tank</p> <p>Hatch end beam</p> <p>Fracture in sloping plating and vertical strake initiated from the connection of topside tank to hatch end beam</p> <p>Topside tank vertical strake</p> <p>Deck plating</p> <p>Fracture</p> <p>Hatch end beam</p> <p>Topside tank knuckle line</p> <p>Original bracket (See "Sketch of repair")</p> <p><b>View A-A</b></p>		<p><b>Sketch of repair</b></p>

<p>Hatch end coaming</p> <p>Hatch side coaming</p> <p>Topside tank vertical strake</p> <p>Insert plate</p> <p>Cross deck plating</p> <p>Original bracket</p> <p>Deck plating</p> <p>New bracket</p> <p>Sloping plating</p> <p>Hatch end beam</p>

<p><b>Notes on possible cause of damage</b></p> <ol style="list-style-type: none"> <li>1. Stress concentration at the connection of hatch end beam to topside tank.</li> </ol>		<p><b>Notes on repairs</b></p> <ol style="list-style-type: none"> <li>1. Fractured part to be cropped and renewed with increased thickness.</li> <li>2. Additional bracket should be considered for reinforcement.</li> </ol>

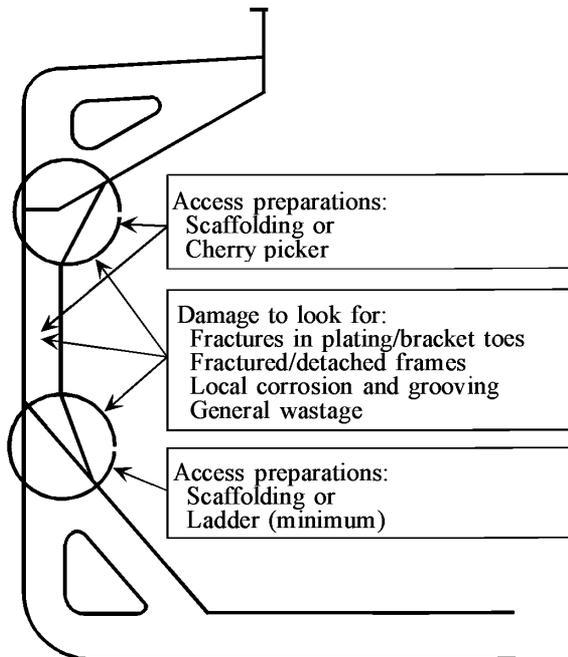
**Figure 1**  
Side shell frame - Potential problem areas

- 1.6 A summary of potential problem areas is shown in **Figures 1 - 4**. Examples of failure and damaged ship side structure are illustrated in **Photographs 1- 2**.

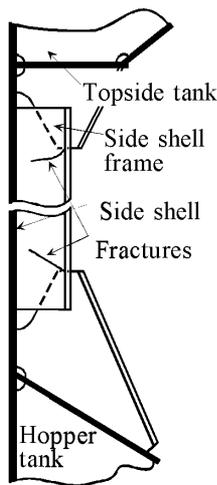
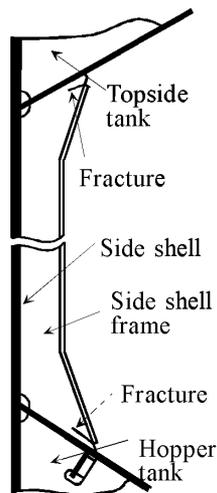
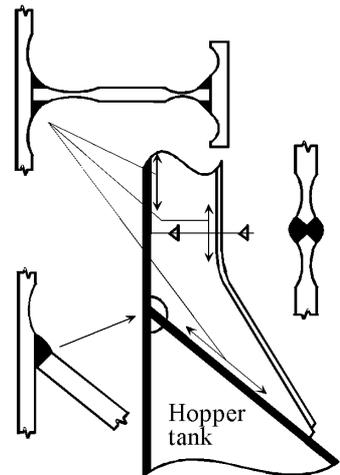
**(a) Separate bracket configuration**

**(b) Integral bracket configuration**

**(c) Examples of grooving**

**Figure 2** Damages to side shell frame - Potential problem areas

(Note) The type of bracket configuration used will, to a large extent, dictate the location and extent of fracture. Where separate brackets are employed, the fracture location is normally at the bracket toe position on the frames, whereas with integral brackets the location is at the toe position on the hopper and topside tank.

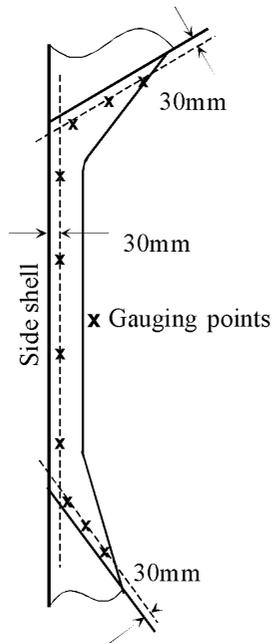
**Figure 3**  
**Representative gauging locations on the side shell frame - Potential problem areas**

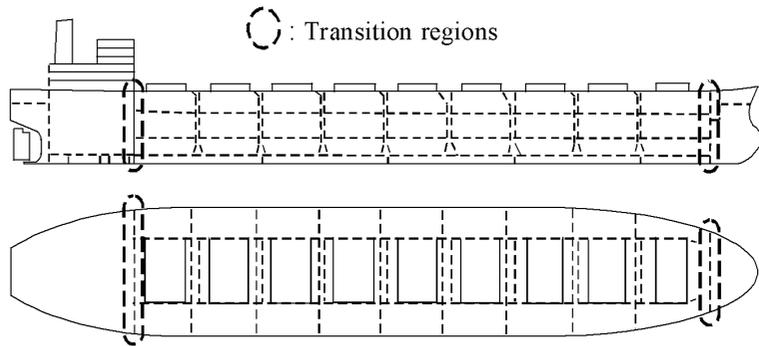
**Figure 4**    **Transition regions - Potential problem area**

- 1.5 The structure at the transition regions at the fore and aft ends of the ship are subject to stress concentrations due to structural discontinuities. The side shell plating at the transition regions is also subject to panting. The lack of continuity of the longitudinal structure, and the increased slenderness and flexibility of the side structure, makes the structure at the transition regions more prone to fracture damages.

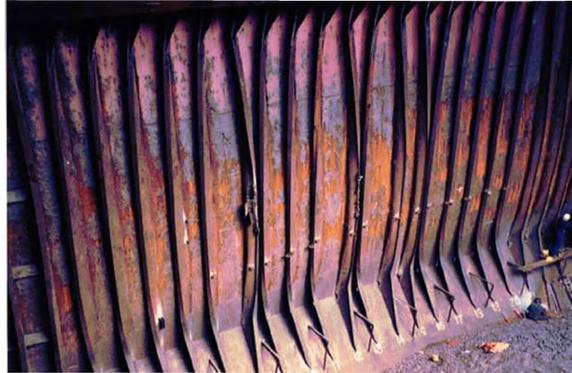
**Photograph 1** Collapsed side shell frames (See Example 4)

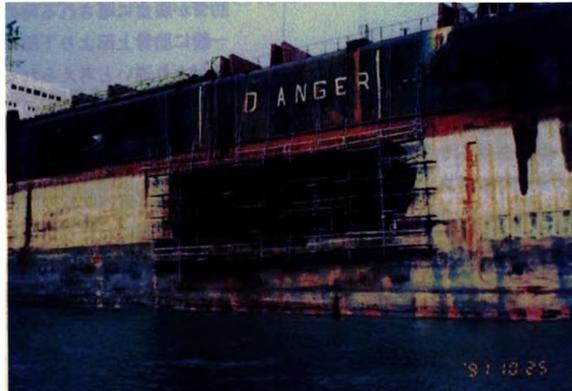
**Photograph 2** Missing side shell structure (See Examples 4 and 5)

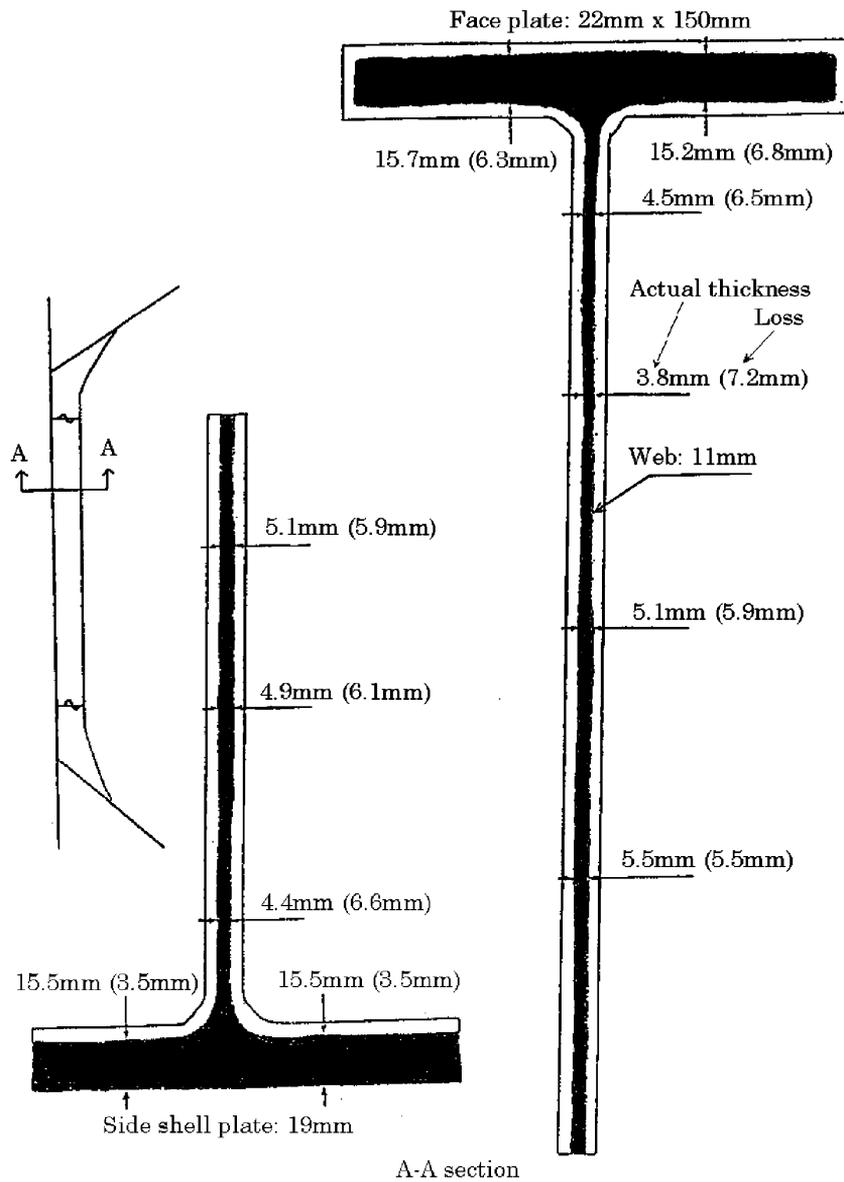
**Figure 5 Uniform corrosion of side shell frame**

- 2.1.1** Attention is drawn to the fact that side shell frames may be significantly weakened by loss of thickness although diminution and deformations may not be apparent. Inspection should be made after the removal of any scale or rust deposit. Thickness measurements may be necessary, particularly if the corrosion is smooth and uniform, to determine the condition of the structure (See **Figure 5**).

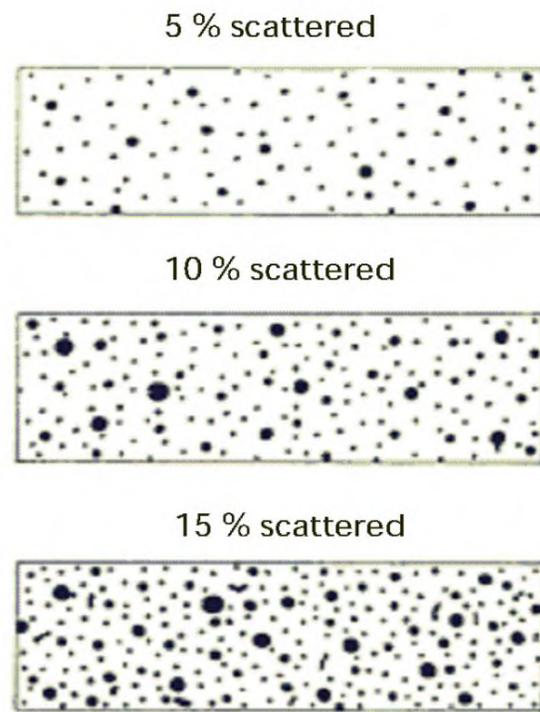
**Figure 6 Pitting intensity diagrams (from 5% to 15% intensity)**

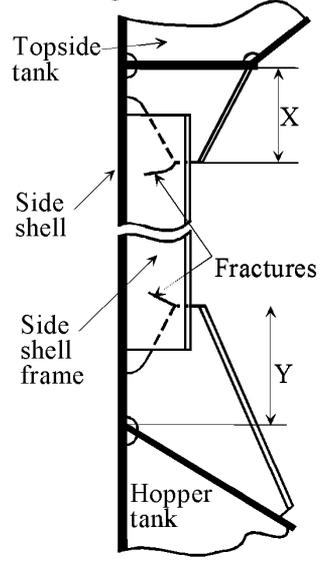
<b>BULK CARRIERS</b>		<b>Guidelines for Surveys, Assessment and Repair of Hull Structure</b>	
<b>Part 1</b>	<b>Cargo hold region</b>	<b>Example No.</b>	
<b>Area 3</b>	<b>Cargo hold side structure</b>	<b>1-b</b>	
<b>Detail of damage</b>		Fractures in side shell frame at bracket's toe	
<p><b>Sketch of damage</b></p>

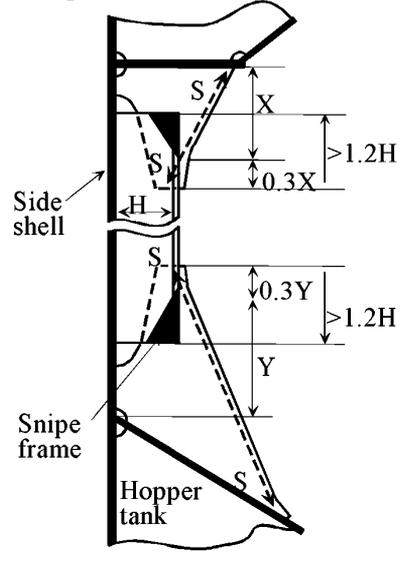
<p style="text-align: center;"><b>Separate bracket configuration</b></p>		<p><b>Sketch of repair</b></p>

<p style="text-align: center;"><b>S=Snipped end</b></p>	
<p><b>Notes on possible cause of damage</b></p> <ol style="list-style-type: none"> <li>1. This type of damage is caused due to stress concentration.</li> </ol>		<p><b>Notes on repairs</b></p> <ol style="list-style-type: none"> <li>1. For small fractures, e. g. hairline fractures, the fracture can be veed-out, welded up, ground, examined by NDT for fractures, and rewelded.</li> <li>2. For larger/significant fractures consideration is to be given to cropping and partly renewing/ renewing the frame brackets. If renewing the brackets, end of frames can be sniped to soften them.</li> <li>3. If felt prudent, soft toes are to be incorporated at the boundaries of the bracket to the hopper plating.</li> <li>4. Attention to be given to the structure in wing tanks in way of the extended bracket arm. i.e. reinforcement provided in line with the bracket.</li> </ol>

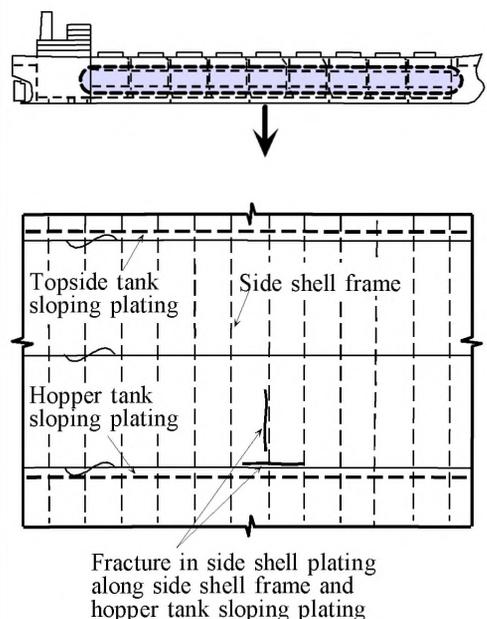
<b>BULK CARRIERS</b>		<b>Guidelines for Surveys, Assessment and Repair of Hull Structure</b>	
<b>Part 1</b>	<b>Cargo hold region</b>	<b>Example No.</b>	
<b>Area 3</b>	<b>Cargo hold side structure</b>	<b>3</b>	
<b>Detail of damage</b>	Fractures in side shell frame/lower bracket and side shell plating near hopper		
<b>Sketch of damage</b>

<p>Topside tank sloping plating</p> <p>Side shell frame</p> <p>Hopper tank sloping plating</p> <p>Fracture in side shell plating along side shell frame and hopper tank sloping plating</p>		<b>Sketch of repair</b>

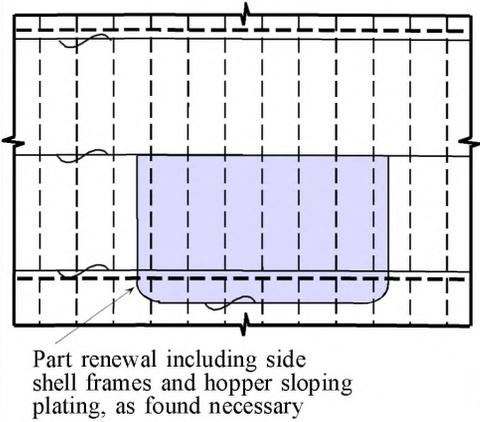
<p>Part renewal including side shell frames and hopper sloping plating, as found necessary</p>	
<b>Notes on possible cause of damage</b> 1. Heavy corrosion (grooving). Refer to <b>Figure 2 (c)</b> .		<b>Notes on repairs</b> 1. Sketch of repair applies when damage extends over several frames. 2. Isolated fractures may be repaired by veeing-out and rewelding. 3. Isolated cases of grooving may be repaired by build up of welding.

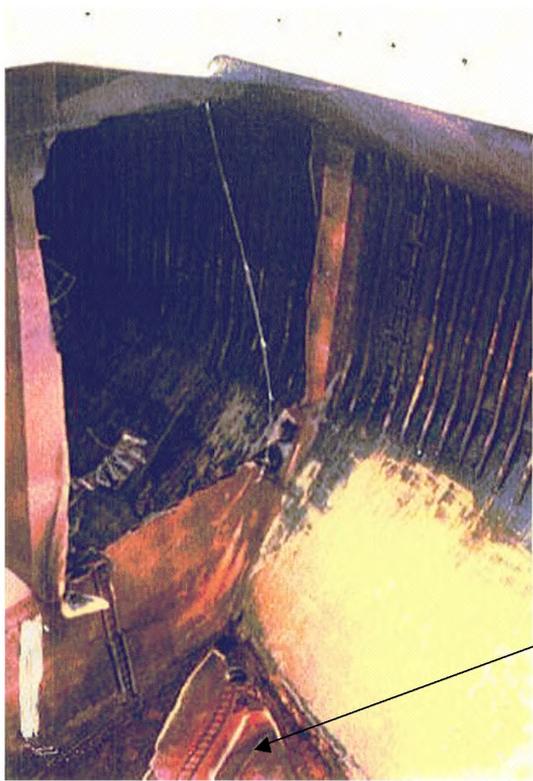
**Photograph 1**  
**Collapsed and detached transverse bulkhead**

Collapsed and detached transverse bulkhead on the tank top

- The filling is restricted to a level that corresponds to the dry cargo hold scantlings, in particular the transverse bulkheads scantlings, and must only be carried out in port. In no case should these cargo holds be partially filled during voyage to save time at the berth. Such filling at sea may cause sloshing resulting in catastrophic failure such as indicated in **Photograph 1**.

- 1.5** Heavy corrosion may lead to collapse of the structure under extreme load, such as indicated in **Photograph 1** if it is not rectified properly.

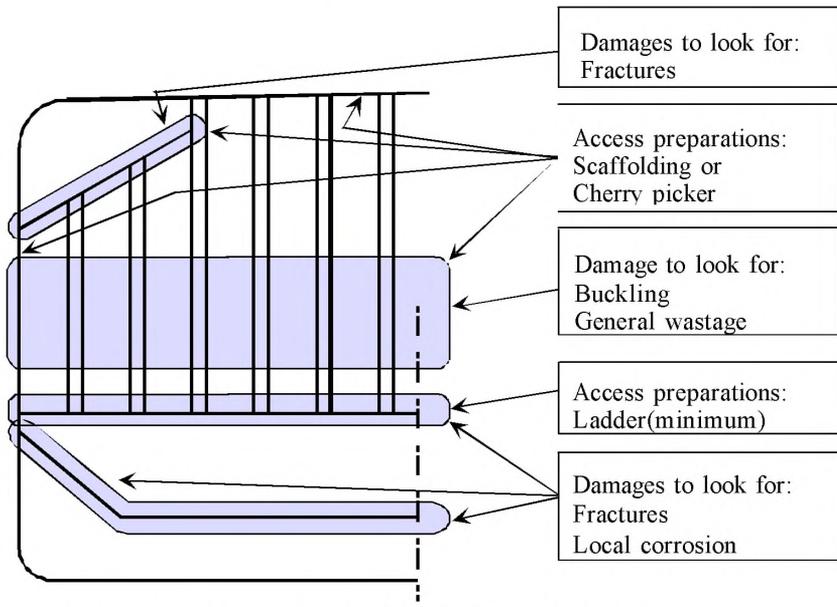
**Figure 1** Transverse bulkhead - Potential problem areas

- 1.6** A summary of potential problem areas is shown in **Figure 1**. It is emphasised that appropriate access arrangement as indicated in **Chapter 4 Survey planning, preparation and execution** of the guidelines, should be provided to enable a proper close-up inspection and thickness measurement as necessary.

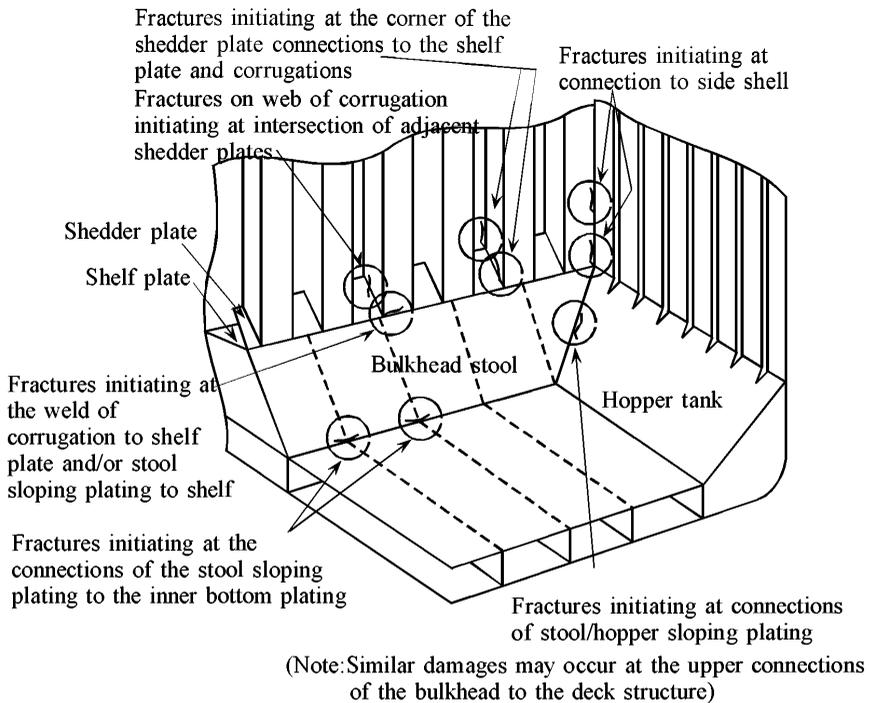
**Figure 2 Typical fracturing at the connection of transverse bulkhead structure**

2.3.1 Fractures usually occur at the boundaries of corrugations and bulkhead stools particularly in way of shelf plates, shedder plates, deck, inner bottom, etc. (See **Figure 2**).

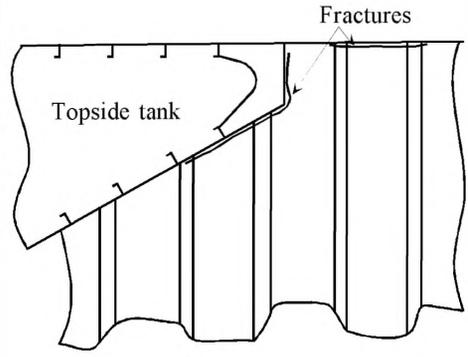
<b>BULK CARRIERS</b>		<b>Guidelines for Surveys, Assessment and Repair of Hull Structure</b>	
<b>Part 1</b>	<b>Cargo hold region</b>	<b>Example No.</b>	
<b>Area 4</b>	<b>Transverse bulkhead and associated structure in cargo hold</b>	<b>2</b>	
<b>Detail of damage</b>		Fractures at the upper boundaries to topside tanks	
<b>Sketch of damage</b>		<b>Sketch of repair</b>

<p>Continuous or intercostal reinforcement in line with flanges or gussets where not already fitted</p> <p>Adjacent to the topside tank either a gusset to a bulb plate stiffener may be</p>

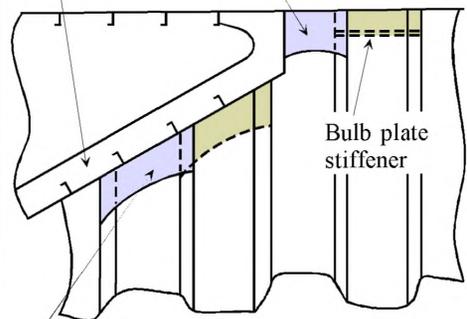
<p>Gusset(similar gusset on the opposite)</p>	
<b>Notes on possible cause of damage</b>		<b>Notes on repairs</b>	
<ol style="list-style-type: none"> <li>1. Damage due to poor design and/or defective welds.</li> </ol>		<ol style="list-style-type: none"> <li>1. Fractures may be veed-out and rewelded. If necessary corrugated plating cropped and renewed.</li> <li>2. It is recommended that reinforcement as shown above be incorporated, giving due consideration to the following criteria:             <ol style="list-style-type: none"> <li>2.1 It is important to have the gusset plates well aligned with the transverse structure inside the tank. Gusset plates may be joggled to obtain this alignment.</li> <li>2.2 If there is no transverse web already existing inside the topside tank and in line with the flanges of corrugation or gusset plates, reinforcement as shown above to be fitted.</li> </ol> </li> </ol>

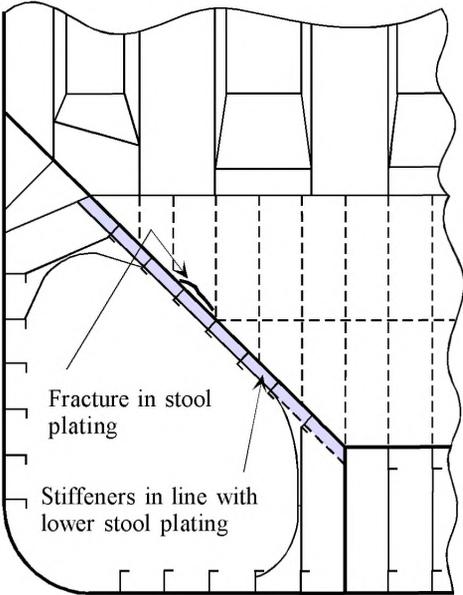
<b>BULK CARRIERS</b>		<b>Guidelines for Surveys, Assessment and Repair of Hull Structure</b>
<b>Part 1</b>	<b>Cargo hold region</b>	<b>Example No.</b>
<b>Area 4</b>	<b>Transverse bulkhead and associated structure in cargo hold</b>	<b>6</b>
<b>Detail of damage</b> Fractures at the connection of lower stool to hopper		
<b>Sketch of damage</b>		<b>Sketch of repair</b>

<p>Fracture in stool plating</p> <p>Stiffeners in line with lower stool plating</p>

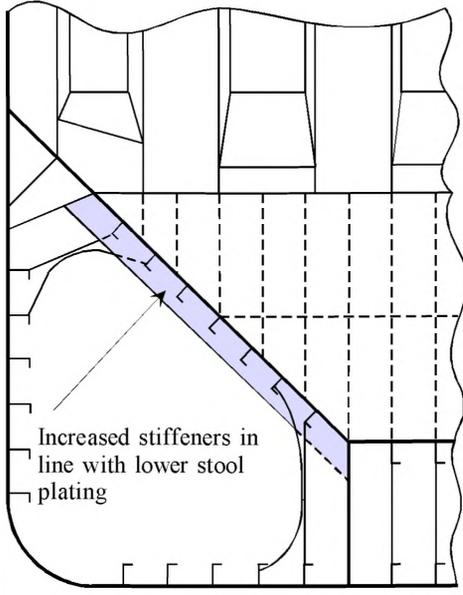
<p>Increased stiffeners in line with lower stool plating</p>
<b>Notes on possible cause of damage</b>		<b>Notes on repairs</b>
<ol style="list-style-type: none"> <li>1. Insufficient strength of the connection</li> <li>2. Corrosion</li> </ol>		<ol style="list-style-type: none"> <li>1. Fractured stool plating should be partly cropped and renewed (thicker plate) if considered necessary.</li> <li>2. If the damage occurred due to insufficient strength, stiffeners in line with stool plating should be increased.</li> </ol>

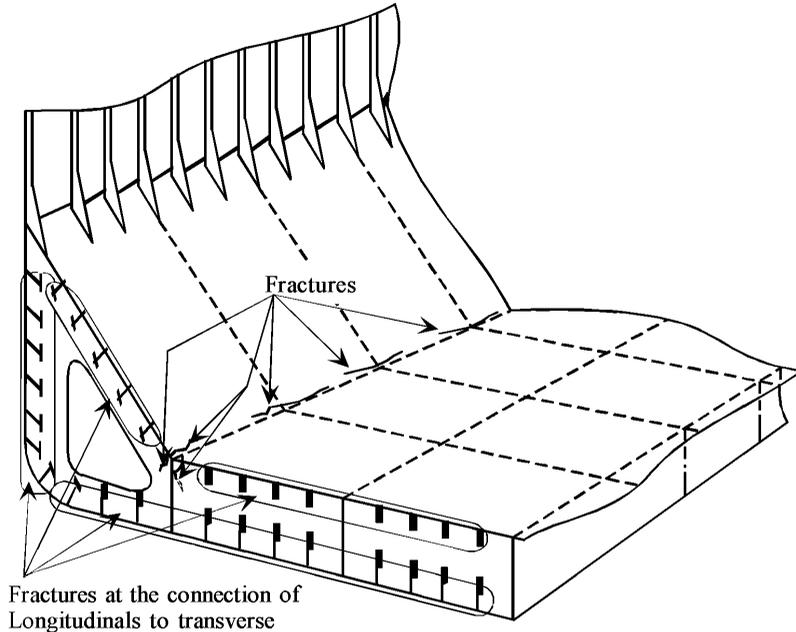
**Figure 1** Typical fractures in the connection of hopper sloping plating to inner bottom (tank top) and longitudinals to transverse (or transverse bulkhead)

extend through the thickness of the plating or through the welds may be observed during pressure testing of the double bottom tanks (See **Figure 1** and **2** of **Area 4**).

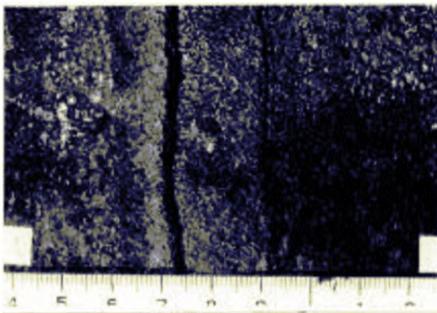
**Photograph 1**  
Grooving corrosion of welding of bottom plating

**4.1.2** Severe grooving along welding of bottom plating is often found (See **Photographs 1** and **2**). This grooving can be accelerated by poor maintenance of the protective coating and/or sacrificial anodes fitted to the bottom plating.

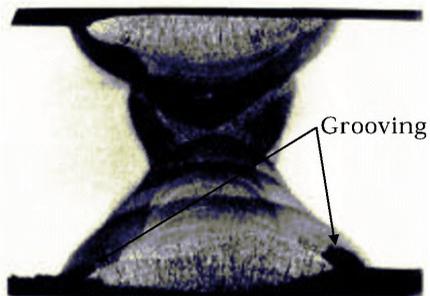
**Photograph 2**  
Section of the grooving shown in Photograph 1

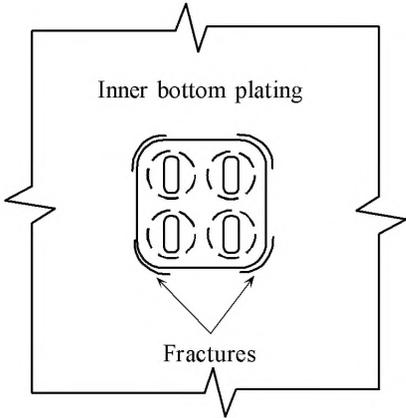
<b>BULK CARRIERS</b>		<b>Guidelines for Surveys, Assessment and Repair of Hull Structure</b>	
<b>Part 1</b>	<b>Cargo hold region</b>	<b>Example No.</b>	
<b>Area 5</b>	<b>Double bottom structure including hopper</b>	<b>1</b>	
<b>Detail of damage</b>		Fractures in inner bottom plating around container bottom pocket	
<p><b>Sketch of damage</b></p>

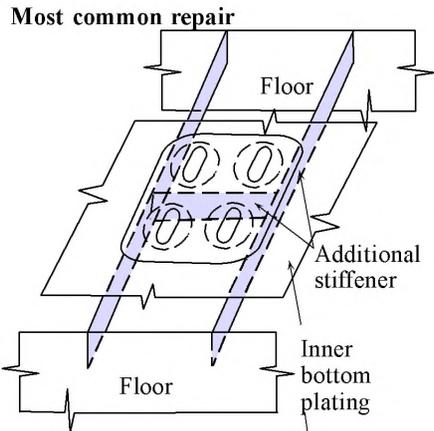
<p><b>Sketch of repair</b></p> <p><b>Most common repair</b></p>

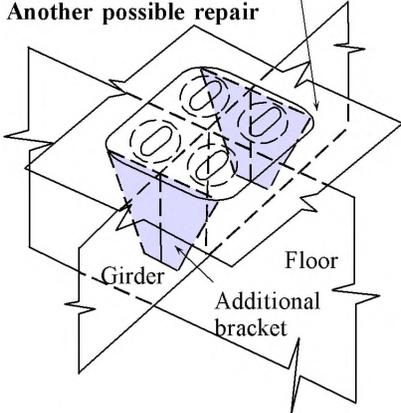
<p><b>Another possible repair</b></p>

<p><b>Notes on possible cause of damage</b></p> <ol style="list-style-type: none"> <li>1. Pocket is not supported correctly by floor, longitudinal and/or stiffener.</li> </ol>		<p><b>Notes on repairs</b></p> <ol style="list-style-type: none"> <li>1. Fractured plating should be cropped and part renewed.</li> <li>2. Adequate reinforcement should be considered.</li> </ol>

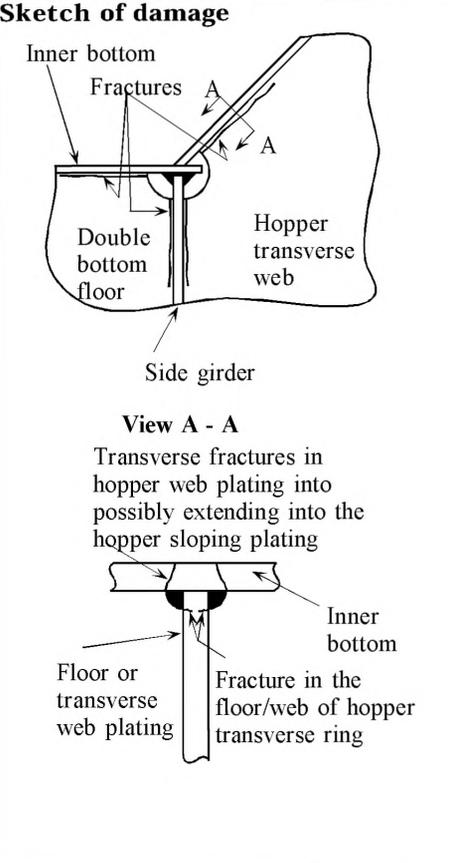
<b>BULK CARRIERS</b>		<b>Guidelines for Surveys, Assessment and Repair of Hull Structure</b>	
<b>Part 1</b>	<b>Cargo hold region</b>	<b>Example No. 4</b>	
<b>Area 5</b>	<b>Double bottom tank structure including hopper</b>		
<b>Detail of damage</b>		Fractures at weld connections of floors in way of hopper/inner bottom interface (welded knuckle)	
<b>Sketch of damage</b>		<b>Sketch of repair</b>

<p><b>View A - A</b> Transverse fractures in hopper web plating into possibly extending into the hopper sloping plating</p> <p><b>View B - B</b> Fracture in the floor/web of hopper transverse ring</p>

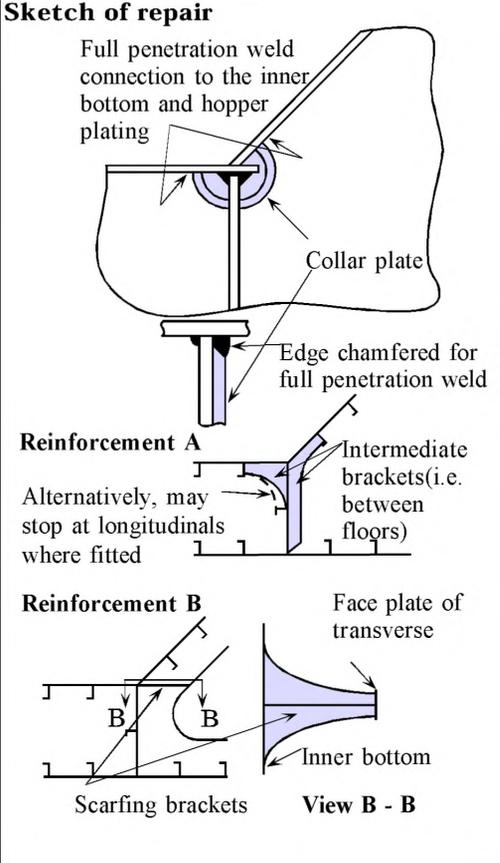
<p><b>Reinforcement A</b> Alternatively, may stop at longitudinals where fitted</p> <p><b>Reinforcement B</b></p> <p><b>View B - B</b></p>	
<b>Notes on possible cause of damage</b>		<b>Notes on repairs</b>	
<ol style="list-style-type: none"> <li>1. The damage is partly due to stress concentration at the edges of the weld created by the presence of the deflections in the inner bottom/hopper plating.</li> </ol>		<ol style="list-style-type: none"> <li>1. The fracture in the weld and/or plating is veed-out/cropped and renewed as appropriate.</li> <li>2. The cut-outs are eliminated by introducing suitable collar plates with emphasis on edge preparation and sequence of welding as shown above.</li> <li>3. Further reinforcements may be incorporated as shown above and depending on the judged cause of damage.</li> </ol>

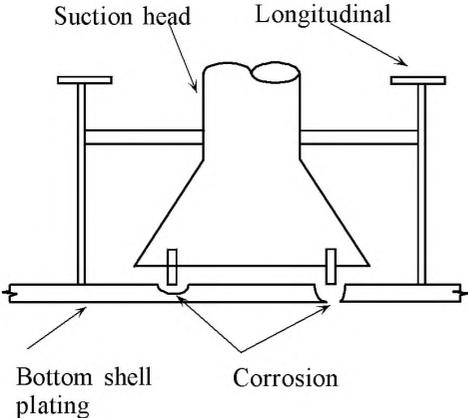
<b>BULK CARRIERS</b>		<b>Guidelines for Surveys, Assessment and Repair of Hull Structure</b>	
<b>Part 1</b>	<b>Cargo hold region</b>	<b>Example No. 14</b>	
<b>Area 5</b>	<b>Double bottom tank structure including hopper</b>		
<b>Detail of damage</b>		Corrosion in bottom plating below suction head	
<b>Sketch of damage</b>

<p>Suction head      Longitudinal</p> <p>Bottom shell plating      Corrosion</p>		<b>Sketch of repair</b>

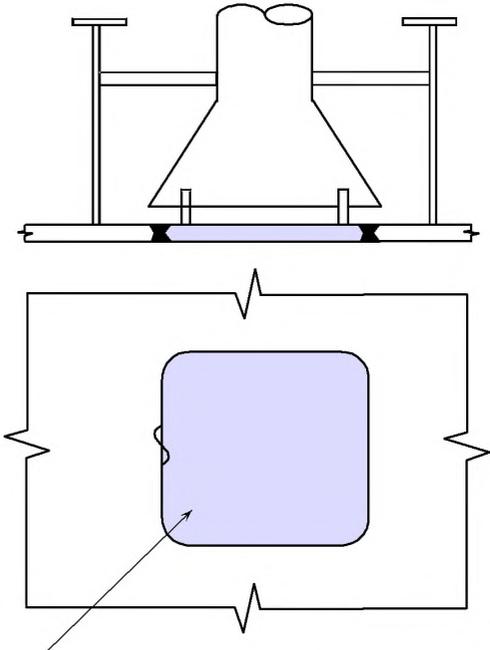
<p>1. Insert to have round corners 2. Non-destructive examination to be applied after welding based on the Society's rules</p>	
<b>Notes on possible cause of damage</b> 1. High flow rate associated with insufficient corrosion prevention system. 2. Galvanic action between dissimilar metals.		<b>Notes on repairs</b> 1. Affected plating should be cropped and part renewed. Thicker plate and suitable beveling should be considered. 2. If the corrosion is limited to a small area, i. e. pitting corrosion, repair by welding is acceptable.

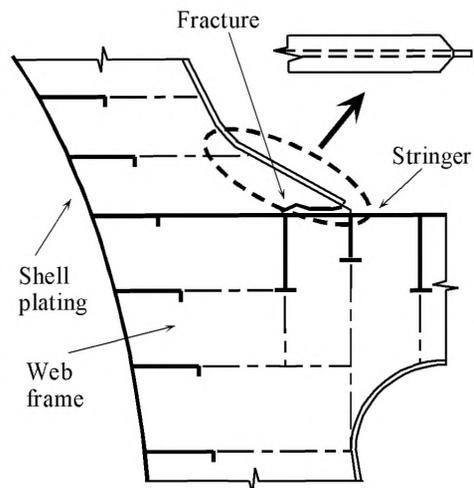
<b>BULK CARRIERS</b>		<b>Guidelines for Surveys, Assessment and Repair of Hull Structure</b>	
<b>Part 2</b>	<b>Fore and aft end regions</b>	<b>Example No.</b>	
<b>Area 1</b>	<b>Fore end structure</b>	<b>6</b>	
<b>Detail of damage</b>		Fractures at toe of web frame bracket connection to stringer platform bracket	
<p><b>Sketch of damage</b></p>

<p>The diagram shows a cross-section of the hull structure. A dashed line indicates a fracture at the toe of a web frame bracket where it connects to a stringer. Labels include 'Fracture', 'Stringer', 'Shell plating', and 'Web frame'. An inset shows a close-up of the bracket's end.</p>		<p><b>Sketch of repair</b></p>

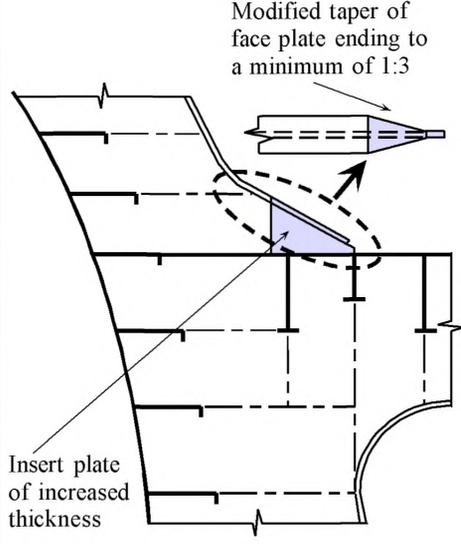
<p>The diagram shows the same cross-section after repair. A blue shaded area represents an 'Insert plate of increased thickness' at the fracture location. The bracket's end is now tapered, labeled as 'Modified taper of face plate ending to a minimum of 1:3'. An inset shows the tapered end of the bracket.</p>

<p><b>Notes on possible cause of damage</b></p> <ol style="list-style-type: none"> <li>1. Inadequate bracket forming the web frame connection to the stringer.</li> <li>2. Localized material wastage in way of coating failure at bracket due to flexing of the structure.</li> <li>3. Dynamic seaway loading in way of bow flare.</li> </ol>		<p><b>Notes on repairs</b></p> <ol style="list-style-type: none"> <li>1. Adequate soft nose bracket endings with a face plate taper of at least 1 : 3 to be provided.</li> </ol>

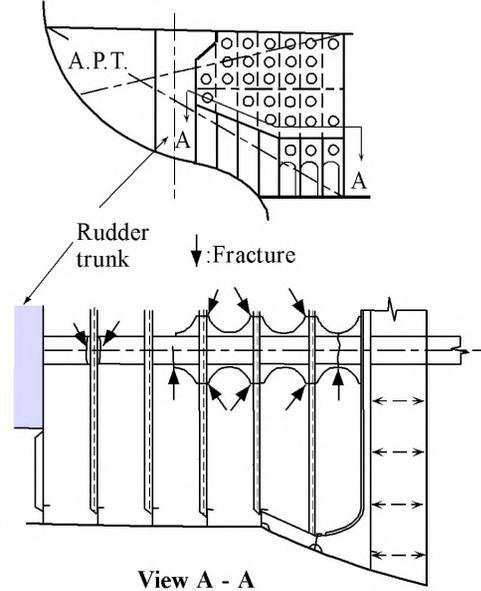
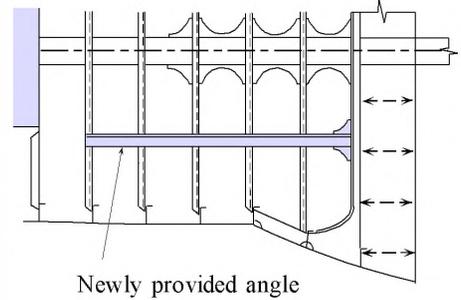
<b>BULK CARRIERS</b>		<b>Guidelines for Surveys, Assessment and Repair of Hull Structure</b>	
<b>Part 2</b>	<b>Fore and aft end regions</b>	<b>Example No.</b>	
<b>Area 2</b>	<b>Aft end structure</b>	<b>2</b>	
<b>Detail of damage</b>		Fractures at the connection of floors and girders/side brackets	
<b>Sketch of damage</b>		<b>Sketch of repair</b>

<p>View A - A</p>

<p>Newly provided angle</p>	
<b>Notes on possible cause of damage</b>		<b>Notes on repairs</b>	
<ol style="list-style-type: none"> <li>1. Vibration.</li> </ol>		<ol style="list-style-type: none"> <li>1. The fractured plating should be cropped and renewed.</li> <li>2. Natural frequency of the panel should be changed, e.g. reinforcement by additional strut.</li> </ol>

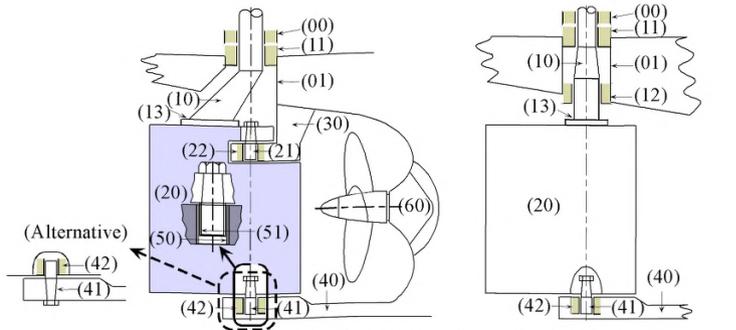
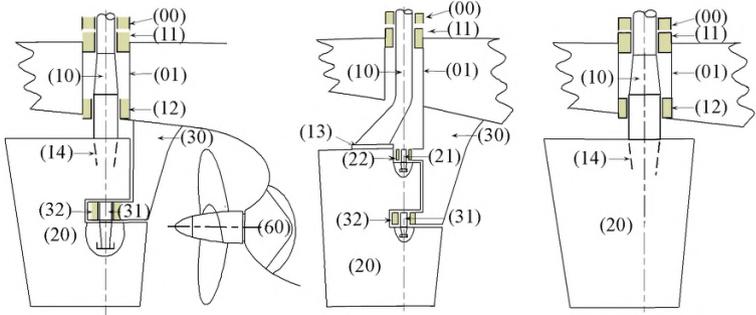
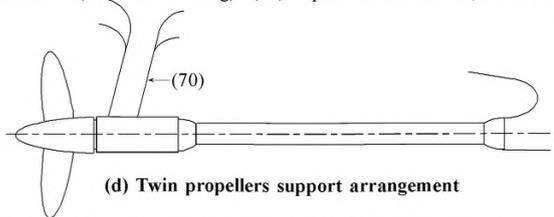
**Figure 1 Nomenclature for stern frame, rudder arrangement and propeller shaft support**

(a) Rudders supported by sole piece

(b) Semi-spade rudders

(c) Spade rudder

- (00)Rudder carrier
- (01)Rudder trunk
- (10)Rudder stock
- (11)Carrier bearing
- (12)Neck bearing
- (13)Horizontal coupling(Flange coupling)
- (14)Cone coupling
- (20)Rudder blade
- (21)Upper pintle
- (22)Upper pintle bearing
- (30)Rudder horn
- (31)Horn pintle
- (32)Horn pintle bearing
- (40)Sole piece
- (41)Bottom pintle
- (42)Bottom pintle bearing
- (50)Bush
- (51)Sleeve(Liner)
- (60)Propeller boss(Stern tube casting)
- (70)Propeller shaft support

(d) Twin propellers support arrangement

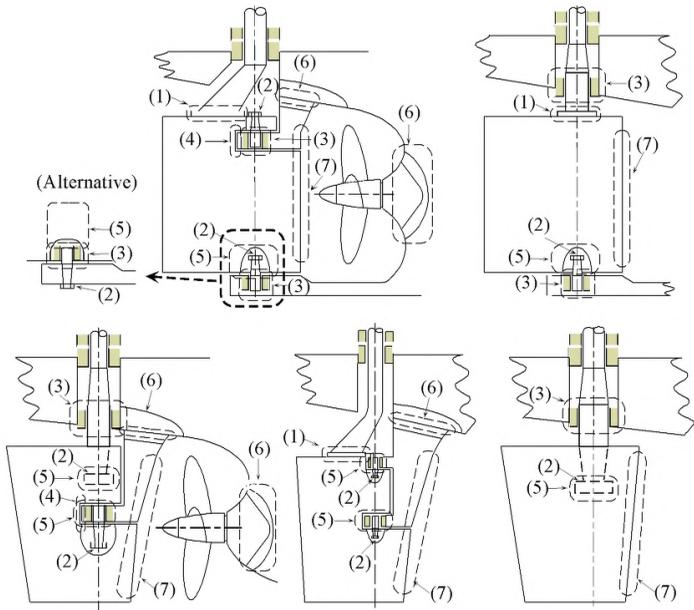
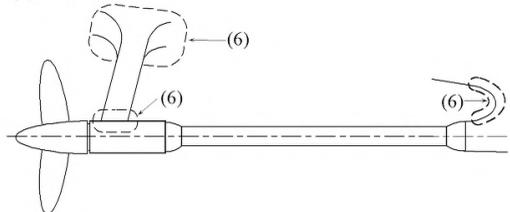
**Figure 2 Potential problem areas**

**Damage to look for:**

- (1) Fractures and loose coupling bolts
- (2) Loose nut
- (3) Wear (excessive bearing clearance)
- (4) Fractures in way of pintle cutout
- (5) Fractures in way of removable access plate
- (6) Fractures
- (7) Erosion

- 1.6 Pre-existing manufacturing internal defects in cast pieces may lead to fatigue cracking.
- 1.7 A summary of potential problem areas is shown in **Figure 2**.

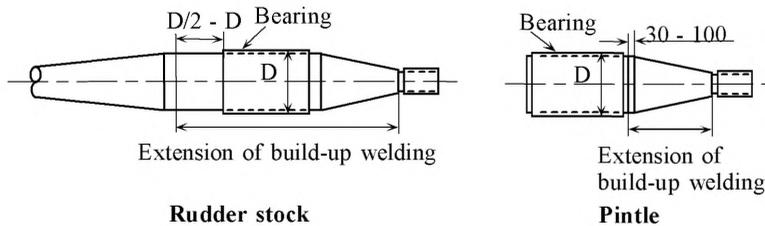
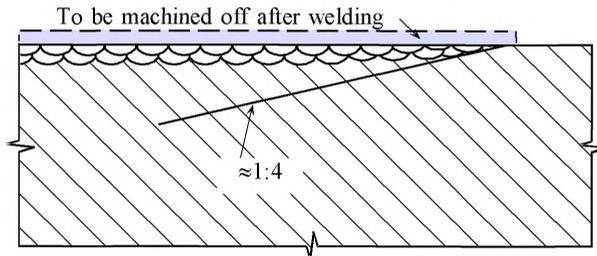
**Figure 3 Rudder stock repair by welding**

- Removal of the wasted area by machining and/or grinding, non-destructive examination for fractures (magnetic particle inspection preferred)
- Build-up welding by automatic spiral welding (turning device) according to an approved welding procedure (weld process, preheating, welding consumables, etc.)
- Extension of build-up welding over the area of **large bending moments (shafts)** according to the sketch

- Sufficient number of weld layers to compensate removed material, at least one layer in excess (heat treatment of the remaining layer)
- Transition at the end of the build-up welding according to the following sketch

- Post weld heat treatment if required in special cases (never for stainless steel cladding on ordinary steel)
- Final machining, at least two layers of welding material have to remain on the rudder stock (See the above sketch)
- Non-destructive fracture examination
