**РОССИЙСКИЙ МОРСКОЙ РЕГИСТР СУДОХОДСТВА  
RUSSIAN MARITIME REGISTER OF SHIPPING**

**ПРИЛОЖЕНИЕ К ПРАВИЛАМ  
РОССИЙСКОГО МОРСКОГО РЕГИСТРА СУДОХОДСТВА  
УНИФИЦИРОВАННЫЕ ИНТЕРПРЕТАЦИИ  
И РЕКОМЕНДАЦИИ  
МЕЖДУНАРОДНОЙ АССОЦИАЦИИ  
КЛАССИФИКАЦИОННЫХ ОБЩЕСТВ**

**IACS UNIFIED INTERPRETATIONS  
AND RECOMMENDATIONS**

НД № 2-020101-085-R-E

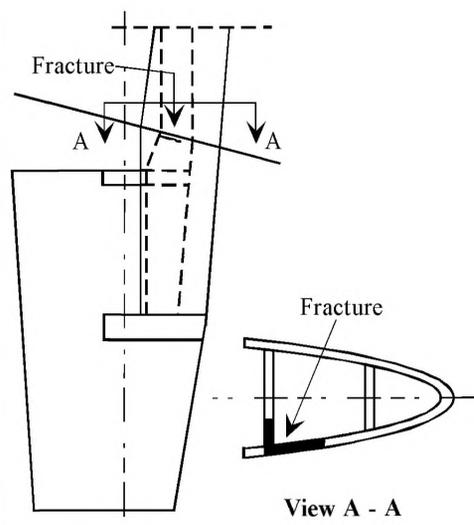
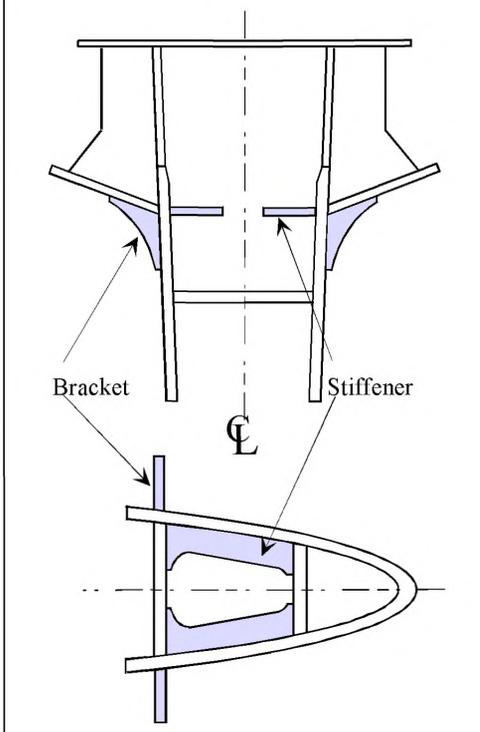
<b>BULK CARRIERS</b>		<b>Guidelines for Surveys, Assessment and Repair of Hull Structure</b>	
<b>Part 2</b>	<b>Fore and aft end regions</b>		<b>Example No.</b>
<b>Area 3</b>	<b>Stern frame, rudder arrangement and propeller shaft support</b>		<b>1</b>
<b>Detail of damage</b>		Fractures in rudder horn along bottom shell plating	
<p><b>Sketch of damage</b></p>

<p><b>Sketch of repair</b></p>

<p><b>Notes on possible cause of damage</b></p> <ol style="list-style-type: none"> <li>1. Insufficient strength due to poor design.</li> </ol>		<p><b>Notes on repairs</b></p> <ol style="list-style-type: none"> <li>1. Fractured plating to be veed-out and rewelded.</li> <li>2. Fractured plating to be cropped and renewed if considered necessary.</li> <li>3. Reinforcement should be considered if considered necessary.</li> </ol>

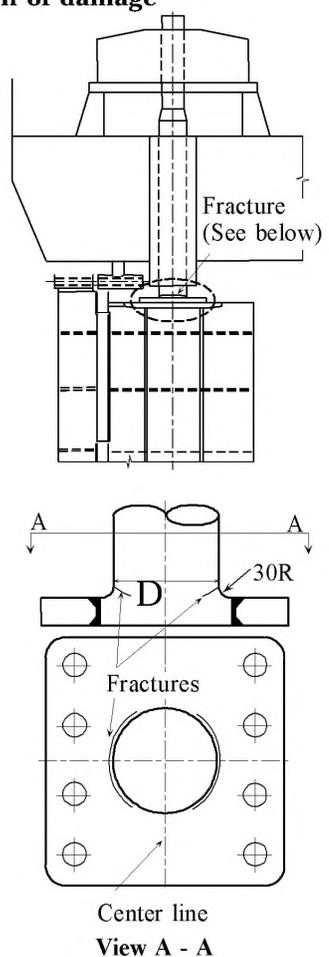
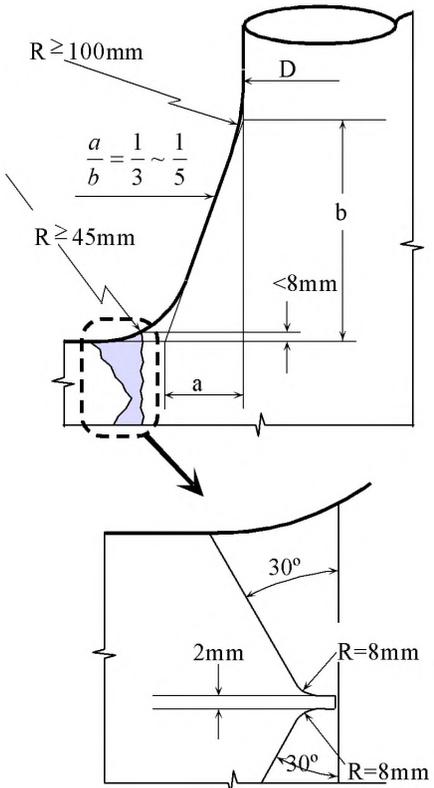
<b>BULK CARRIERS</b>		<b>Guidelines for Surveys, Assessment and Repair of Hull Structure</b>	
<b>Part 2</b>	<b>Fore and aft end regions</b>	<b>Example No. 2</b>	
<b>Area 3</b>	<b>Stern frame, rudder arrangement and propeller shaft support</b>		
<b>Detail of damage</b>		Fractures in rudder stock	
<b>Sketch of damage</b>		<b>Sketch of repair</b>

<p>Fracture (See below)</p> <p>Center line View A - A</p>

<p><math>R \geq 100\text{mm}</math></p> <p><math>\frac{a}{b} = \frac{1}{3} \sim \frac{1}{5}</math></p> <p><math>R \geq 45\text{mm}</math></p> <p><math>D</math></p> <p><math>b</math></p> <p><math>&lt;8\text{mm}</math></p> <p><math>30^\circ</math></p> <p><math>2\text{mm}</math></p> <p><math>R=8\text{mm}</math></p> <p><math>30^\circ</math></p> <p><math>R=8\text{mm}</math></p>	
<b>Notes on possible cause of damage</b>		<b>Notes on repairs</b>	
<ol style="list-style-type: none"> <li>Inadequate design for stress concentration in rudder stock.</li> </ol>		<ol style="list-style-type: none"> <li>Modification of detail design of rudder stock to reduce the stress concentration.</li> </ol>

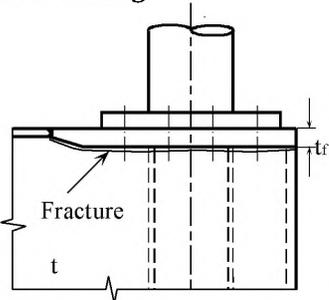
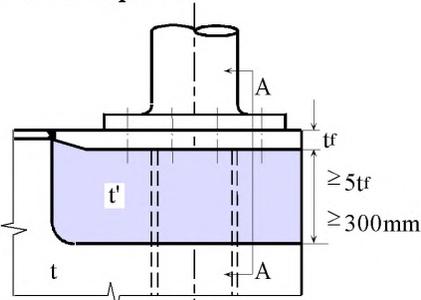
<b>BULK CARRIERS</b>		<b>Guidelines for Surveys, Assessment and Repair of Hull Structure</b>	
<b>Part 2</b>	<b>Fore and aft end regions</b>		<b>Example No.</b>
<b>Area 3</b>	<b>Stern frame, rudder arrangement and propeller shaft support</b>		<b>3</b>
<b>Detail of damage</b>		Fractures in connection of palm plate to rudder blade	
<b>Sketch of damage</b>		<b>Sketch of repair</b>

<p style="text-align: center;"><b>View A - A</b></p>

<p>Full penetration weld</p> <p>Backing bar fully welded before closing</p> <p><math>t</math> = plate thickness, mm  <math>tr</math> = actual flange thickness, mm  <math>t = \frac{tr}{3} + 5</math>, mm, where <math>tr \leq 50</math>mm  <math>t = 3\sqrt{tr}</math>, mm, where <math>tr \geq 50</math>mm</p>	
<b>Notes on possible cause of damage</b>		<b>Notes on repairs</b>	
<p>1. Inadequate connection between palm plate and rudder blade plating (insufficient plating thickness and/or insufficient fillet weld).</p>		<p>1. Modification of detail design of the connection by increasing the plate thickness and full penetration welding.</p>

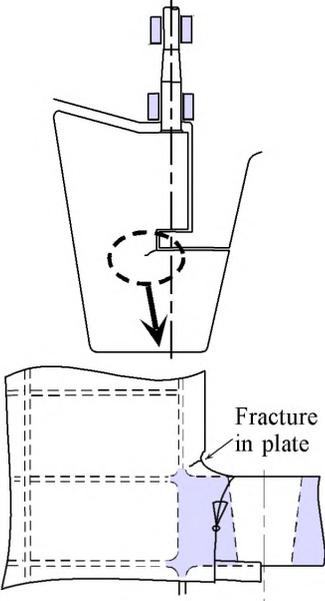
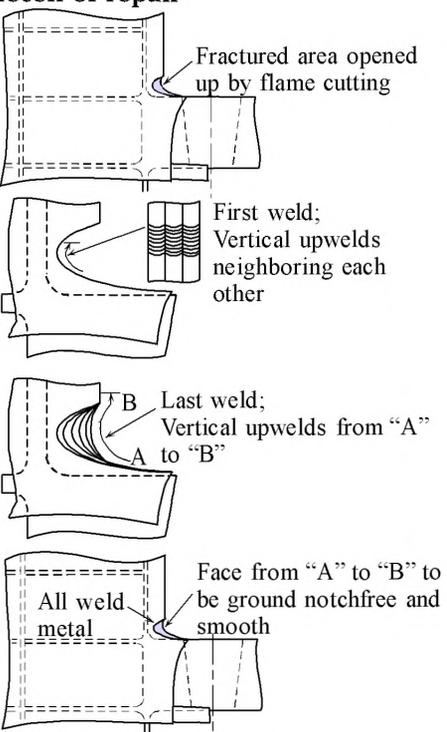
<b>BULK CARRIERS</b>		<b>Guidelines for Surveys, Assessment and Repair of Hull Structure</b>	
<b>Part 2</b>	<b>Fore and aft end regions</b>		<b>Example No.</b>
<b>Area 3</b>	<b>Stern frame, rudder arrangement and propeller shaft support</b>		<b>4</b>
<b>Detail of damage</b>		Fractures in rudder plating of semi-spade rudder (short fracture with end located forward of the vertical web)	
<b>Sketch of damage</b>		<b>Sketch of repair</b>

<b>Notes on possible cause of damage</b>		<b>Notes on repairs</b>	
<p>1. Stress concentration due to inadequate local design and/or fabrication notches in way of the butt weld between cast piece and plating.</p>		<p>1. Grooving-out and welding of the fracture is not always adequate (metallurgical notch in way of a high stressed area).</p> <p>2. In the proposed repair procedure the metallurgical notches are shifted into a zone exposed to lower stresses.</p> <p>3. After welding a modification of the radius according to the proposal in <b>Example 5</b> is to be carried out.</p> <p>4. In case of very small crack it can be ground off by increasing the radius.</p>

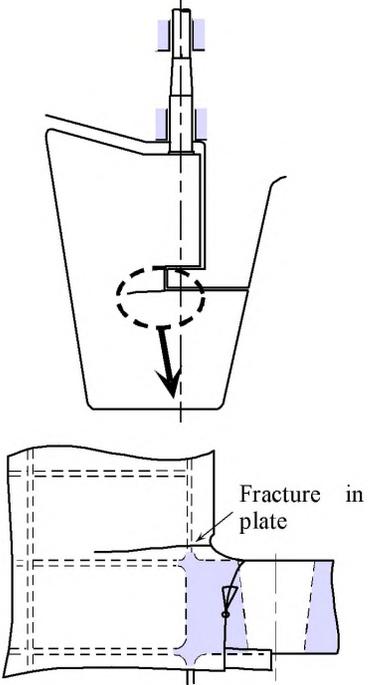
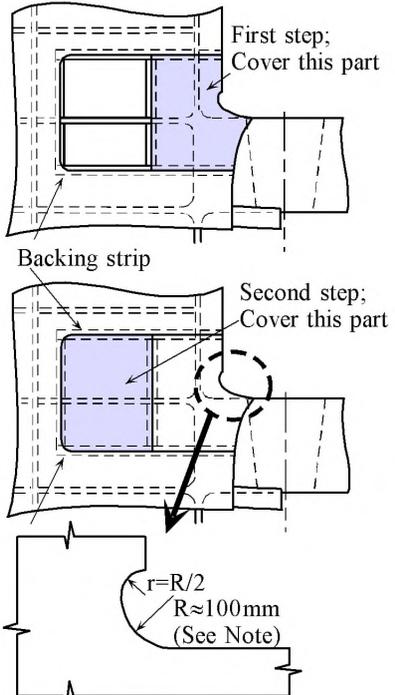
<b>GENERAL CARGO SHIPS</b>		<b>Guidelines for Surveys, Assessment and Repair of Hull Structure</b>
<b>Part 2</b>	<b>Fore and aft end regions</b>	<b>Example No.</b>
<b>Area 3</b>	<b>Stern frame, rudder arrangement and propeller shaft support</b>	<b>5</b>
<b>Detail of damage</b>	Fractures in rudder plating of semi-spade rudder extending beyond the vertical web	
<b>Sketch of damage</b>	<b>Sketch of repair</b>

<p>Fracture in plate</p>

<p>First step; Cover this part</p> <p>Backing strip</p> <p>Second step; Cover this part</p> <p><math>r=R/2</math> <math>R \approx 100\text{mm}</math> (See Note)</p> <p>Note: R should be considered according to local detail</p>	
<b>Notes on possible cause of damage</b>	<b>Notes on repairs</b>	
<ol style="list-style-type: none"> <li>1. Stress concentration due to inadequate local design and/or fabrication notches in way of the butt weld between cast piece and plating.</li> </ol>	<ol style="list-style-type: none"> <li>1. Fractured plating is to be cut-out.</li> <li>2. Internal structures are to be checked.</li> <li>3. Cut-out is to be closed by an insert plating according to the sketch (welding only from one side is demonstrated).</li> <li>4. Modification of the radius.</li> <li>5. In case of a new cast piece, connection with the plating is to be shifted outside the high stress area.</li> </ol>

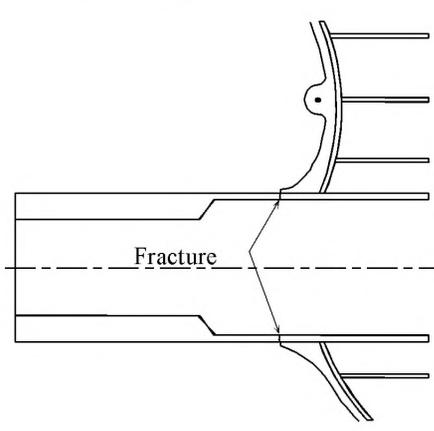
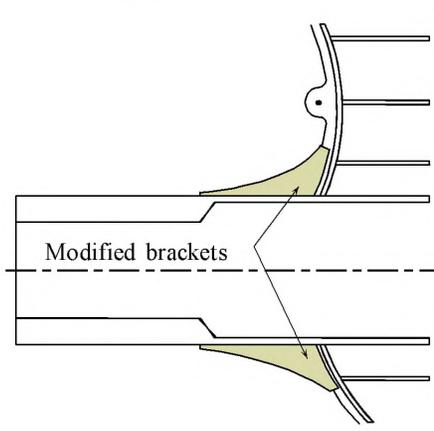
<b>BULK CARRIERS</b>		<b>Guidelines for Surveys, Assessment and Repair of Hull Structure</b>	
<b>Part 2</b>	<b>Fore and aft end regions</b>		<b>Example No.</b>
<b>Area 3</b>	<b>Stern frame, rudder arrangement and propeller shaft support</b>		<b>8</b>
<b>Detail of damage</b>		Fractures in stern tube at the connection to stern frame	
<b>Sketch of damage</b>		<b>Sketch of repair</b>

<b>Notes on possible cause of damage</b>		<b>Notes on repairs</b>	
<ol style="list-style-type: none"> <li>1. Fatigue fracture due to vibration.</li> </ol>		<ol style="list-style-type: none"> <li>1. Fractured tube is to be veed-out and welded from both sides.</li> <li>2. Brackets are to be replaced by modified brackets with soft transition.</li> </ol>

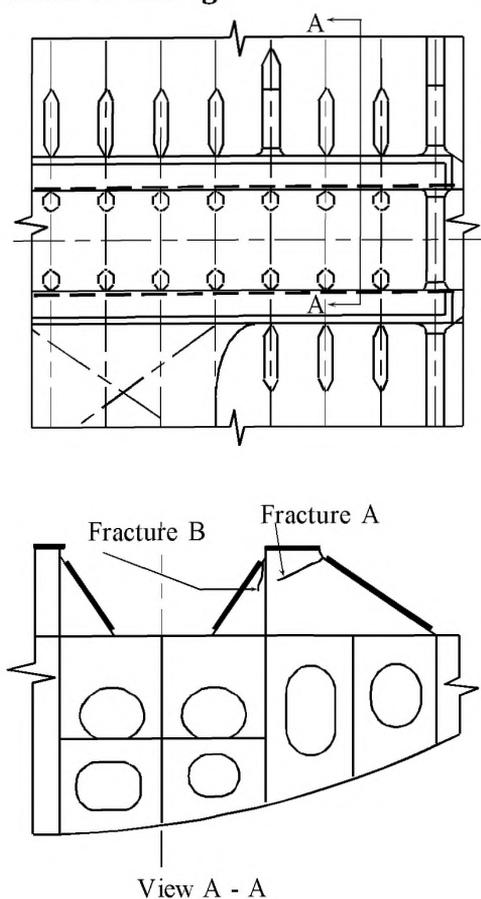
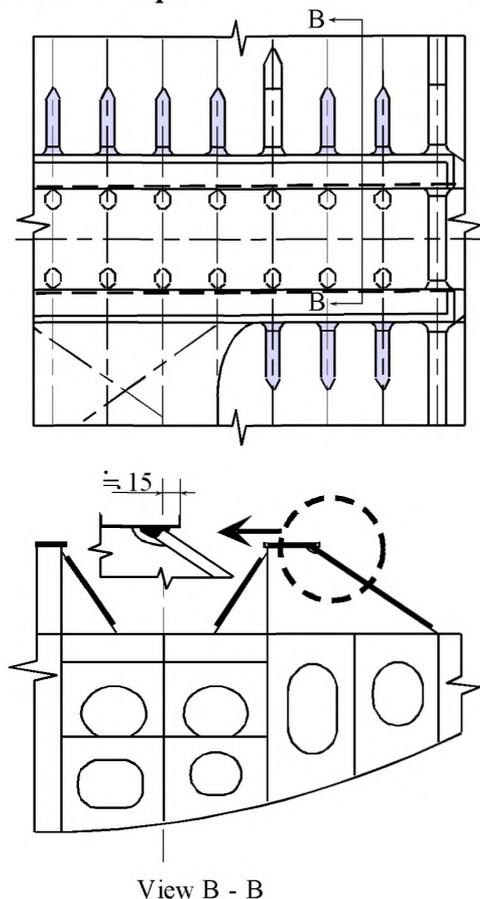
<b>BILK CARRIERS</b>		<b>Guidelines for Surveys, Assessment and Repair of Hull Structure</b>	
<b>Part 3</b>	<b>Machinery and accommodation spaces</b>	<b>Example No. 1</b>	
<b>Area 1</b>	<b>Engine room structure</b>	<b>1</b>	
<b>Detail of damage</b>	Fractures in brackets at main engine foundation		
<b>Sketch of damage</b>		<b>Sketch of repair</b>

<b>Notes on possible cause of damage</b>		<b>Notes on repairs</b>	
<ol style="list-style-type: none"> <li>1. Vibration of main engine.</li> <li>2. Insufficient strength of brackets at main engine foundation.</li> <li>3. Insufficient pre-load bolts.</li> </ol>		<ol style="list-style-type: none"> <li>1. Fractures are to be veed-out and rewelded.</li> <li>2. New modified brackets at main engine foundation.</li> <li>3. Or insert pieces and additional flanges to increase section modulus of the brackets.</li> </ol>

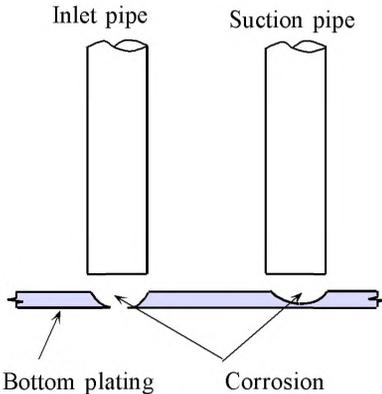
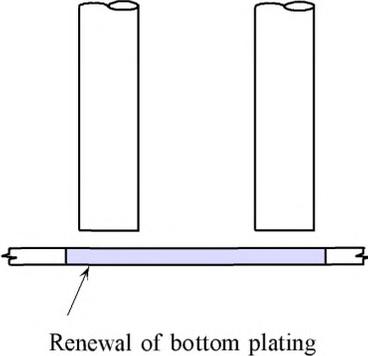
<b>BULK CARRIERS</b>		<b>Guidelines for Surveys, Assessment and Repair of Hull Structure</b>	
<b>Part 3</b>	<b>Machinery and accommodation spaces</b>		<b>Example No.</b>
<b>Area 1</b>	<b>Engine room structure</b>		<b>3</b>
<b>Detail of damage</b>	Corrosion in bottom plating under inlet/suction/pipe in way of bilge tank in engine room		
<b>Sketch of damage</b>		<b>Sketch of repair</b>

<b>Notes on possible cause of damage</b>		<b>Notes on repairs</b>	
<ol style="list-style-type: none"> <li>1. Heavy corrosion of bottom plating under the inlet/suction pipe.</li> </ol>		<ol style="list-style-type: none"> <li>1. Corroded bottom plating is to be cropped and part renewed. Thicker plate is preferable.</li> <li>2. Replacement of pipe end by enlarged conical opening (similar to suction head in ballast tank) is preferable.</li> </ol>

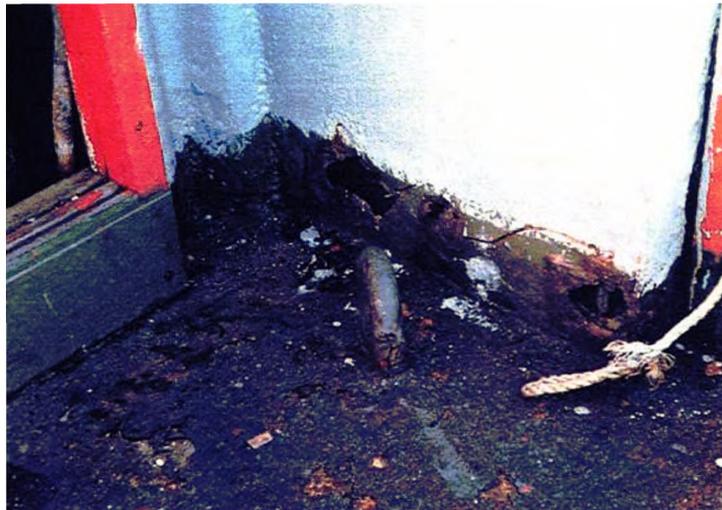
**Photograph 1** Corroded accommodation house side structure

Severe corrosion may be found in exposed deck plating and deck house side structure adjacent to the deck plating where water is liable to accumulate (See **Photograph 1**). Corrosion may also be found in accommodation bulkheads around cutout for fittings, such as doors, side scuttles, ventilators, etc., where proper maintenance of the area is relatively difficult. Deterioration of the bulkheads including fittings may impair the integrity of weathertightness.

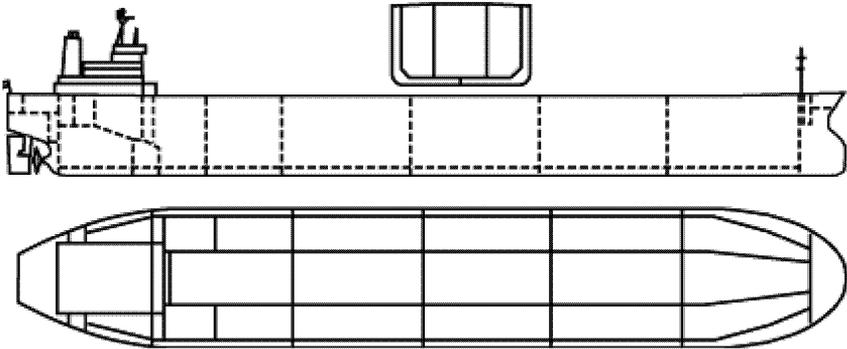
**Figure 1** General view of a typical double hull oil tanker (150,000 DWT and greater)

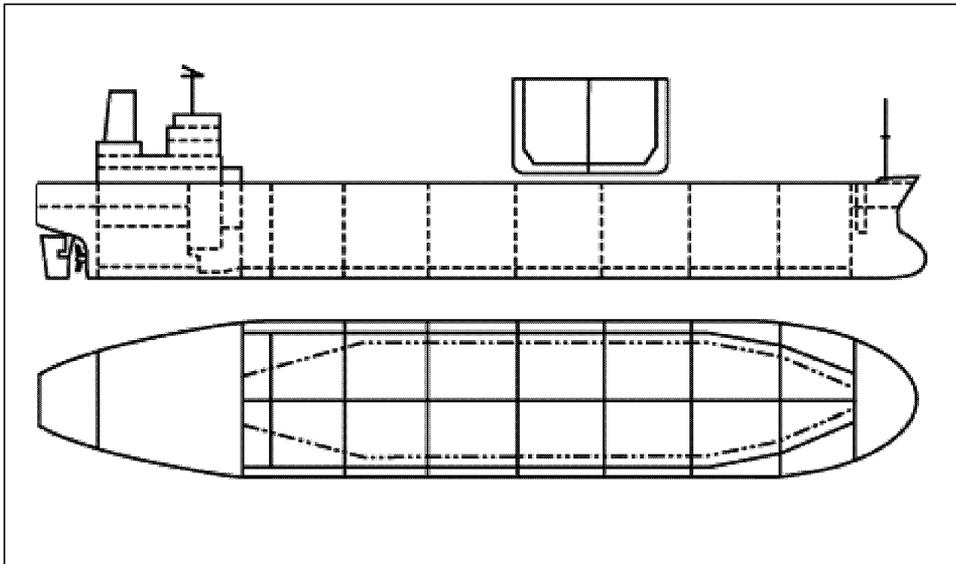
**Figure 2** General view of a typical double hull oil tanker (150,000 DWT or less)

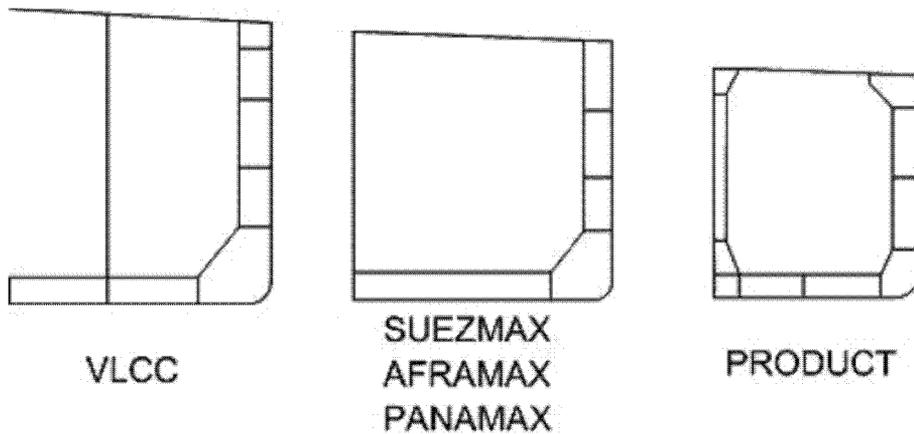
**Figure 3** Categories of Bulkhead Configurations

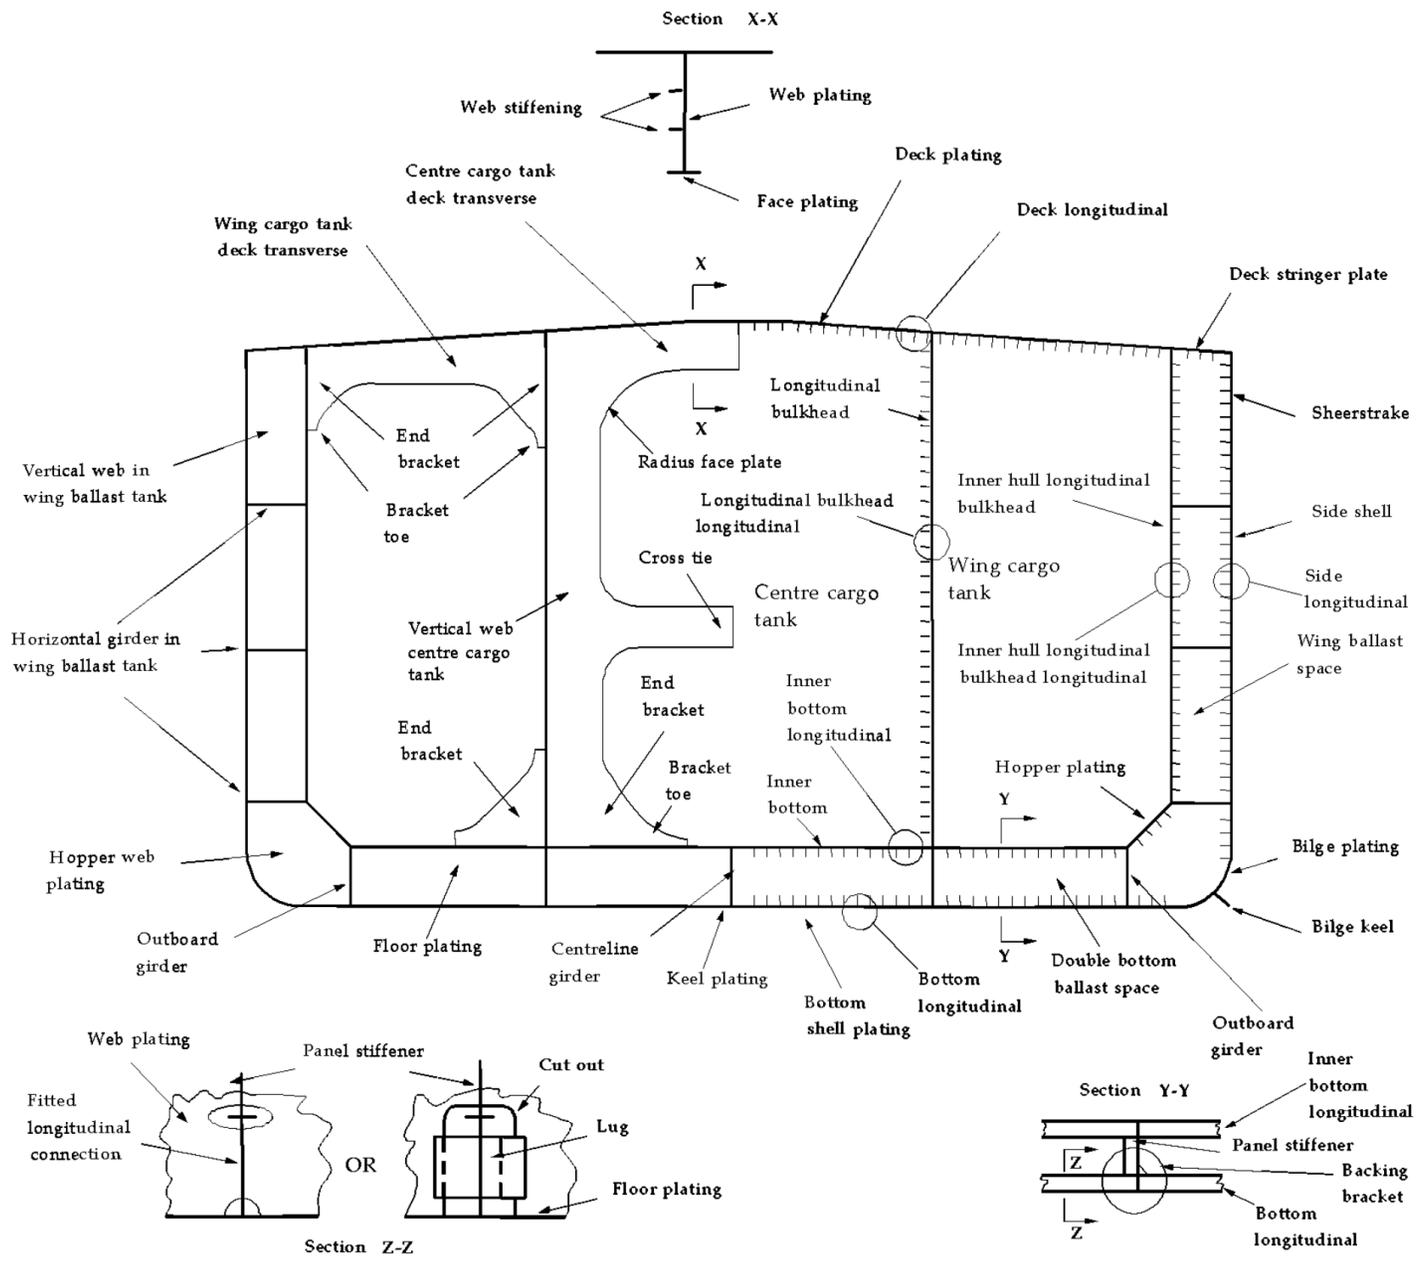
**Figure 4 Typical midship section of a double hull oil tanker with two longitudinal bulkheads including nomenclature**

Figures 4 to 6 show the typical nomenclature used for the midship section and transverse bulkhead.

**3.2.1** For clarity of definition and reporting of survey data, it is recommended that standard nomenclature for structural elements be adopted. A typical midship section is illustrated in **Figures 4 to 6**. These figures show the generally accepted nomenclature.

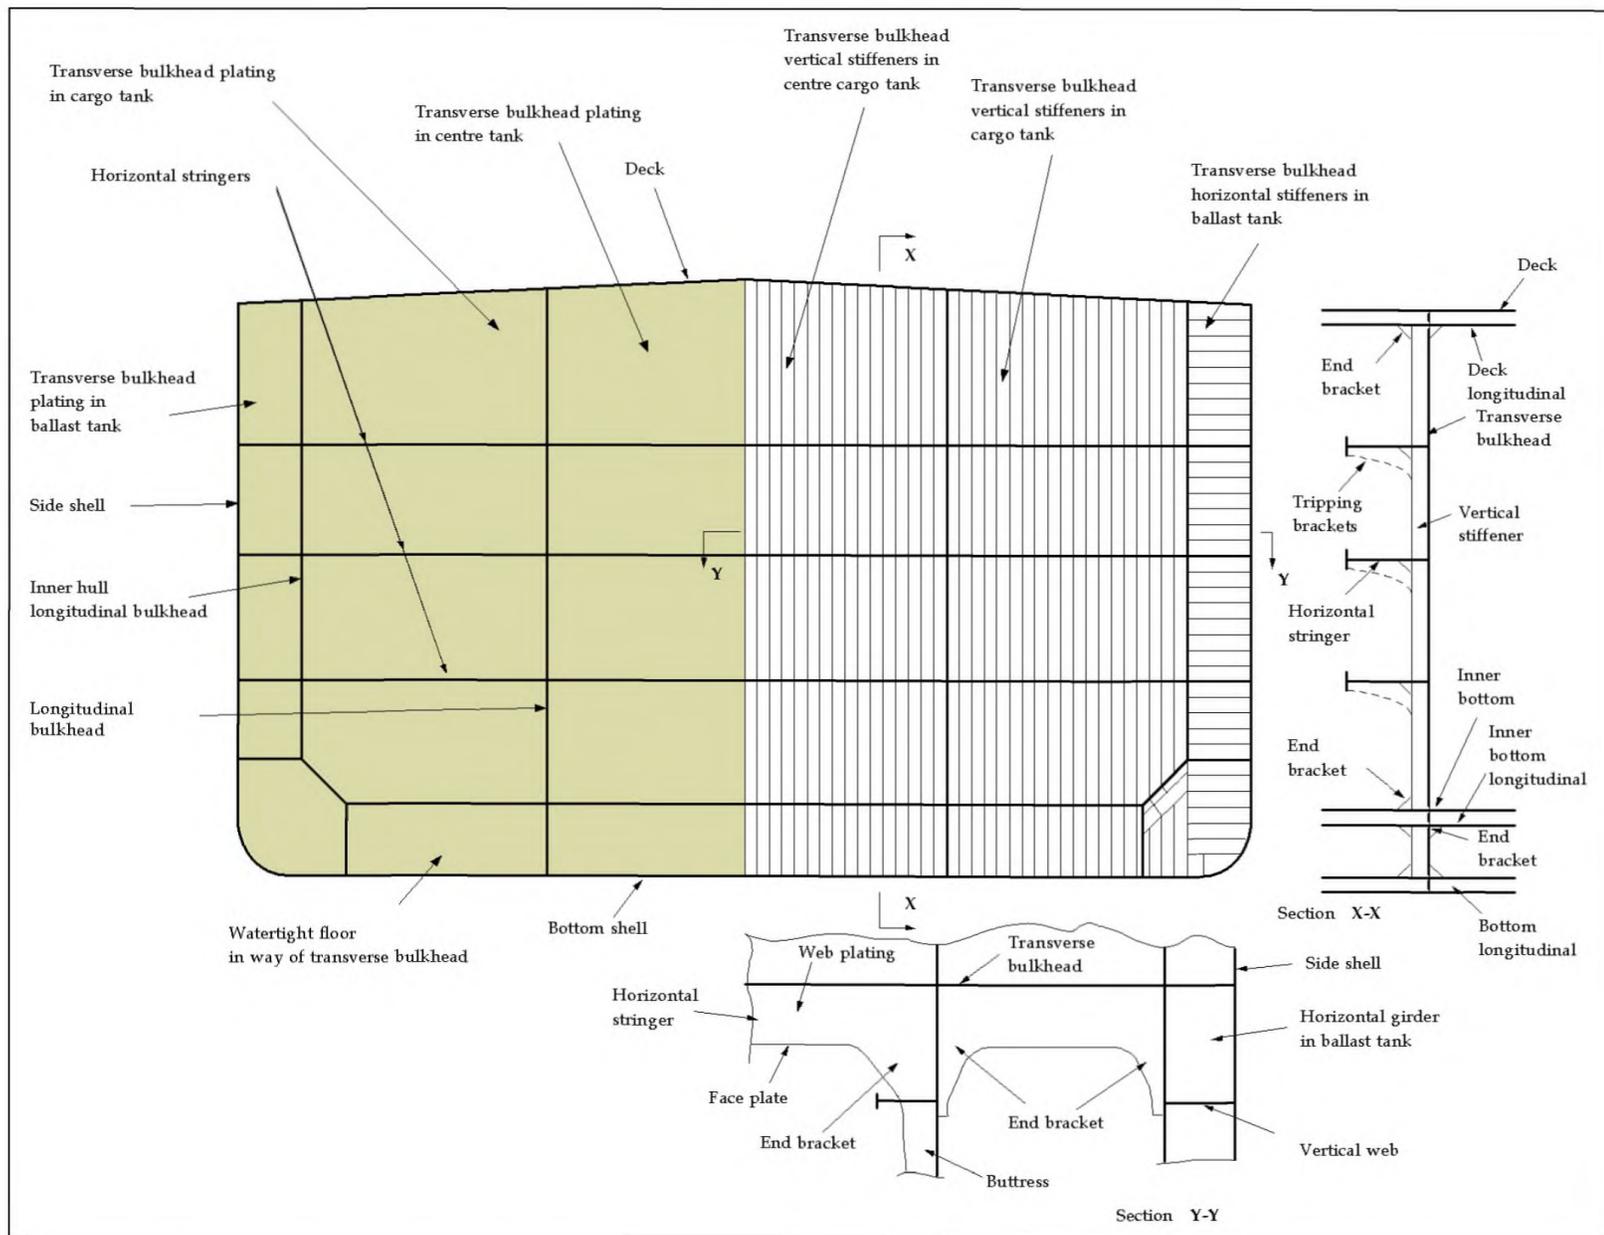
**Figure 5 Double Hull Tanker – Typical Transverse Bulkhead**

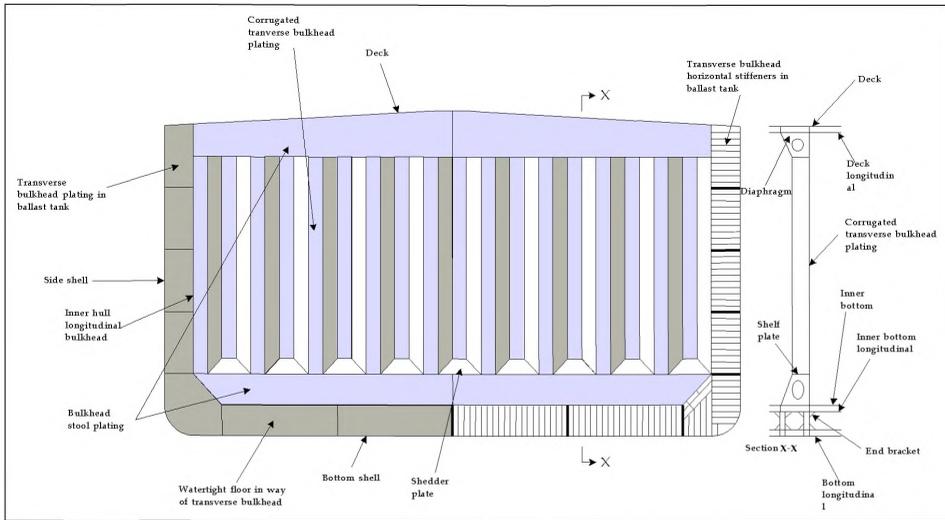
**Figure 6 Corrugated Transverse Bulkhead Nomenclature**

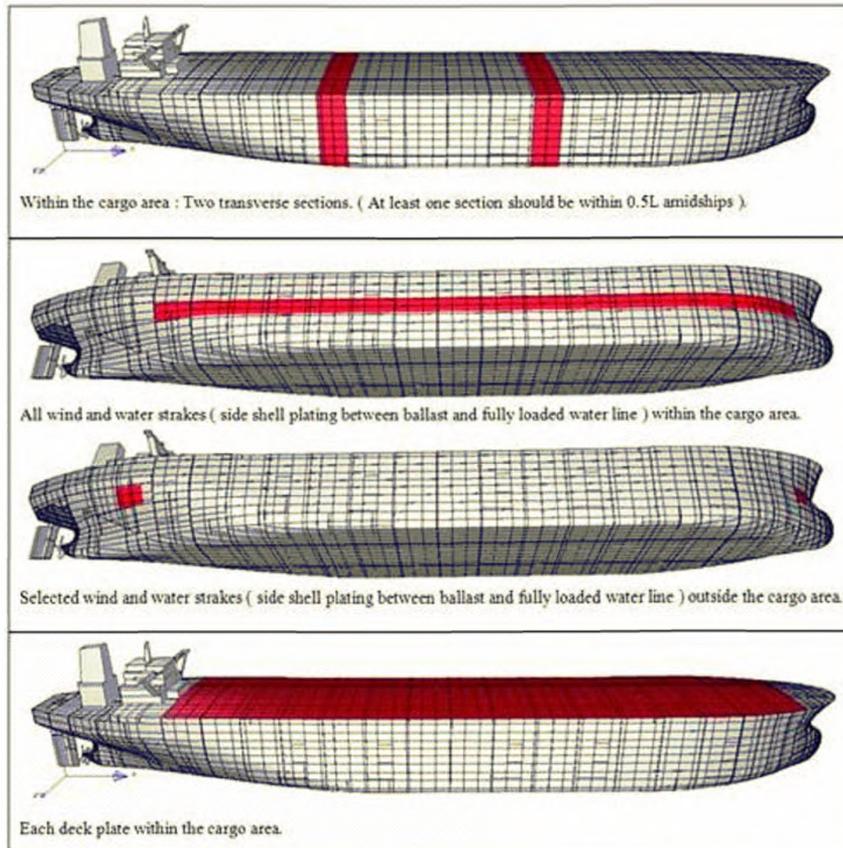
**Figure 7** Example of Transverse Sections of Shell Plating and Main Deck Thickness Measurement Requirements for an oil tanker 15 years of age.

**2.4.2** The Special Survey concentrates on close-up surveys in association with thickness measurements and is aimed at detecting fractures, buckling, corrosion and other types of structural deterioration. See Figure 7.

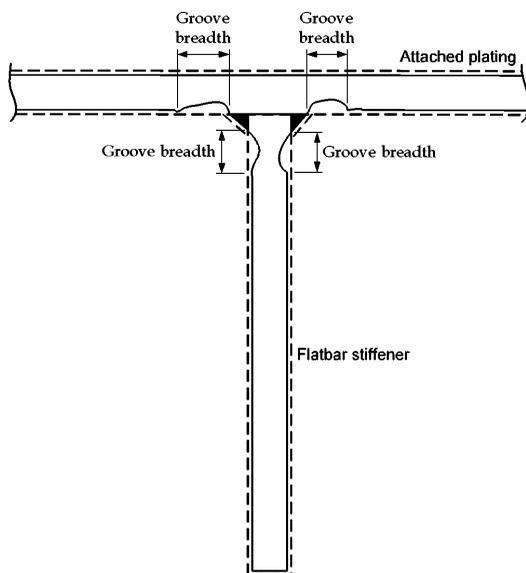
Grooving corrosion is often found in or beside welds, especially in the heat affected zone. This corrosion is sometimes referred to as 'inline pitting attack' and can also occur on vertical members and flush sides of bulkheads in way of flexing. The corrosion is caused by the galvanic current generated from the difference of the metallographic structure between the heat affected zone and base metal. Coating of the welds is generally less effective compared to other areas due to roughness of the surface, which exacerbates the corrosion. Grooving corrosion may lead to stress concentrations and further accelerate the corrosion process. Grooving corrosion may be found in the base material where coating has been scratched or the metal itself has been mechanically damaged. An example of grooving corrosion is shown in Figure 8.

**Figure 8 Grooving Corrosion**

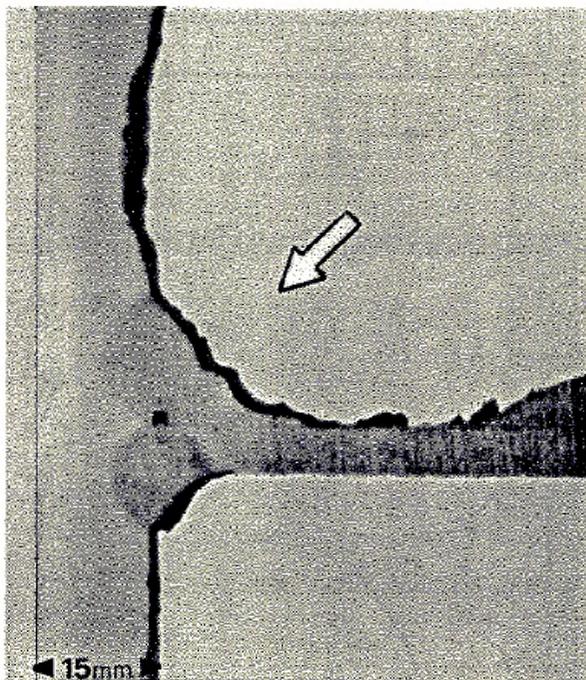
**Figure 10** Detail of Necking Effect

- Necking occurs at the junction of the longitudinal bulkhead plating and longitudinals. The deflection of the bulkhead plating and longitudinals due to reverse, cyclic loading from cargo oil and water ballast plus the accumulated mixtures of water, mud and scale at their junctures accelerates the corrosion rate. As the steel thins and weakens, the flexing consequently increases and hence corrosion accelerates (see Figure 10). The similar necking effect could also occur in the transverse bulkhead plating and stiffeners, or in the inner bottom plating and longitudinals inside the double bottom space. In the coated water ballast tanks, the plating is the principally affected area due to local corrosion in way of coating failure.

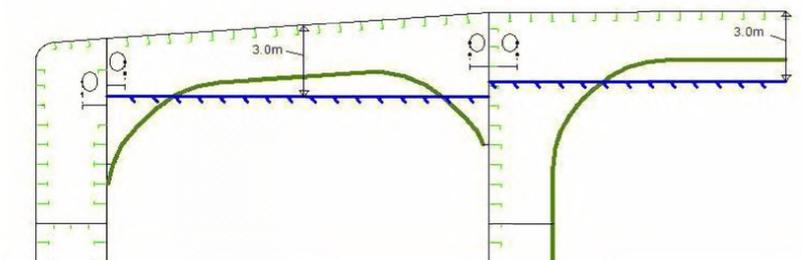
**Figure 11**

- .1 when the coating of the under deck structure is in GOOD condition and there is no evidence of wastage; or
- .2 if a permanent means of access is provided in each bay to allow safe entry and exit. This means:
  - .1 access direct from the deck via a vertical ladder and a small platform fitted approximately 2 m below the deck in each bay; or
  - .2 access to deck from a longitudinal permanent platform having ladders to deck in each end of the tank. The platform shall, for the full length of the tank, be arranged in level with, or above, the maximum water level needed for rafting of under deck structure. For this purpose, the ullage corresponding to the maximum water level is to be assumed not more than 3m from the deck plate measured at the midspan of deck transverses and in the middle length of the tank. See Figure 11.

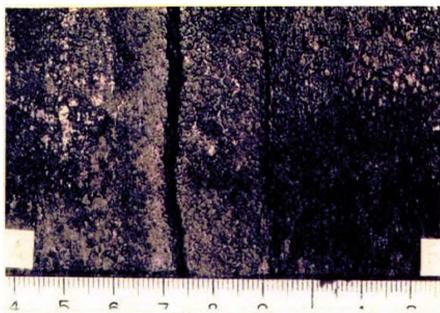
**Photograph 1**  
Grooving corrosion of welding of bottom plating

4.1.2 Severe grooving along welding of bottom plating is often found (See **Photographs 1** and **2**). This grooving can be accelerated by poor maintenance of the protective coating and/or sacrificial anodes fitted to the bottom plating.

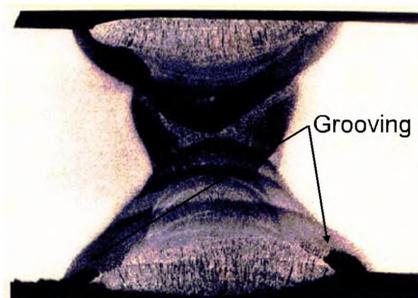
**Photograph 2**  
Section of the grooving shown in Photograph 1

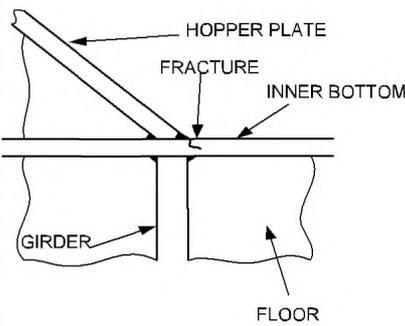
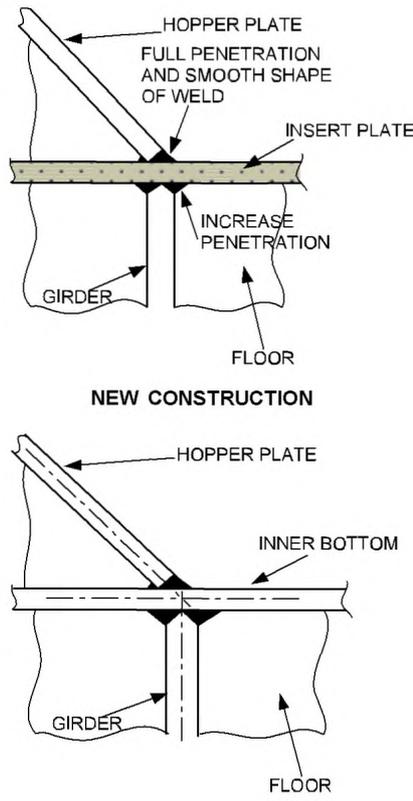
OIL Tankers		Guidelines for Surveys, Assessment and Repair of Hull Structure	
Group 1	Cargo area	Example No.	
	<b>Hopper and double bottom ballast tank</b>	<b>1</b>	
<b>Detail of damage</b>	Fracture on the inner bottom plating at the connection of hopper plate to inner bottom		
<b>Sketch of damage</b>	<b>Sketch of repair</b>

<b>Notes: Plate midlines intersect</b>		
<b>Factors which may have caused damage</b>	<b>Notes on repairs</b>		
<ol style="list-style-type: none"> <li>1. Stress concentration at juncture of hopper plate to inner bottom.</li> <li>2. Insufficient welding connection.</li> <li>3. Misalignment between hopper plate, inner bottom and girder.</li> </ol>	See Sketch.

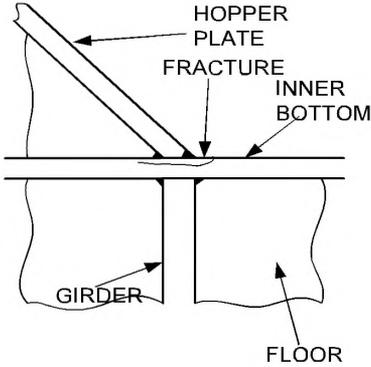
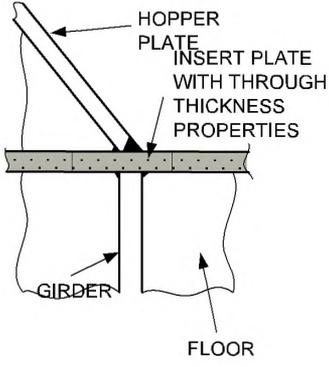
OIL Tankers		Guidelines for Surveys, Assessment and Repair of Hull Structure	
Group 1	Cargo area	Example No.	
	Hopper and double bottom ballast tank	2	
Detail of damage	Fracture at connection of bilge hopper plate and inner bottom		
Sketch of damage

<p>Notes: Plate midlines intersect</p>		
Factors which may have caused damage	Notes on repairs		
1. Stress concentration at the knuckle.	See Sketch.

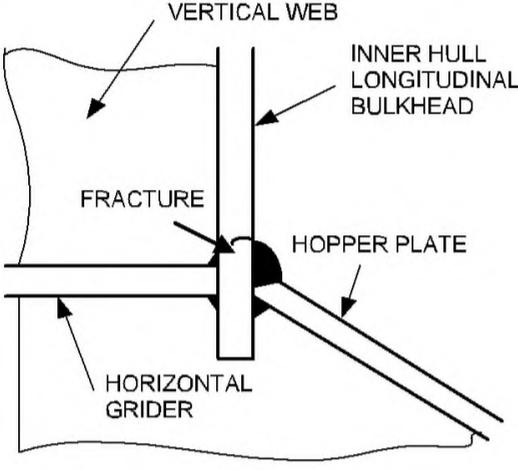
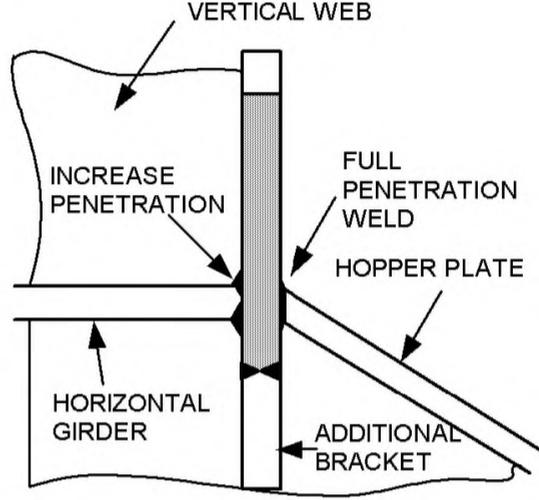
<b>OIL Tankers</b>		<b>Guidelines for Surveys, Assessment and Repair of Hull Structure</b>	
<b>Group 1</b>	<b>Cargo area</b>	<b>Example No.</b>	
	<b>Wing cargo tank</b>	<b>8</b>	
<b>Detail of damage</b>		Fracture at the connection of hopper plate to outside longitudinal bulkhead.	
<b>Sketch of damage</b>		<b>Sketch of repair</b>

<b>Factors which may have caused damage</b>		<b>Notes on repairs</b>	
<ol style="list-style-type: none"> <li>1. Stress concentration at junction of hopper plate to outside longitudinal bulkhead.</li> <li>2. Insufficient welding connection and/or incorrect shape of the weld toe.</li> <li>3. Misalignment between hopper plate, outside longitudinal bulkhead and side stringer.</li> </ol>		See Sketch.

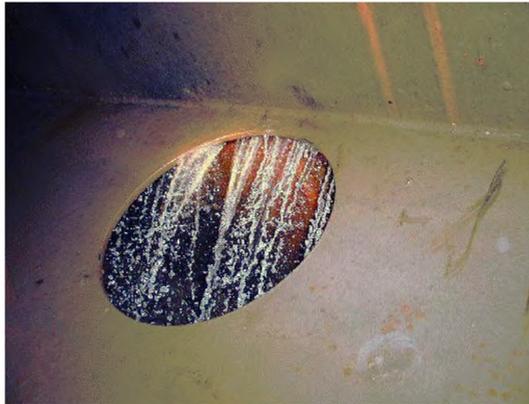
**Photograph 1 Side shell fracture in way of horizontal stringer weld**

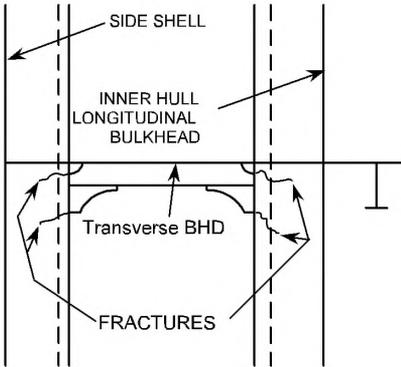
OIL Tankers		Guidelines for Surveys, Assessment and Repair of Hull Structure	
Group 2	Cargo area	Example No.	
	Wing ballast tank	1	
Detail of damage		Crack in way of connection of longitudinals to transverse bulkhead	
<p><b>Sketch of damage</b></p>

<p><b>Factors which may have caused damage</b></p> <ol style="list-style-type: none"> <li>1. Asymmetrical connection of bracket without backing bracket.</li> <li>2. Relative deflection of adjoining transverse web against transverse bulkhead.</li> <li>3. Additional biaxial bending stresses due to asymmetry of the angle bar longitudinal instead of symmetric T section.</li> <li>4. Dynamic load in the vicinity of the water line.</li> <li>5. Large upstand at bracket toe.</li> </ol>		<p><b>Notes on repairs</b></p> <p>See Sketch.</p>

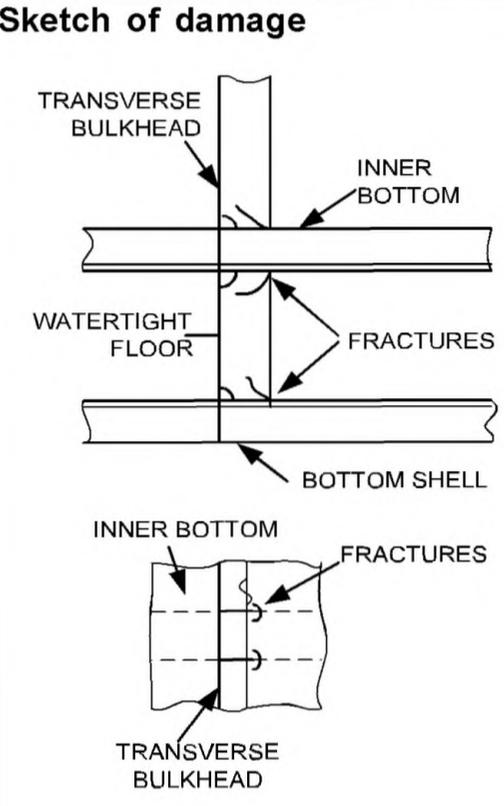
OIL Tankers		Guidelines for Surveys, Assessment and Repair of Hull Structure	
Group 3	Cargo area	Example No.	
	Bottom ballast tank	2	
<b>Detail of damage</b>		Fracture in way of stiffeners at connection of inner bottom and bottom shell to transverse bulkhead and floors.	
<b>Sketch of damage</b>		<b>Sketch of repair</b>

<p>The sketch of damage consists of two parts. The top part is a cross-sectional view showing a vertical TRANSVERSE BULKHEAD intersecting a horizontal INNER BOTTOM and a lower horizontal WATERTIGHT FLOOR. Both the inner bottom and the watertight floor are supported by a BOTTOM SHELL. Fractures are indicated by jagged lines at the connections between the bulkhead and the inner bottom, and between the bulkhead and the watertight floor. The bottom part is a top-down view showing the INNER BOTTOM and TRANSVERSE BULKHEAD with dashed lines indicating the location of FRACTURES.</p>

<b>Factors which may have caused damage</b>		<b>Notes on repairs</b>	
<ol style="list-style-type: none"> <li>Misalignment between bulkhead stiffener and inner bottom longitudinal.</li> <li>High stress concentration.</li> </ol>		<p>See Sketch.</p> <ol style="list-style-type: none"> <li>If tank top plating is fractured, part crop and insert.</li> <li>Proper alignment between bulkhead stiffener and inner bottom longitudinal is critical for successful repair.</li> <li>Soft backing brackets may also be added.</li> </ol>

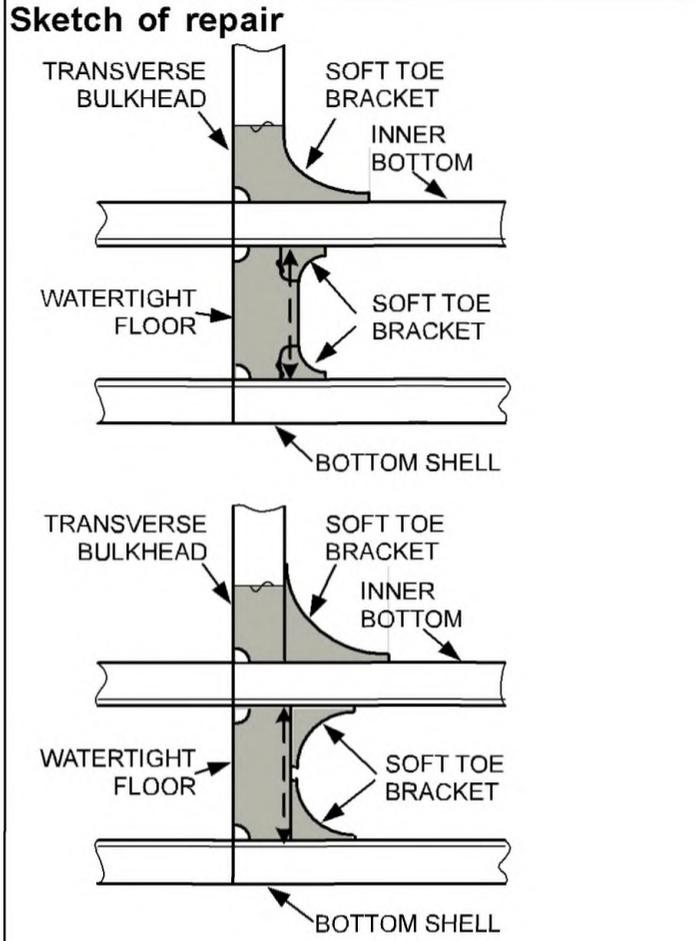
<p>The sketch of repair consists of two parts. The top part is a cross-sectional view similar to the damage sketch, but it shows the addition of SOFT TOE BRACKETs. These brackets are curved plates that fit between the TRANSVERSE BULKHEAD and the INNER BOTTOM, and between the TRANSVERSE BULKHEAD and the WATERTIGHT FLOOR. The bottom part is a top-down view showing the SOFT TOE BRACKETs installed at the intersections of the INNER BOTTOM and TRANSVERSE BULKHEAD.</p>

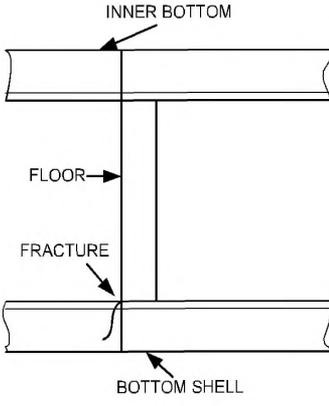
<b>OIL Tankers</b>		<b>Guidelines for Surveys, Assessment and Repair of Hull Structure</b>	
<b>Group 3</b>	<b>Cargo area</b>	<b>Example No.</b>	
	<b>Bottom ballast tank</b>	<b>4</b>	
<b>Detail of damage</b>		<b>Connection of longitudinals to ordinary floors</b>	
<p><b>Sketch of damage</b></p>

<p><b>Factors which may have caused damage</b></p> <ol style="list-style-type: none"> <li>1. Stress concentration at the connection of bottom longitudinal and stiffener on floor.</li> </ol>		<p><b>Notes on repairs</b></p> <p>See Sketch.</p> <ol style="list-style-type: none"> <li>1. Butt welds in bottom longitudinal should be kept clear of the soft toe bracket toes.</li> <li>2. If possible soft toe bracket and vertical stiffener should be integral.</li> </ol>

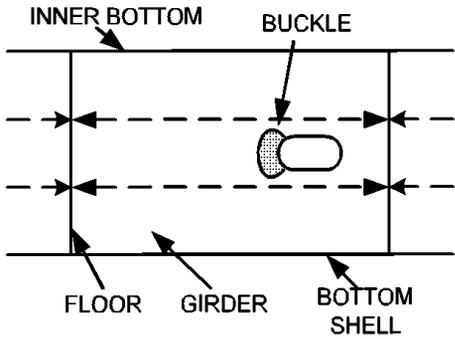
<b>OIL Tankers</b>		<b>Guidelines for Surveys, Assessment and Repair of Hull Structure</b>	
<b>Group 3</b>	<b>Cargo area</b>	<b>Example No.</b>	
	<b>Bottom ballast tank</b>	<b>5</b>	
<b>Detail of damage</b>		<b>Panels of bottom girders in way of openings.</b>	
<p><b>Sketch of damage</b></p>

<p>The sketch shows a cross-section of the hull structure. At the top is the 'INNER BOTTOM'. Below it is a 'GIRDER'. At the bottom is the 'BOTTOM SHELL'. A 'BUCKLE' is shown as a shaded oval area on the side of the girder. Dashed lines with arrows indicate the direction of stress or movement.</p>		<p><b>Sketch of repair</b></p>

<p><b>Factors which may have caused damage</b></p> <ol style="list-style-type: none"> <li>1. High shear or compressive stress in the side girder.</li> <li>2. Insufficient buckling strength.</li> </ol>		<p><b>Notes on repairs</b></p> <p>See Sketch.</p>

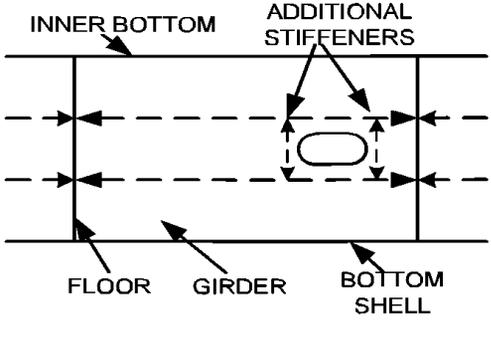
<p>The sketch shows the same cross-section as the damage sketch, but with 'ADDITIONAL STIFFENERS' added to the side of the girder. The buckle is shown as a dashed oval, indicating its location before repair. Labels include 'INNER BOTTOM', 'FLOOR', 'GIRDER', 'BOTTOM SHELL', and 'ADDITIONAL STIFFENERS'.</p>

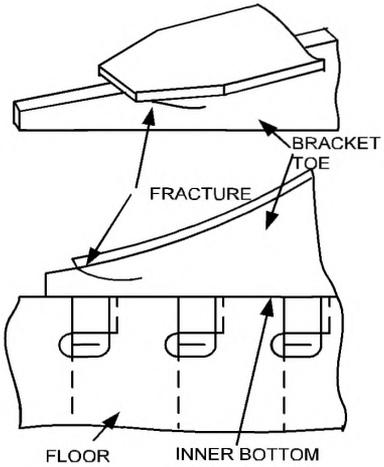
OIL Tankers		Guidelines for Surveys, Assessment and Repair of Hull Structure	
Group 4	Cargo area	Example No.	
	<b>Web Frame in cargo tank</b>	<b>1</b>	
<b>Detail of damage</b>		Fracture at toe of web frame bracket connection to inner bottom.	
<p><b>Sketch of damage</b></p>

<p><b>Factors which may have caused damage</b></p> <ol style="list-style-type: none"> <li>1. Inadequate tapering the toe end.</li> <li>2. Insufficient tapering of flange.</li> <li>3. Lateral flexing of the bracket.</li> </ol>		<p><b>Notes on repairs</b></p> <p>See Sketch.</p>

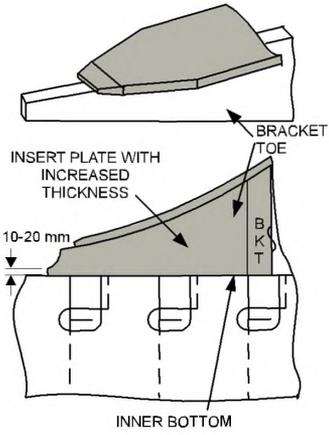
<p><b>Sketch of repair</b></p> <p>Modify Face Taper</p> <ol style="list-style-type: none"> <li>1. Breadth taper 20 degrees.</li> <li>2. Breadth at toe as small as practical.</li> <li>3. Thickness taper 1 in 3 to 10mm.</li> </ol>

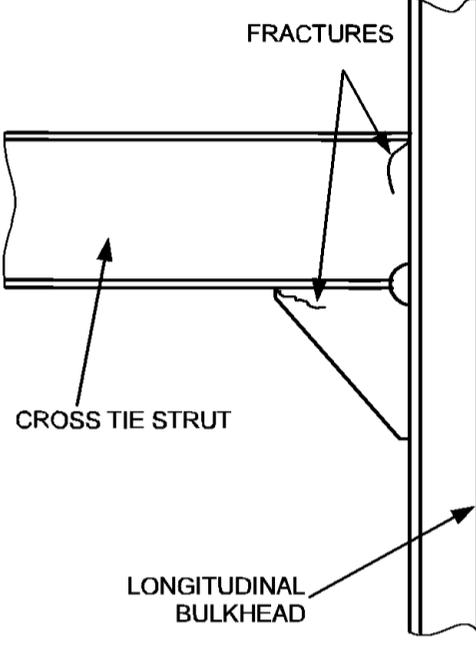
<b>OIL Tankers</b>		<b>Guidelines for Surveys, Assessment and Repair of Hull Structure</b>	
<b>Group 4</b>	<b>Cargo area</b>	<b>Example No.</b>	
	<b>Web Frame in cargo tank</b>	<b>2</b>	
<b>Detail of damage</b>		<b>Cross ties and their end connections</b>	
<b>Sketch of damage</b>		<b>Sketch of repair</b>

<p>The sketch shows a horizontal cross tie strut connected to a vertical longitudinal bulkhead. Two jagged lines labeled 'FRACTURES' indicate breakage at the connection points. Labels include 'CROSS TIE STRUT' and 'LONGITUDINAL BULKHEAD'.</p>

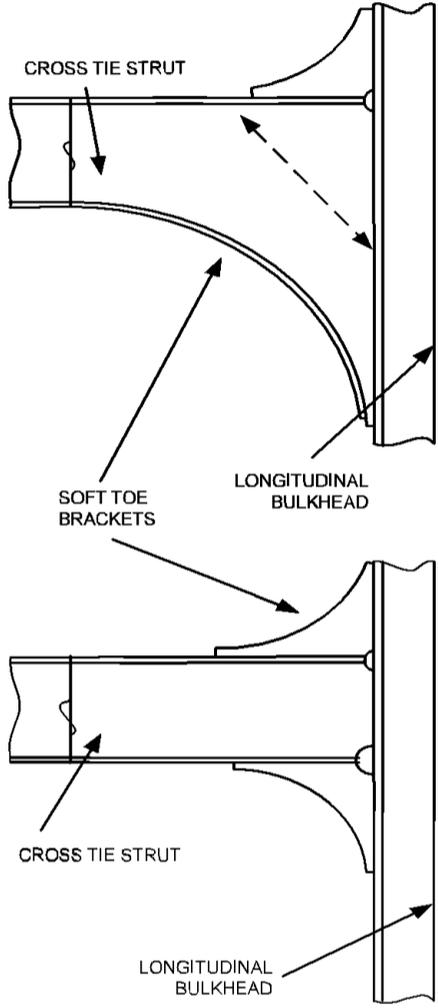
<p>The sketch shows two repair configurations. The top one shows a 'CROSS TIE STRUT' connected to a 'LONGITUDINAL BULKHEAD' using 'SOFT TOE BRACKETS'. The bottom one shows a similar connection with a different bracket design. Labels include 'CROSS TIE STRUT', 'SOFT TOE BRACKETS', and 'LONGITUDINAL BULKHEAD'.</p>	
<b>Factors which may have caused damage</b> 1. Stress concentration due to unsuitable bracket shape at juncture of cross tie to longitudinal. 2. Inadequate panel stiffening of web plate of cross-tie.		<b>Notes on repairs</b> See Sketch.

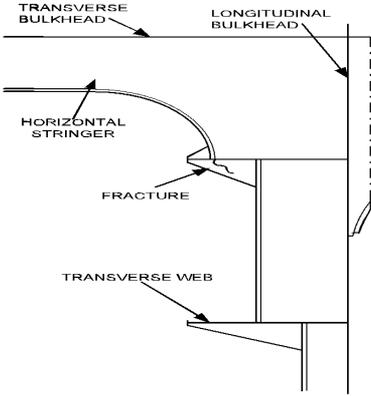
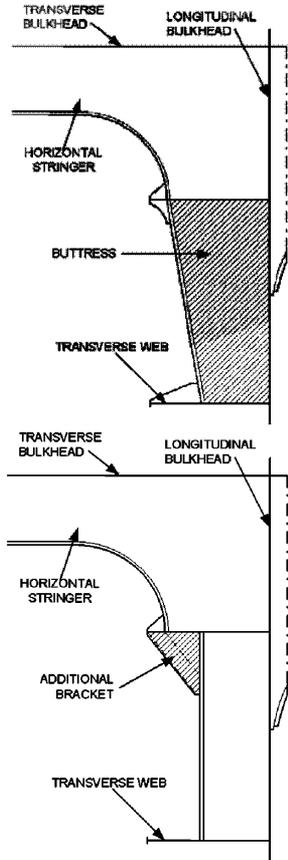
<b>OIL Tankers</b>		<b>Guidelines for Surveys, Assessment and Repair of Hull Structure</b>	
<b>Group 5</b>	<b>Cargo area</b>	<b>Example No.</b>	
	<b>Transverse Bulkhead in cargo tank</b>	<b>1</b>	
<b>Detail of damage</b>	Fracture in way of connection of transverse bulkhead stringer to transverse web frames and longitudinal bulkhead stringer		
<b>Sketch of damage</b>	<b>Sketch of repair</b>

<b>Factors which may have caused damage</b>	<b>Notes on repairs</b>		
<ol style="list-style-type: none"> <li>1. Stress concentration due to discontinuous structure.</li> <li>2. High shear stress in the horizontal stringer.</li> </ol>	See Sketch.
