**РОССИЙСКИЙ МОРСКОЙ РЕГИСТР СУДОХОДСТВА  
RUSSIAN MARITIME REGISTER OF SHIPPING**

**ПРИЛОЖЕНИЕ К ПРАВИЛАМ  
РОССИЙСКОГО МОРСКОГО РЕГИСТРА СУДОХОДСТВА  
УНИФИЦИРОВАННЫЕ ИНТЕРПРЕТАЦИИ  
И РЕКОМЕНДАЦИИ  
МЕЖДУНАРОДНОЙ АССОЦИАЦИИ  
КЛАССИФИКАЦИОННЫХ ОБЩЕСТВ**

**IACS UNIFIED INTERPRETATIONS  
AND RECOMMENDATIONS**

НД № 2-020101-085-R-E

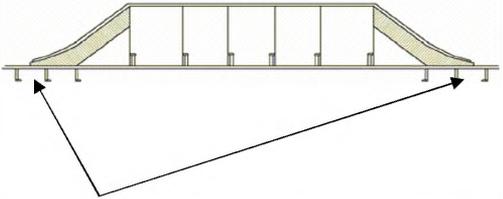
<b>Sketch of repair</b>

<p>Under deck transverse is to be described as mentioned in the following "Note on repairs".</p> <p>"Increase bracket length to end between under deck longitudinals and align end to under deck transverse."</p>		
<b>Factors which may have caused damage</b>	<b>Notes on repairs</b>		
<ol style="list-style-type: none"> <li>1. High stress due to toes bracket ending at cut out for longitudinal.</li> </ol>	<p>See Sketch.</p> <ol style="list-style-type: none"> <li>1. Increase bracket length to end between underdeck longitudinals and align end to underdeck transverse.</li> <li>2. Install fitted collar rather than lapped collar.</li> <li>3. Insert deck plating if fracture extends into deck.</li> </ol>

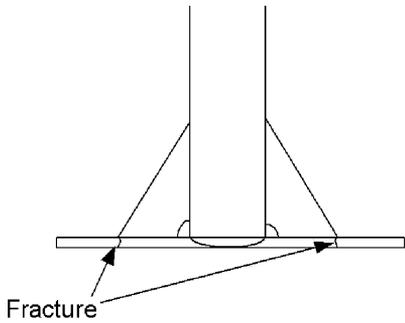
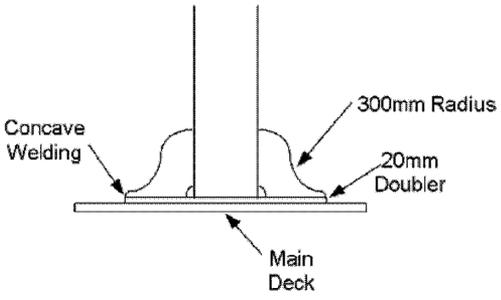
OIL Tankers		Guidelines for Surveys, Assessment and Repair of Hull Structure	
Group 6	Deck Structure	Example No.	
		5	
<b>Detail of damage</b>		Fractured deck plating in way of deck pipe support stanchions (midships)	
<b>Sketch of damage</b>		<b>Sketch of repair</b>

<b>Factors which may have caused damage</b>		<b>Notes on repairs</b>	
<p>1. Stanchions experience more severe relative displacements from hull girder bending.</p>		<p>See Sketch.</p>

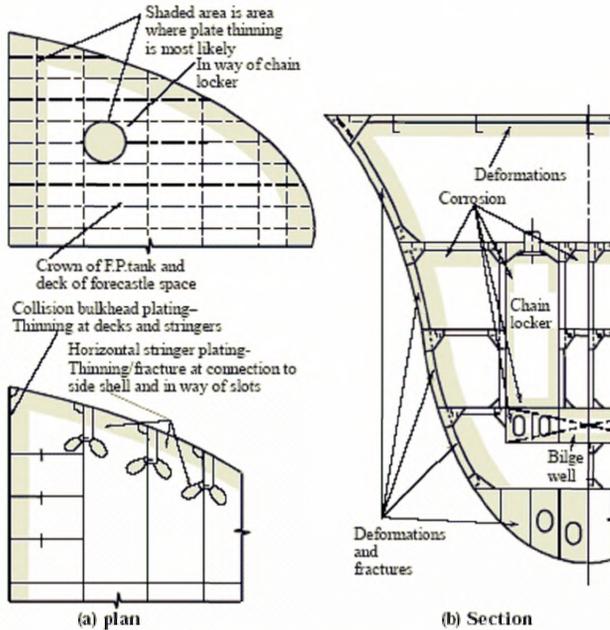
Fig 1 Fore end structure - Potential problem areas

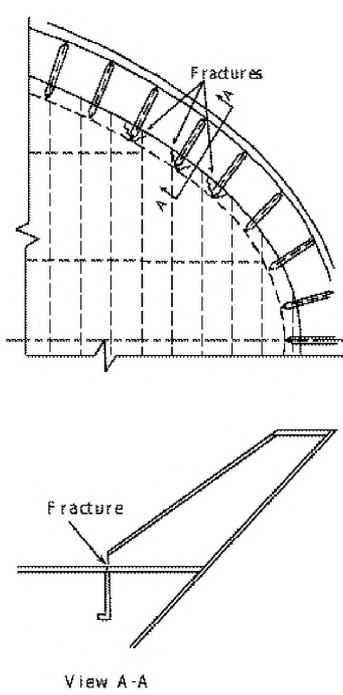
<b>OIL Tankers</b>		<b>Guidelines for Surveys, Assessment and Repair of Hull Structure</b>	
<b>Group 7</b>	Fore region	<b>Example No.</b>	
<b>Area 1</b>	Forecastle	<b>1</b>	
<b>Detail of damage</b>		Fracture in forecastle deck plating at bulwark	
<p><b>Sketch of damage</b></p>

<p style="text-align: center;">View A-A</p>	
<p><b>Factors which may have caused damage</b></p> <ol style="list-style-type: none"> <li>1. Bow Flare effect in heavy weather.</li> <li>2. Stress concentration due to poor design.</li> </ol>		<p><b>Notes on repairs</b></p> <ol style="list-style-type: none"> <li>1. Fractured deck plating should be cropped and renewed.</li> <li>2. Bracket in line with the bulwark stay to be fitted to reduce stress concentration.</li> </ol>

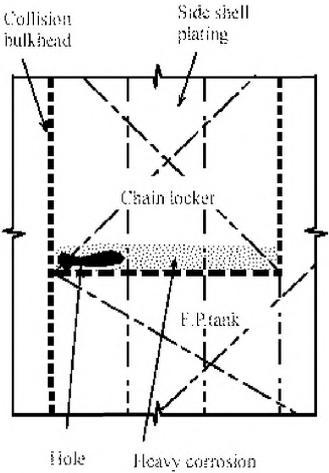
OIL Tankers		Guidelines for Surveys, Assessment and Repair of Hull Structure	
Group 7	Fore region	Example No.	
Area 1	Chain locker	2	
<b>Detail of damage</b>		Fractures in side shell plating in way of chain locker	
<b>Sketch of damage</b>		<b>Sketch of repair</b>

<p>Collision bulkhead</p> <p>Side shell plating</p> <p>Chain locker</p> <p>E. Plank</p> <p>Hole</p> <p>Heavy corrosion</p>

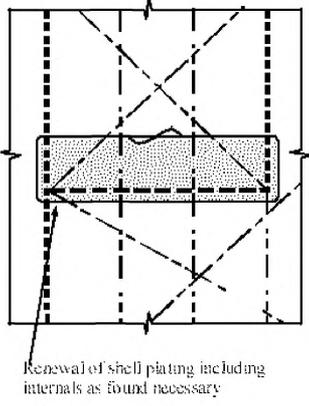
<p>Removal of shell plating including internals as found necessary</p>	
<b>Factors which may have caused damage</b>		<b>Notes on repairs</b>	
<ol style="list-style-type: none"> <li>1. Heavy corrosion in region where mud is accumulated.</li> </ol>		<ol style="list-style-type: none"> <li>1. Corroded plating should be cropped and renewed.</li> <li>2. Protective coating should be applied.</li> </ol>

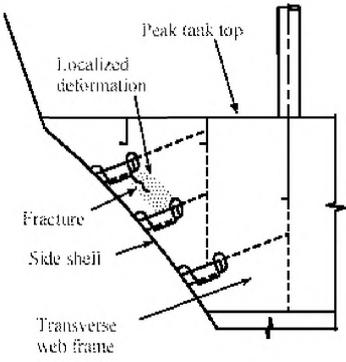
<b>OIL Tankers</b>		<b>Guidelines for Surveys, Assessment and Repair of Hull Structure</b>	
<b>Group 7</b>	<b>Fore region</b>	<b>Example No.</b>	
<b>Area 1</b>	<b>Forepeak ballast tank</b>	<b>3</b>	
<b>Detail of damage</b>	Fractures and deformation of bow transverse webs in way of cut-outs for side longitudinals		
<b>Sketch of damage</b>		<b>Sketch of repair</b>

<p>Labels in sketch: Peak tank top, Localized deformation, Fracture, Side shell, Transverse web frame.</p>

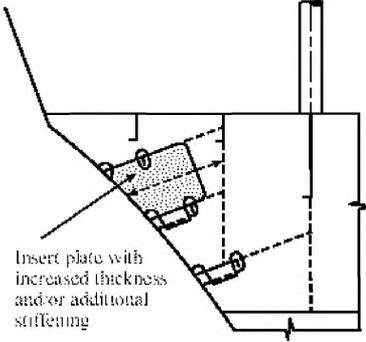
<p>Label in sketch: Insert plate with increased thickness and/or additional stiffening.</p>	
<b>Factors which may have caused damage</b>		<b>Notes on repairs</b>	
<ol style="list-style-type: none"> <li>1. Localized material wastage in way of coating failure at cut-outs and sharp edges due to working of the structure.</li> <li>2. Dynamic seaway loading in way of bow flare.</li> </ol>		<ol style="list-style-type: none"> <li>1. Sufficient panel strength to be provided to absorb the dynamic loads enhanced by bow flare shape.</li> </ol>

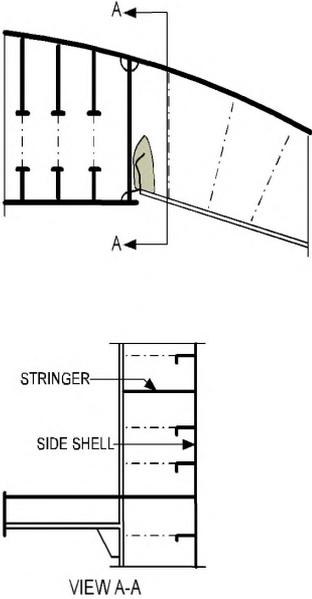
OIL Tankers		Guidelines for Surveys, Assessment and Repair of Hull Structure	
Group 7	Fore region	Example No.	
Area 1	Forepeak ballast tank	5	
Detail of damage	Fractured stringer end connection in way of the parabolic bow structure		
<p><b>Sketch of damage</b></p>

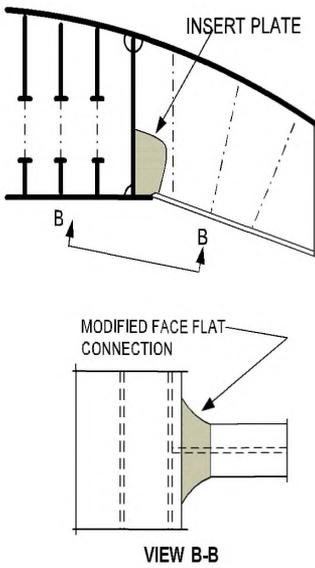
<p><b>Sketch of repair</b></p>

<p><b>Factors which may have caused damage</b></p> <ol style="list-style-type: none"> <li>1. High stress concentration of stringer to stiff girder/deep web intersection due to discontinuity of faceplate.</li> <li>2. Localised thinning in way of coating failure at stringer connection due to flexing of the structure.</li> <li>3. Dynamic seaway loadings at bow causing flexing in way of detail.</li> </ol>		<p><b>Notes on repairs</b></p> <p>See Sketch.</p>

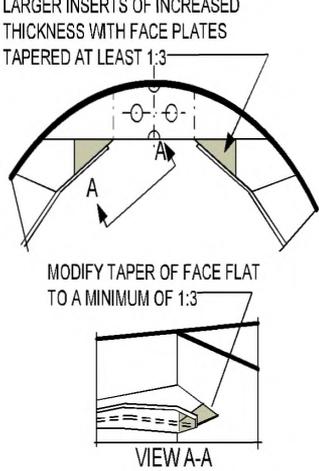
<b>OIL Tankers</b>		<b>Guidelines for Surveys, Assessment and Repair of Hull Structure</b>	
<b>Group 7</b>	<b>Fore region</b>	<b>Example No.</b>	
<b>Area 1</b>	<b>Forepeak ballast tank</b>	<b>6</b>	
<b>Detail of damage</b>		Fracture at end of longitudinal at bow structure.	
<b>Sketch of damage</b>		<b>Sketch of repair</b>

<p>A cross-sectional sketch of the repair. It shows 'LARGER INSERTS OF INCREASED THICKNESS WITH FACE PLATES TAPERED AT LEAST 1:3' at the ends of the side longitudinals. A section line 'A-A' is shown. Below is a detail view 'VIEW A-A' showing the 'MODIFY TAPER OF FACE FLAT TO A MINIMUM OF 1:3'.</p>

<b>Factors which may have caused damage</b>		<b>Notes on repairs</b>	
<ol style="list-style-type: none"> <li>1. Inadequate brackets forming the longitudinal endings at bow structure.</li> <li>2. Localised thinning in way of coating failure at longitudinal endings due to flexing of the structure.</li> <li>3. Dynamic seaway loadings at bow causing flexing at longitudinal endings.</li> </ol>		<p>See Sketch.</p>

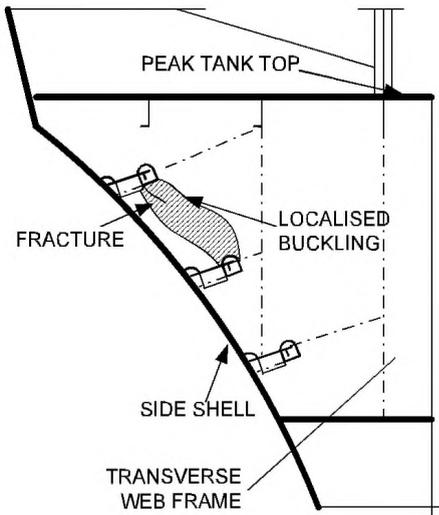
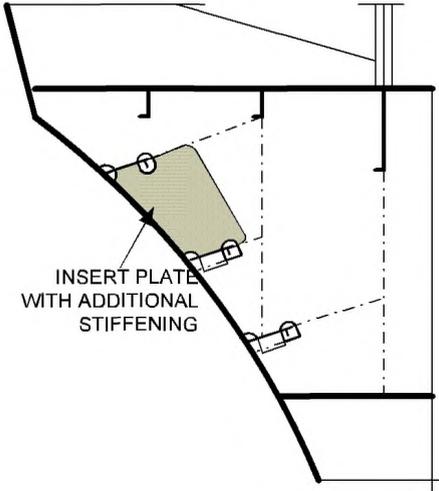
OIL Tankers		Guidelines for Surveys, Assessment and Repair of Hull Structure	
Group 7	Fore region	Example No.	
Area 1	Forepeak ballast tank	7	
Detail of damage		Fracture and buckle of bow transverse web frame in way of longitudinal cut-outs.	
Sketch of damage		Sketch of repair

<p><b>Factors which may have caused damage</b></p> <ol style="list-style-type: none"> <li>1. Localised thinning in way of coating failure at cut-outs and sharp edges due to working of the structure.</li> <li>2. Dynamic seaway loadings in way of bow flare.</li> </ol>		<p><b>Notes on repairs</b></p> <p>See Sketch.</p>

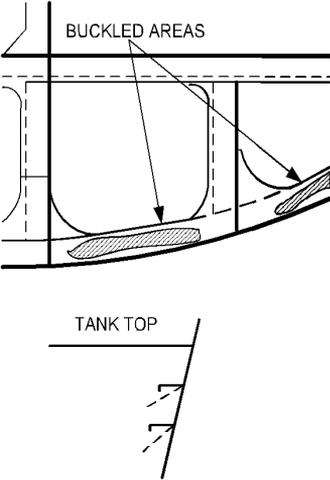
<b>OIL Tankers</b>		<b>Guidelines for Surveys, Assessment and Repair of Hull Structure</b>	
<b>Group 7</b>	<b>Fore region</b>	<b>Example No.</b>	
<b>Area 1</b>	<b>Fore peak ballast tank</b>	<b>8</b>	
<b>Detail of damage</b>		<b>Buckled and tripped breasthooks</b>	
<b>Sketch of damage</b>		<b>Sketch of repair</b>

<p>The sketch shows a cross-section of the fore peak ballast tank structure. A horizontal line at the top is labeled 'BUCKLED AREAS' with arrows pointing to two downward-curving sections. Below this, a dashed line represents the 'TANK TOP'. A separate detail sketch shows a vertical line labeled 'TANK TOP' with three diagonal lines branching downwards, representing the structure's profile.</p>

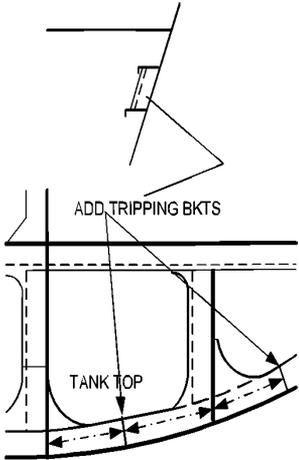
<p>The repair sketch shows the same cross-section as the damage sketch. A detail sketch at the top shows a vertical line with a horizontal bracket-like structure. Below, the main sketch shows the 'TANK TOP' and 'ADD TRIPPING BKTS' (brackets) added to the structure. Arrows indicate the location of these brackets along the tank top.</p>

<b>Factors which may have caused damage</b>		<b>Notes on repairs</b>	
<ol style="list-style-type: none"> <li>1. Bow impact load.</li> <li>2. Low buckling resistance.</li> </ol>		<p>See Sketch.</p>

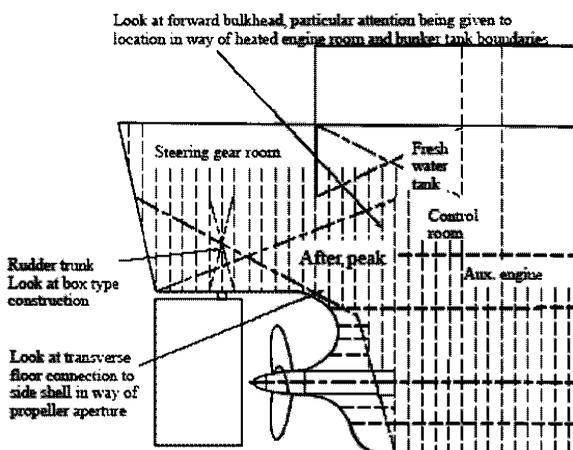
Figure 1 Aft end structure - Potential problem areas

2.1.1 Wastage (and possible subsequent fractures) is more likely to be initiated at in the locations as indicated in Figure 1. A close-up survey should be carried out with selection of representative thickness measurements to determine the extent of corrosion. Particular attention should be given to bunker tank boundaries and spaces adjacent to heated engine room.

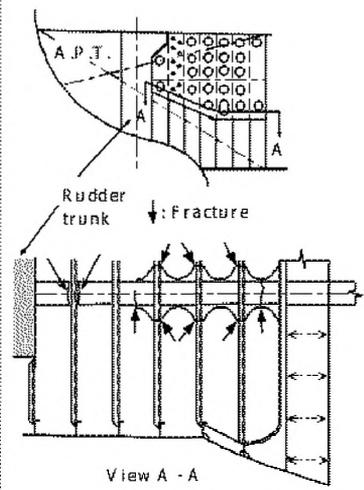
OIL Tankers		Guidelines for Surveys, Assessment and Repair of Hull Structure	
Group 7	Aft region	Example No.	
Area 2	Aft peak ballast tank	10	
Detail of damage		Fractures at the connection of floors and girders/side brackets	
<p><b>Sketch of damage</b></p>

3.3.2 In order to prevent recurrence of damages suspected to be caused by main engine or propeller excited vibration, the cause of the vibration should be ascertained and additional reinforcements provided as found necessary (See Examples 9 and 10).

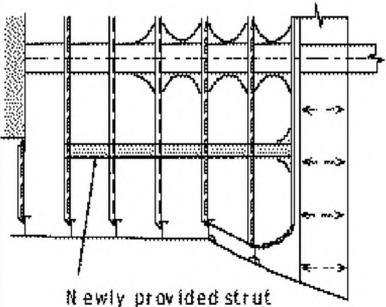
<p><b>Sketch of repair</b></p>

<p><b>Factors which may have caused damage</b></p> <ol style="list-style-type: none"> <li>1. Vibration.</li> </ol>		<p><b>Notes on repairs</b></p> <ol style="list-style-type: none"> <li>1. The fractured plating should be cropped and renewed.</li> <li>2. Natural frequency of the panel should be changed, e.g. reinforcement by additional strut.</li> </ol>

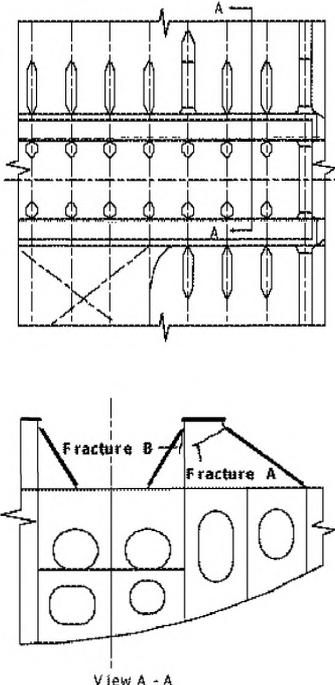
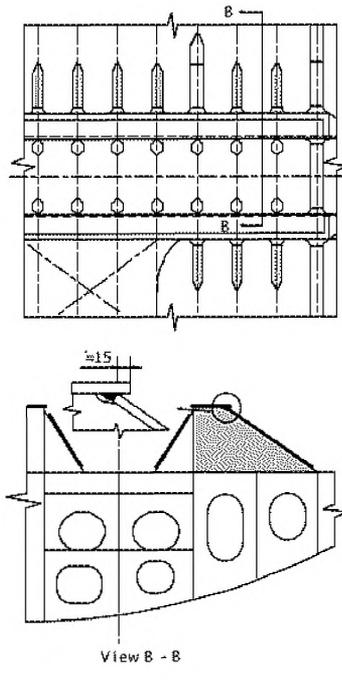
<b>OIL Tankers</b>		<b>Guidelines for Surveys, Assessment and Repair of Hull Structure</b>	
<b>Group 8</b>	<b>Machinery and accommodation spaces</b>	<b>Example No.</b>	
<b>Area 1</b>	<b>Engine room</b>	<b>1</b>	
<b>Detail of damage</b>		<b>Fractures in brackets at main engine foundation</b>	
<b>Sketch of damage</b>		<b>Sketch of repair</b>

<b>Factors which may have caused damage</b>		<b>Notes on repairs</b>	
<ol style="list-style-type: none"> <li>1. Vibration of main engine.</li> <li>2. Insufficient strength of brackets at main engine foundation.</li> <li>3. Insufficient pre-load of the bolts.</li> </ol>		<ol style="list-style-type: none"> <li>1. Fractures may be veed-out and rewelded.</li> <li>2. New modified brackets at main engine foundation.</li> <li>3. Or insert pieces and additional flanges to increase section modulus of the brackets.</li> </ol>

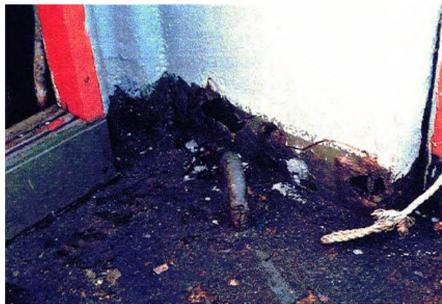
**Photograph 1 Corroded accommodation house side structure**

Severe corrosion may be found in exposed deck plating and deck house side structure adjacent to the deck plating where water is liable to accumulate (See **Photograph 1**). Corrosion may also be found in accommodation bulkheads around cut-out for fittings, such as doors, side scuttles, ventilators, etc., where proper maintenance of the area is relatively difficult. Deterioration of the bulkheads including fittings may impair the integrity of weathertightness.

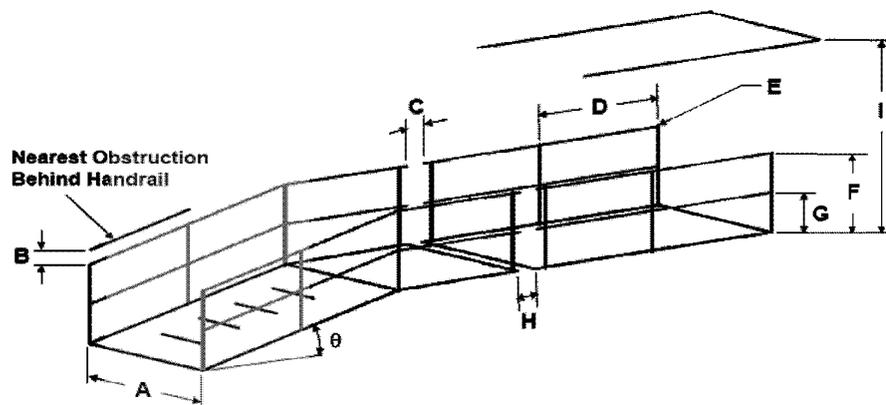
- 1 Toeboard omitted for clarity
- 2 The walkway width may be diminished to ≥ 500 mm around a walkway structure web frames
